## BUILDING SURVEY

Example Composite Cottage  
Made Up Road  
Truro  
TR1 2SQ

Julian P Crosby FRICS  
DowlingDodd  
Chartered Surveyors  
2A River Street  
Truro Cornwall TR1 2SQ

11<sup>th</sup> June 2010

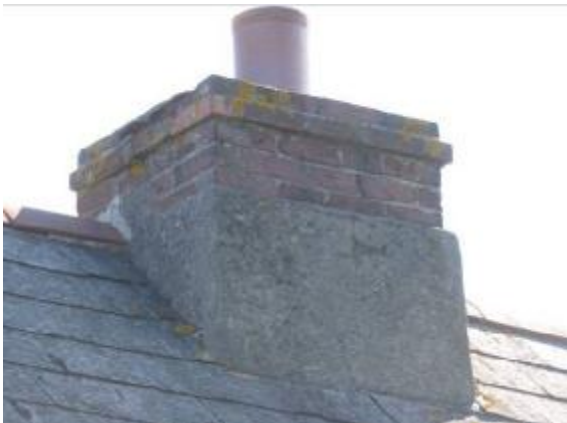
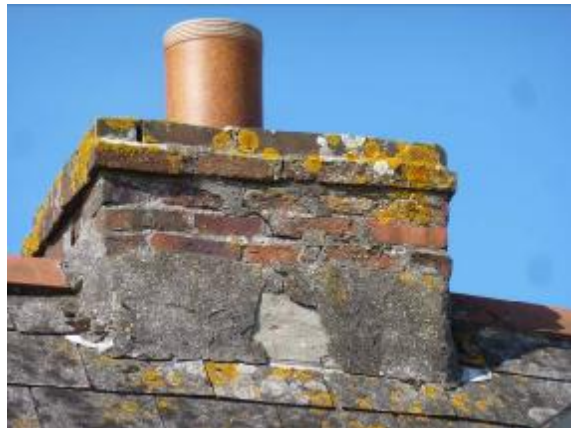
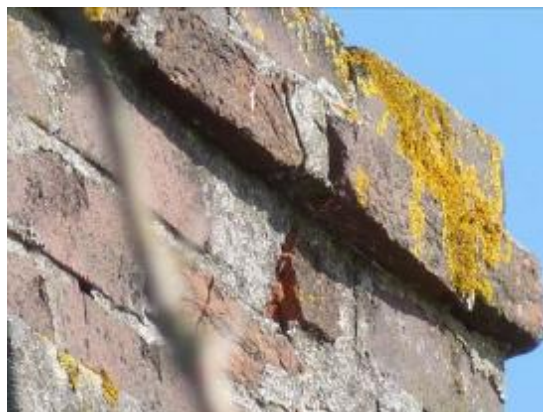
The pointing to the brickwork is becoming a little worn and weathered and indeed on the south eastern side you can clearly see where one or two bricks are beginning to perish.

The render is also a little cracked and in fact a section of render on the north eastern side has fallen away. The render itself has been carried down to the surface of the tiles and therefore it is hard to judge the extent of leadwork.

I recommend that some re-pointing now be carried out to the chimney and if individual bricks are found to be perished beyond repair then they should be replaced. A rain cap as I have said should be fitted and I also recommend that you consider having the render renewed and forming a proper bell cast at the base of the chimney over the leadwork. This should help ensure the chimney remains waterproof as possible to reduce the risk of dampness becoming a problem later.

You should note however that specialist access equipment will be needed and this could add to the cost.

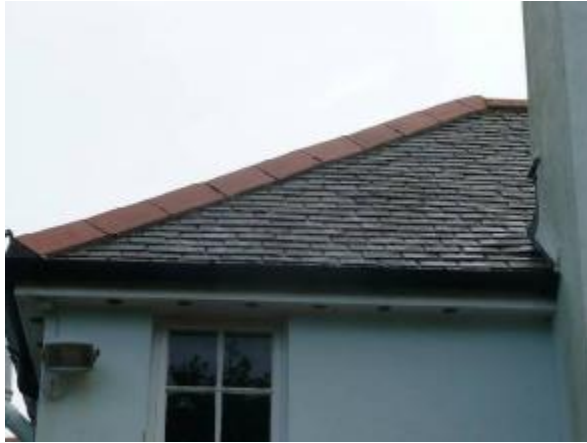
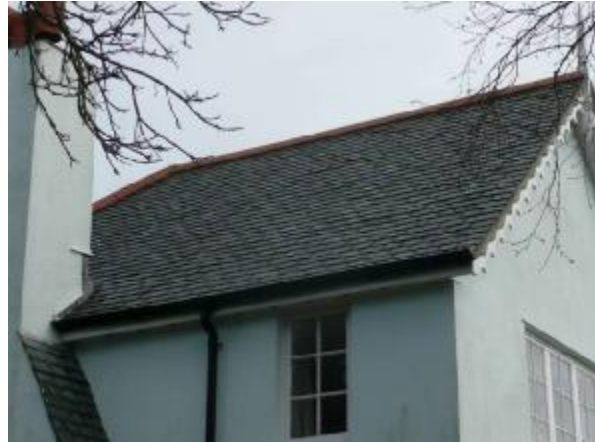
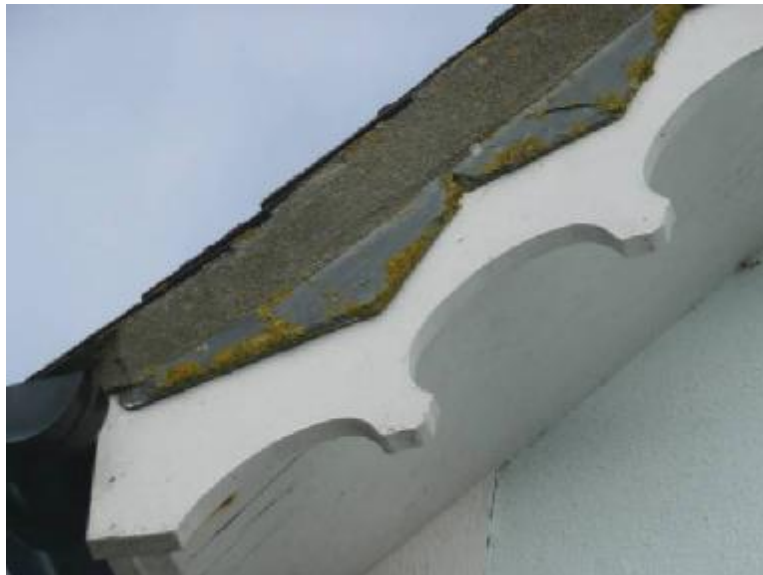
- 1) This is the west facing roof slope over the re-built section of the building. The slope is true, straight and uniform, with no indication of deflection or distortion. Hip and ridge tiles are reasonably well bedded, with proper hip irons provided at the bottom of the hip to stop tiles slipping. No evidence of slippage or significant damage was noted to the slates. The southern verge is pointed with sand and cement on top of the slate which is attached to the barge board; this sand and cement is adequately adhered at the present moment.

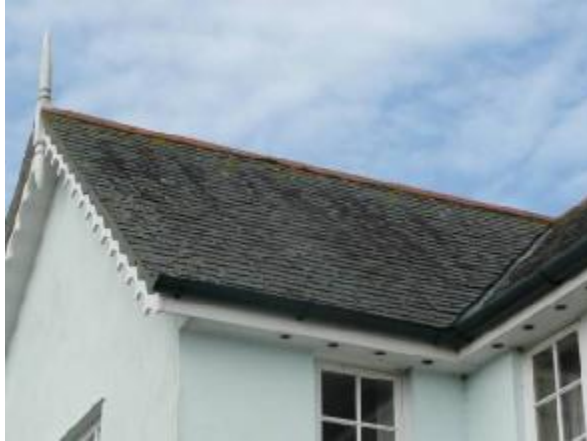
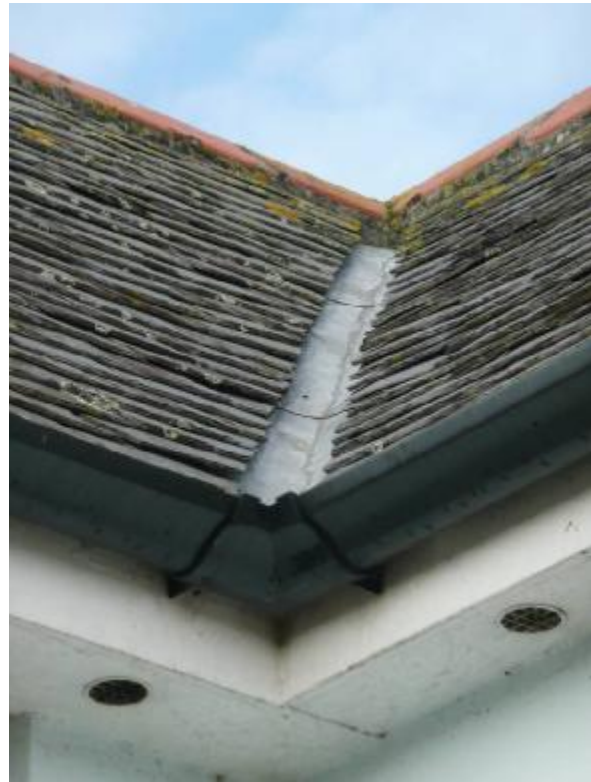
- 2) This is the east facing roof slope over the newly built section. Again the roof slope was true, straight and uniform, with no evidence of significant slippage or damage noted to the slates. Verges are adequately pointed with sand and cement and the valley at the junction of 2 and 3 is formed with lead with three lengths of lead sheeting to take up expansion or contraction that may occur and reduce the likelihood of lead splitting. The valley was clear and free of debris.

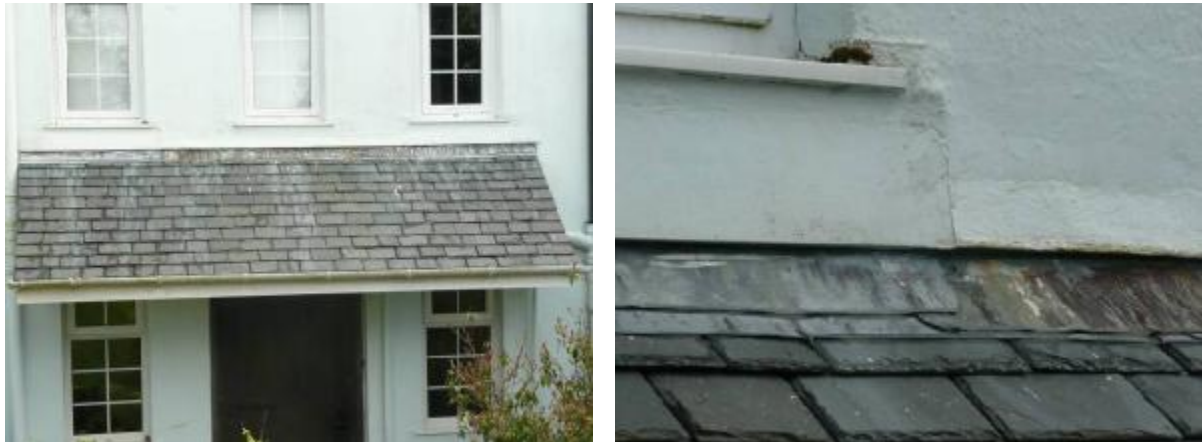
- 12) This is a small pitched slate roof over entrance area. Proper lead flashings are formed at the abutment with the western wall of the building to create a weatherproof seal, although there is some slight evidence of cracking to the bell cast and patch repairs will be needed.

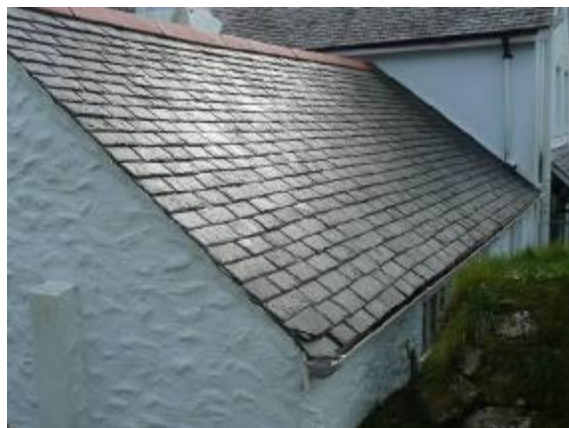
- 13) West-facing roof slope over the breakfast area clad with natural slate with clay roof tiles and lead details formed to its northern end where it abuts the flank wall of the main building. Damage to slates on the north-western corner will need to be repaired and felt where lapped into the gutters is starting to perish.

As I said earlier, the bottom layer of roofing felt will need renewal.

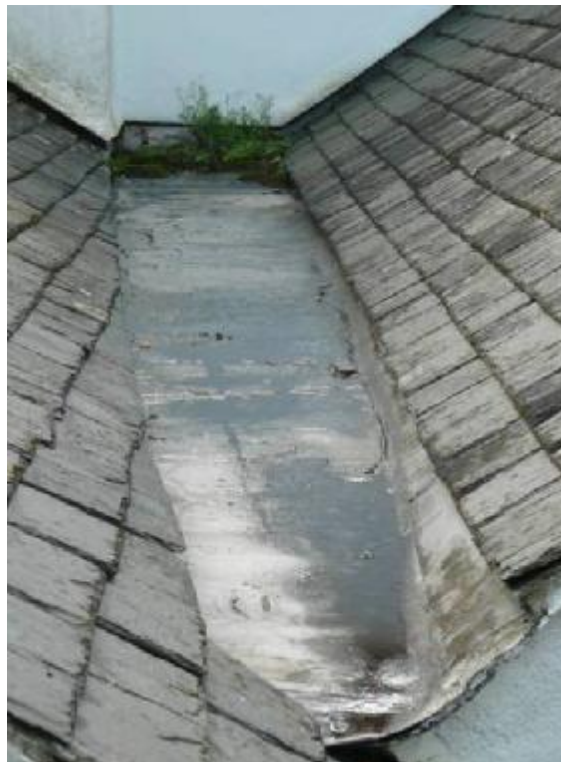
Valley gutter between slopes 14 and 15 formed with bituminous felt run under slates. Some evidence of wear to the surface of the felt but internally there is no sign of any leaks. The valley is becoming quite congested towards the southern end and will need to be cleared. Being of bituminous felt, it is not going to have the same life expectancy as lead and replacement will be needed from time to time.

The older slate roofs I consider are serviceable and should continue to be so subject to routine maintenance and repair. The felt lined valley on the northern side will, however, perish and fail in time, in the short term it needs to be cleared, but in the longer term replacement will probably be required.

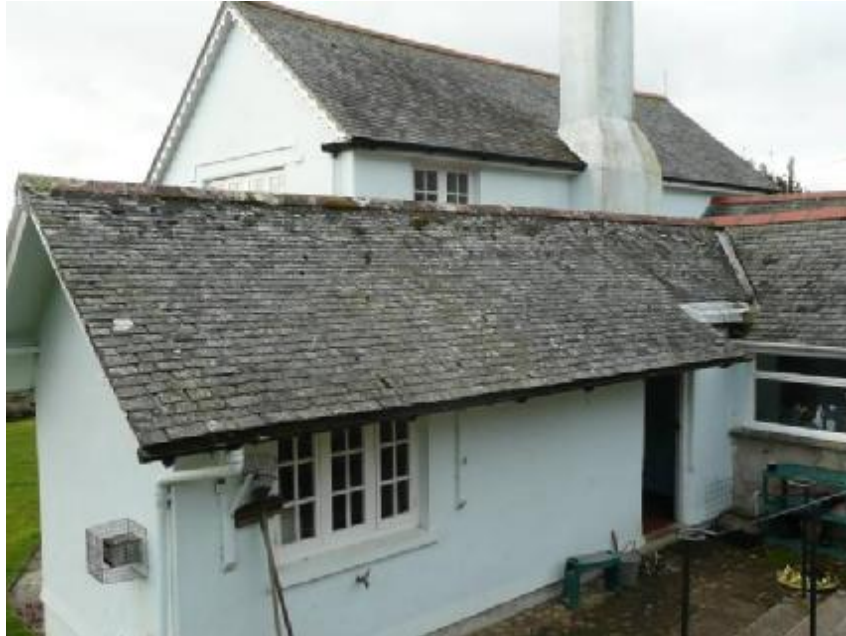
- 17) Natural slate roof over utility area, north-facing. This is an older slate roof which was not recovered at the same time as the other slopes. One or two cracked broken and slipped slates and some weathering noted to ridge tiles.

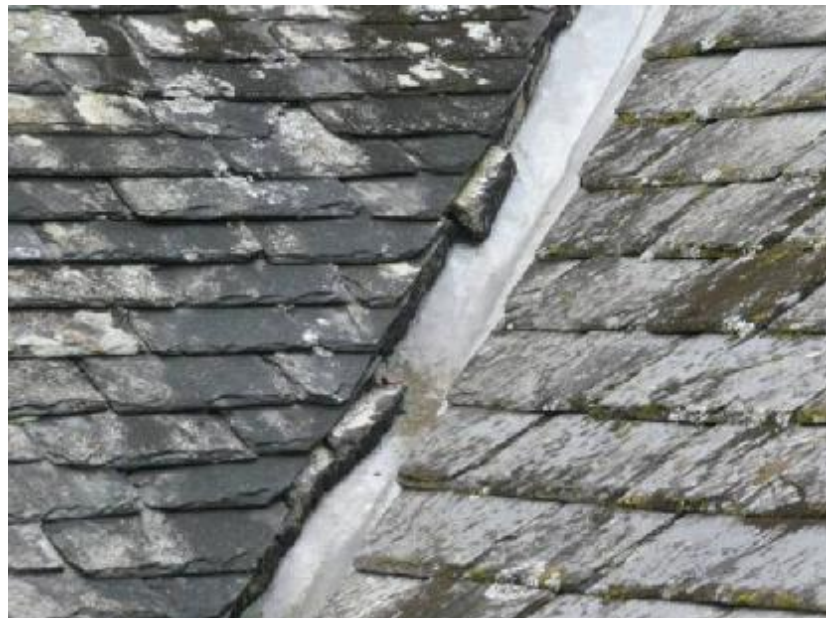
The valley abutment with roof slope 16 formed with lead. Joints provided to take up expansion, although pointing to the sides of the valley is starting to wear and come loose, re-pointing required.

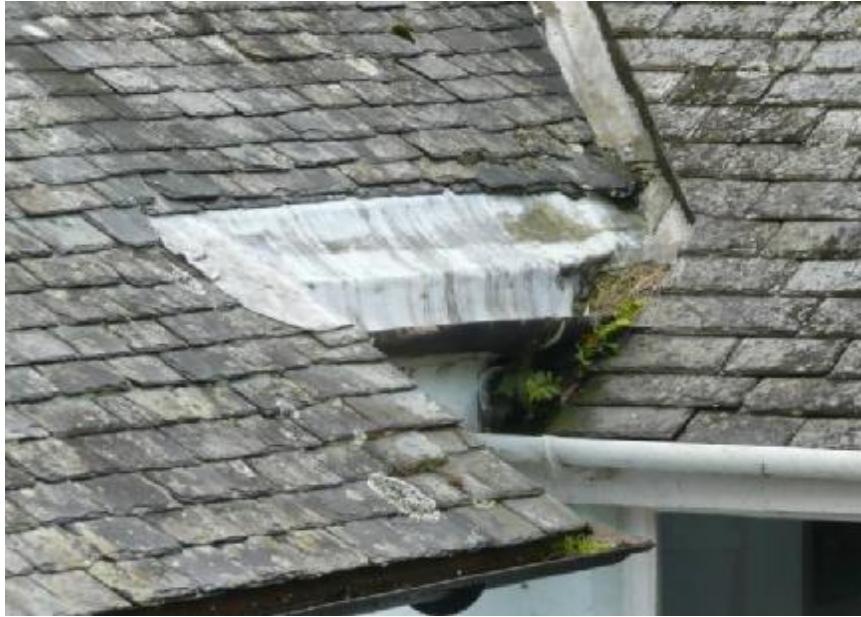
The valley is becoming quite choked and congested, particularly bottom edge, the area will need to be cleared of debris; otherwise damp penetration is going to occur.

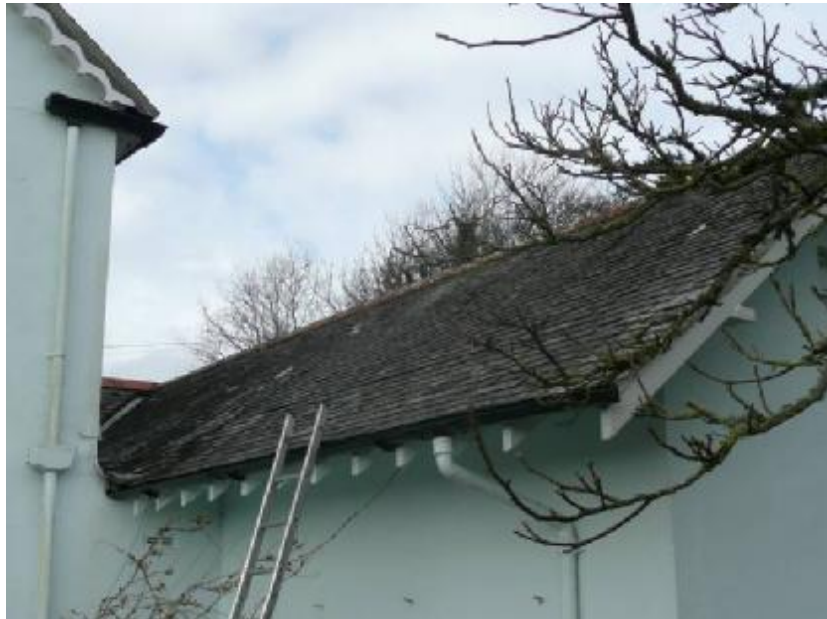
- 18) An older slate roof over the utility area, south-facing. One or two cracked broken slipped slates, roof slope generally uniform.

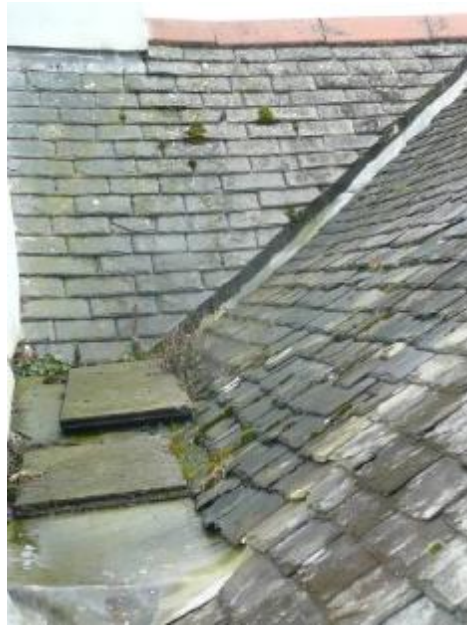
- 19) Older natural slate roof in satisfactory repair with valley at abutment with roof slope 18. Valley formed with lead, generally in satisfactory condition, however, becoming congested and choked towards its bottom edge. Further valley gutter then between roof slope 18 and the wall of the building lined with lead; again needs to be cleared and boards removed so that water can discharge freely, but internally at the moment no sign of any leaks.

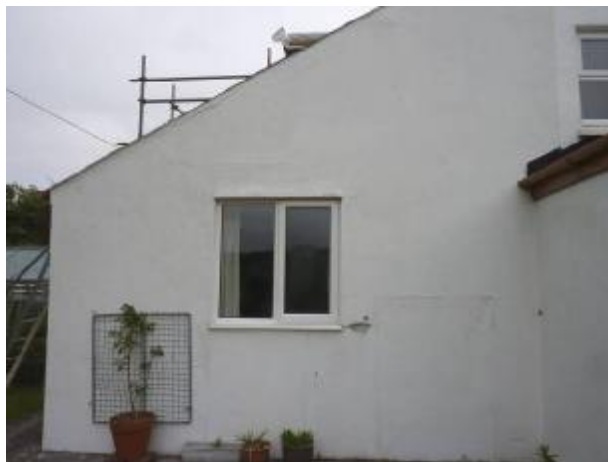
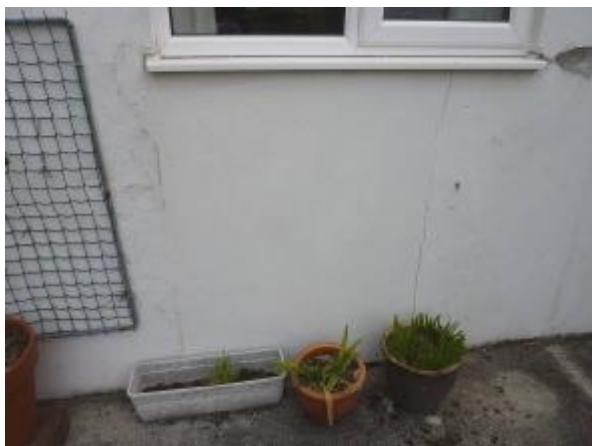
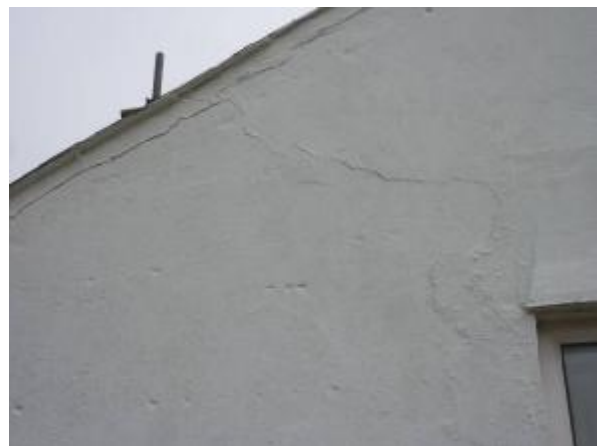
The render finishes are reasonably uniform and there is no sign of any serious movement. There is some slight cracking however that has occurred above the bedroom window and the photographs which were shown me indicate that there was in fact a door in the position of the window originally and you can see where cracking has occurred where the doorway has been blocked up.

There is further slight cracking to the underside of the verge. This I do not consider is of any great significance but I suggest that the render crack be raked out and filled when you redecorate.

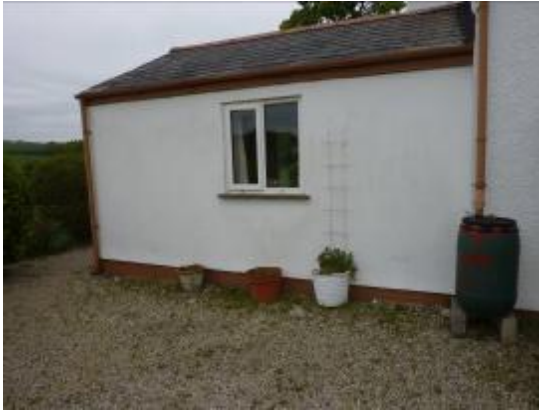
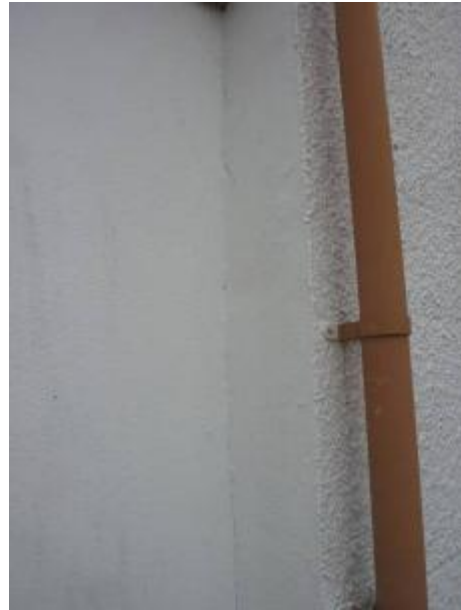
The lounge again is of some 300mm cavity concrete blockwork with sand and cement render finish. On its eastern elevation there is some slight cracking below the eastern window and fine cracking at the junction with this extension of the original building but all of this is within acceptable tolerances and can be raked out and filled when you redecorate.

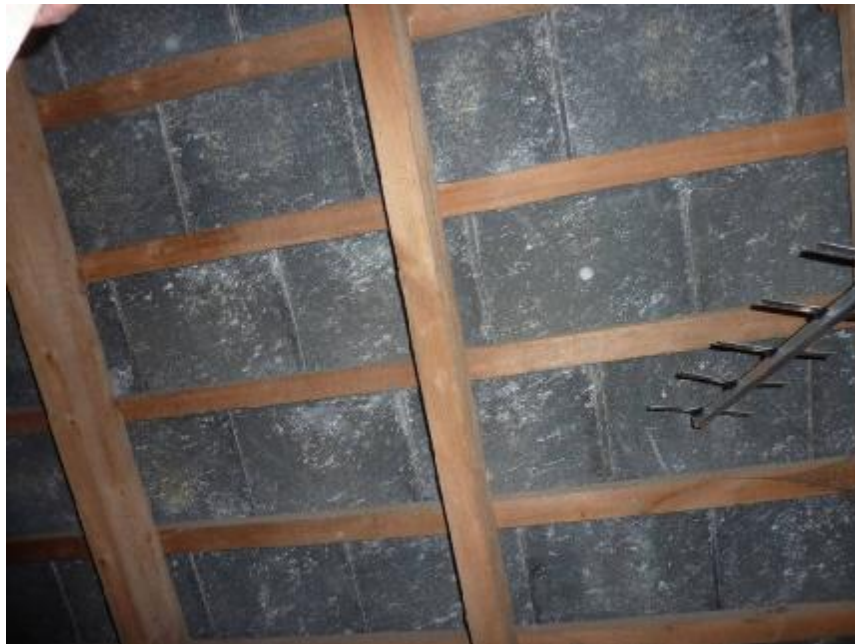
I found evidence of an old infestation of wood boring beetle to some timbers in the roof space. This, however, does not seem to be active and I understand from the vendors that treatments have been carried out under a guarantee.

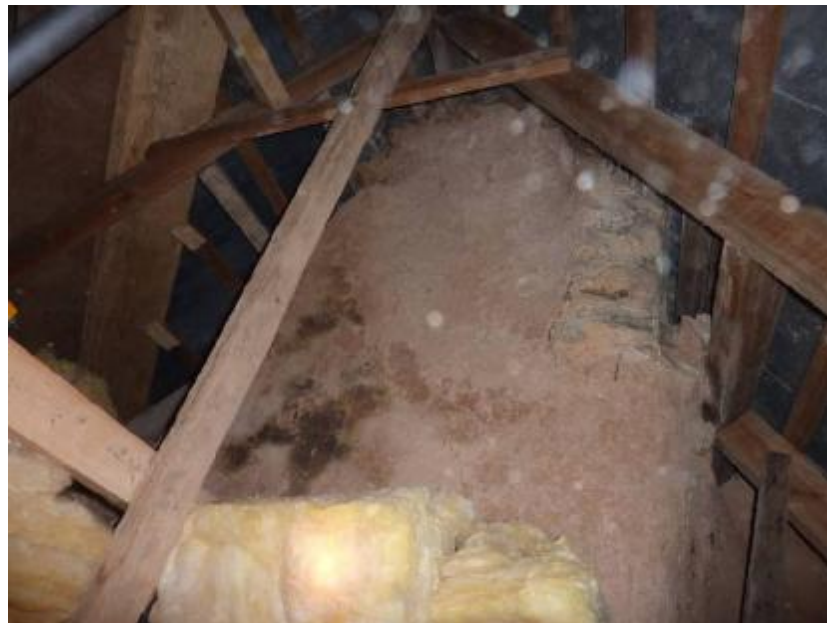
The south eastern party wall was also accessible; again this seems to be of cob incorporating the chimney breast. There is some slight fretting to the surface of the chimney breast and limited dampness but within acceptable tolerances and no more than I would have expected to find in a building of this age and type.

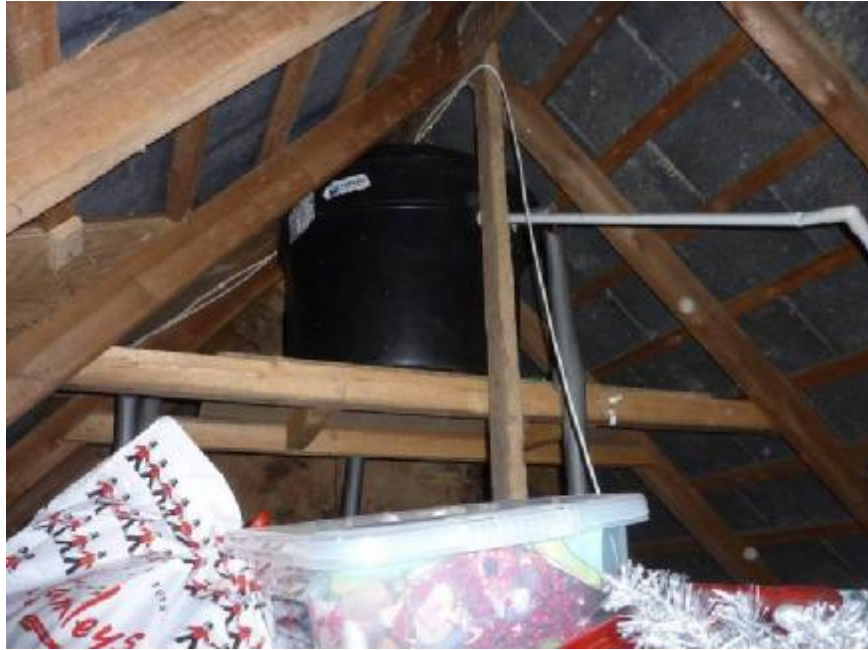
The cold water storage tank in this roof space needs to be better insulated to protect it from frost damage.
