## BUILDING SURVEY

**Example Composite Cottage  
Made Up Road  
Truro  
Cornwall  
TR1 2SQ**

3 January 2017

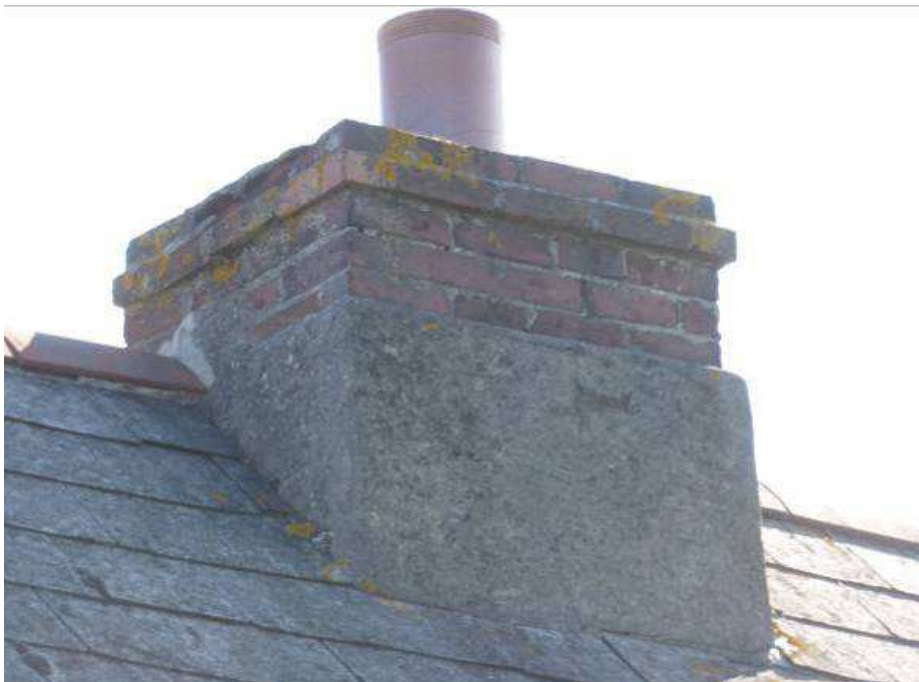
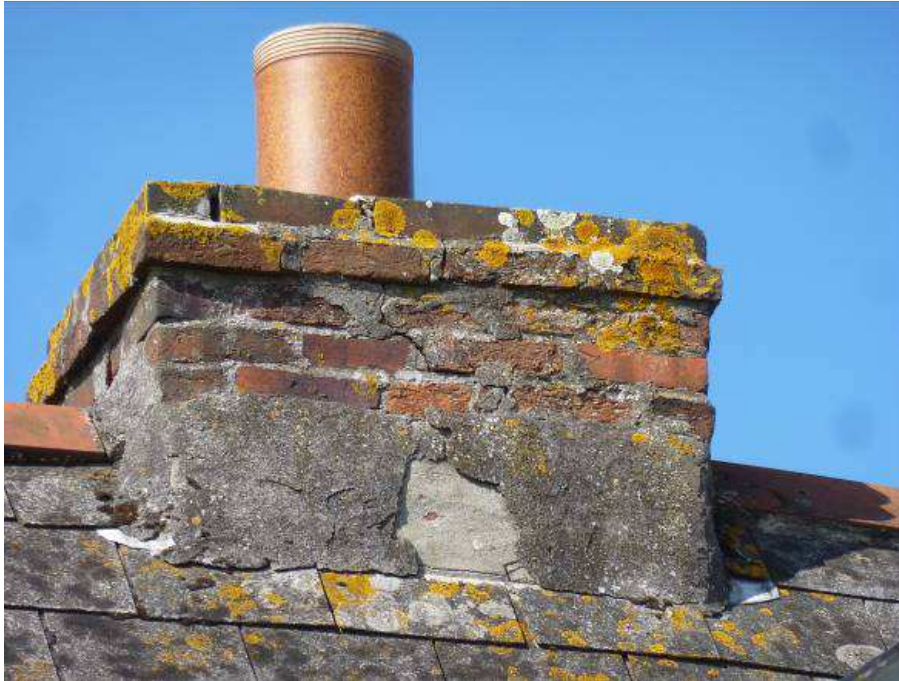
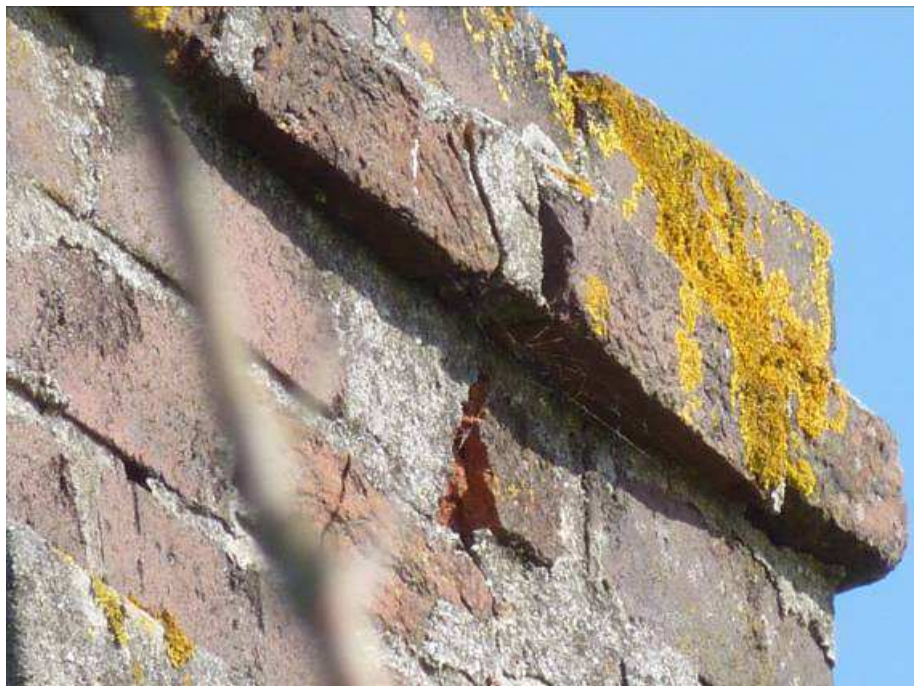
The pointing to the brickwork is becoming a little worn and weathered and indeed on the south eastern side you can clearly see where one or two bricks are beginning to perish.

The render is also a little cracked and in fact a section of render on the north eastern side has fallen away. The render itself has been carried down to the surface of the tiles and therefore it is hard to judge the extent of leadwork.

I recommend that some re-pointing now be carried out to the chimney and if individual bricks are found to be perished beyond repair, they should be replaced. A rain cap as I have said should be fitted and I also recommend that you consider having the render renewed, forming a proper bell cast at the base of the chimney over the leadwork. This should help ensure the chimney remains as waterproof as possible to reduce the risk of dampness becoming a problem later.

You should note, however, that specialist access equipment will be needed and this could add to the cost.

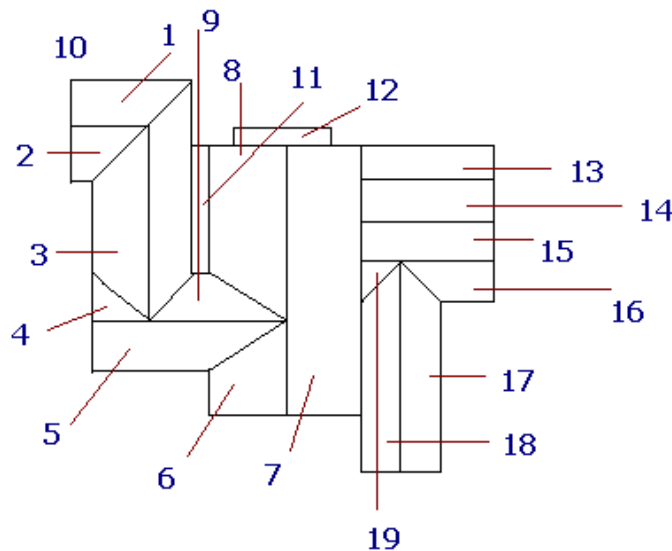
I shall describe the individual roof slopes below and for ease of reference and in addition to photographs, the annotated sketch plan identifies individual slopes.

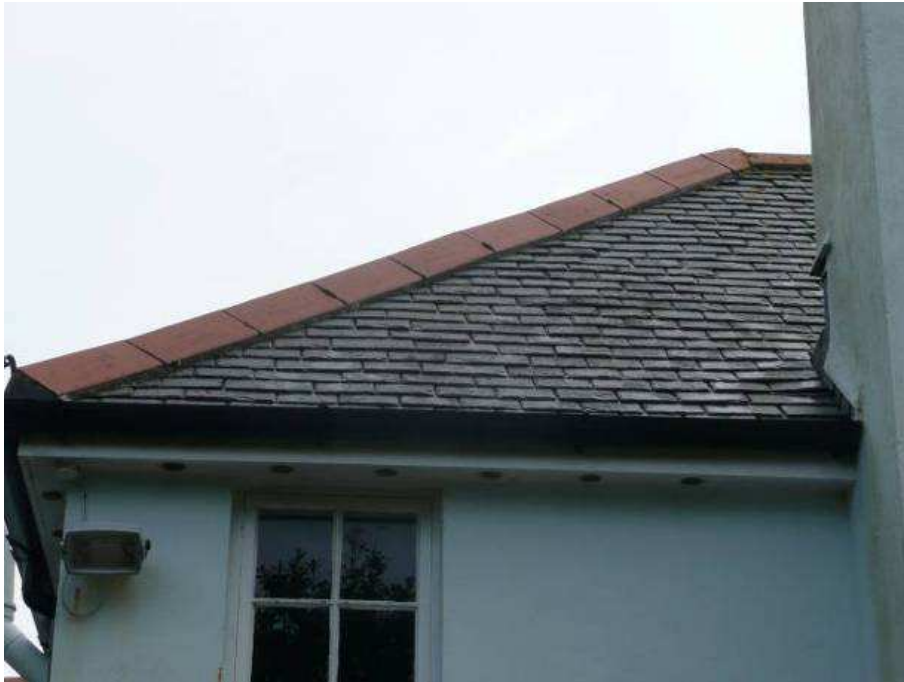
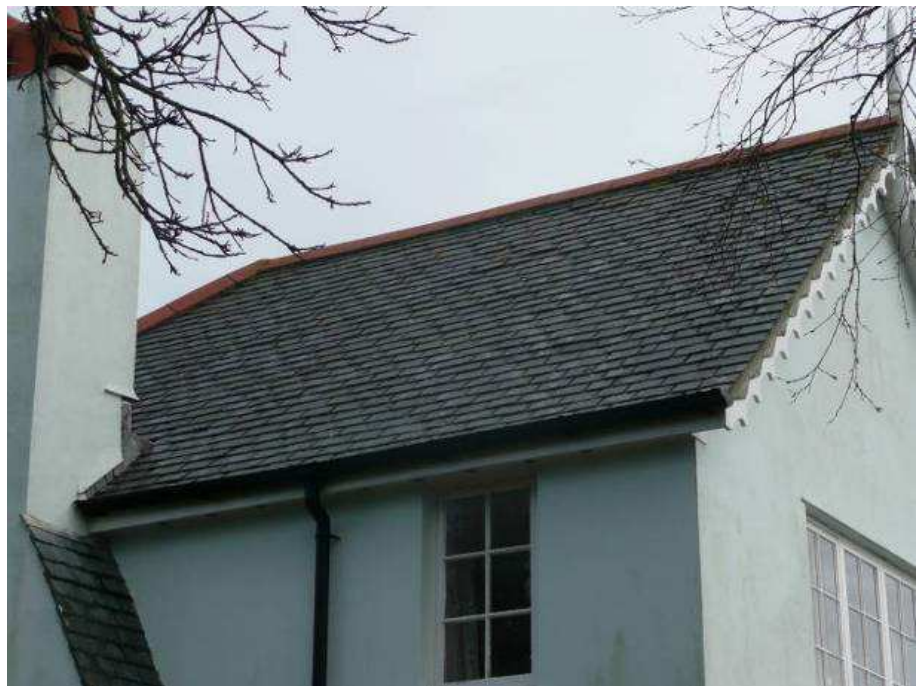
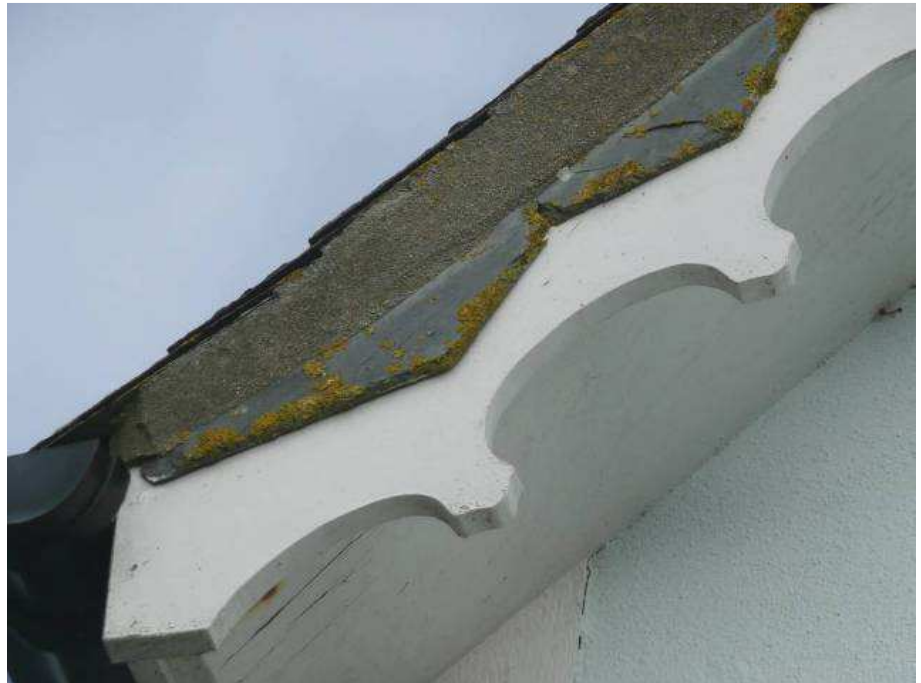
- 1) This is the west facing roof slope over the re-built section of the building. The slope is true, straight and uniform with no indication of deflection or distortion. Hip and ridge tiles are reasonably well bedded with proper hip irons provided at the bottom of the hip to stop tiles slipping. No evidence of slippage or significant damage was noted to the slates. The southern verge is pointed with sand and cement on top of the slate which is attached to the barge board; the sand and cement is adequately adhered at the present moment.

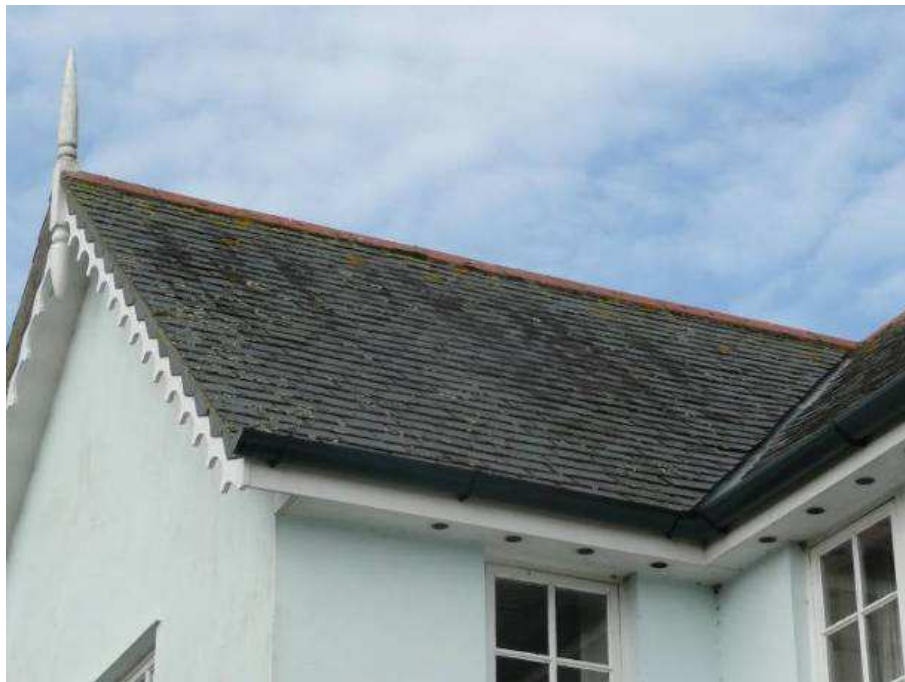
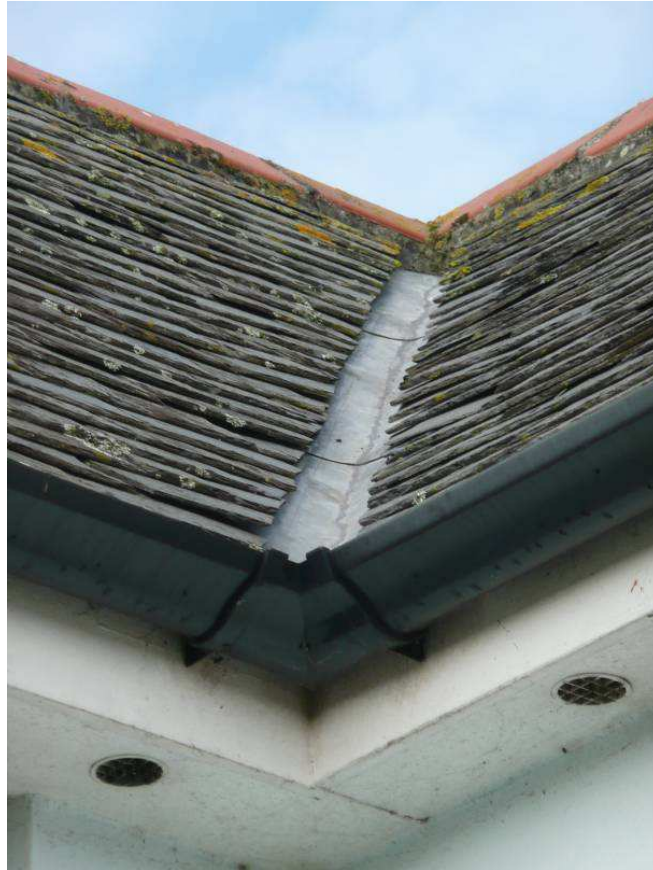
- 2) This is the east facing roof slope over the newly built section. Again, the roof slope was true, straight and uniform with no evidence of significant slippage or damage noted to the slates. Verges are adequately pointed with sand and cement and the valley at the junction of 2 and 3 is formed with lead with three lengths of lead sheeting to take up expansion or contraction that may occur and reduce the likelihood of lead splitting. The valley was clear and free of debris.

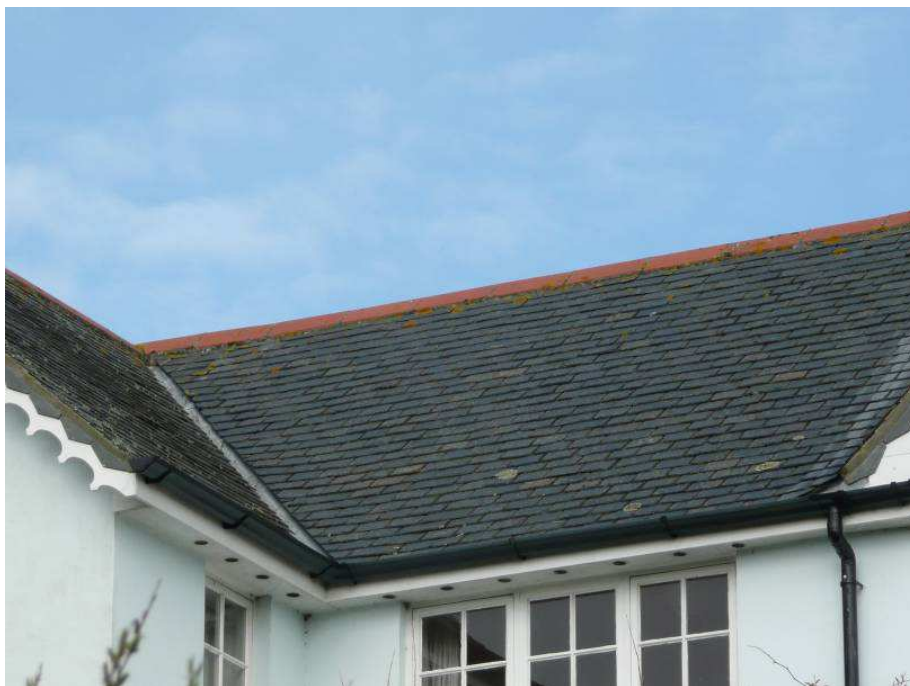
- 3) This is the south facing roof slope. The surface of the roof was true, straight and uniform with no sign of any slippage or significant damage to the slates and the ridge tiles adequately bedded.

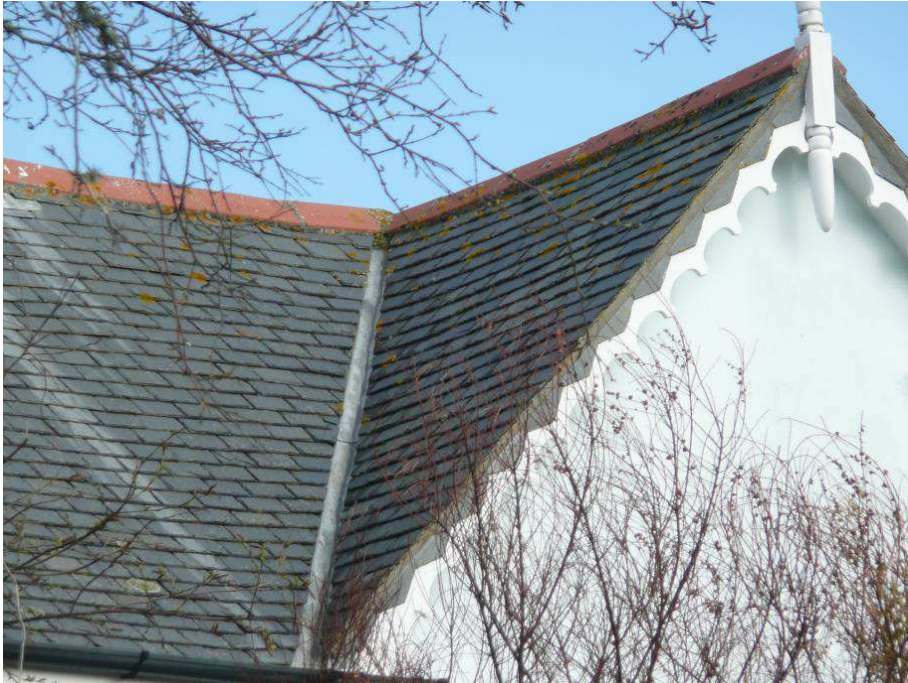
- 4) The west facing roof slope was true, straight and uniform; no significant slippage of slates was noted. Verges are pointed with sand and cement and are in satisfactory repair. The lead valley between slopes 3 and 4 is in satisfactory condition and clear of debris, and joints are provided to take up expansion and contraction of the leadwork.

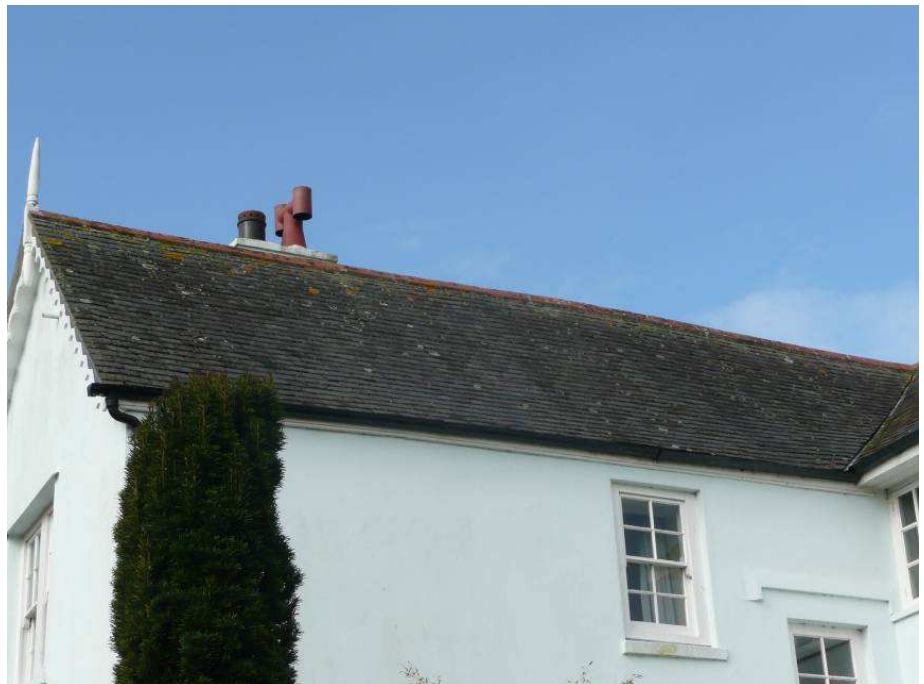
- 5) Again, this slope is true, straight and uniform with no evidence of any significant damage or slippage to the slates. Verges are pointed with sand and cement and in satisfactory condition. There is a slight rise in ridge tile corresponding with the original roof line.

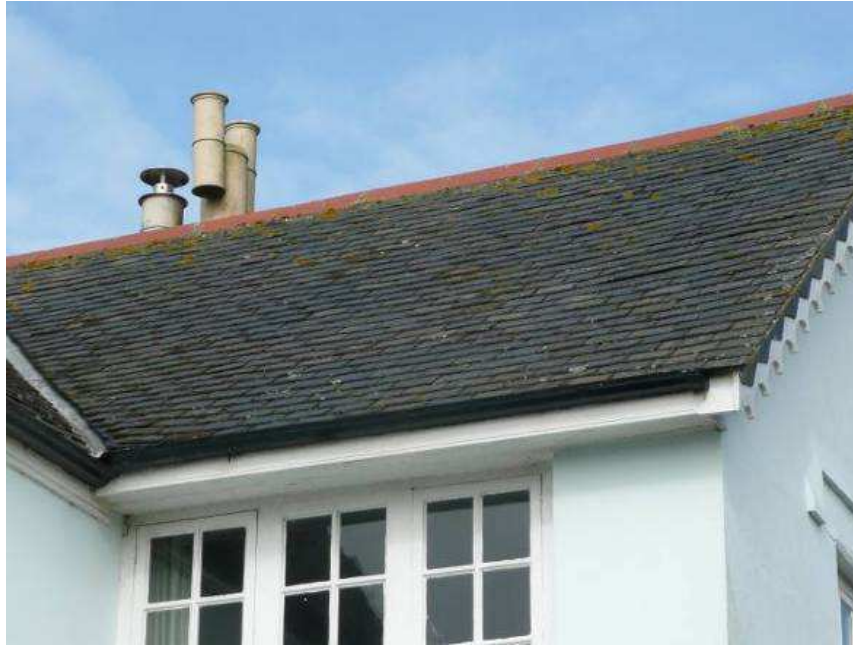
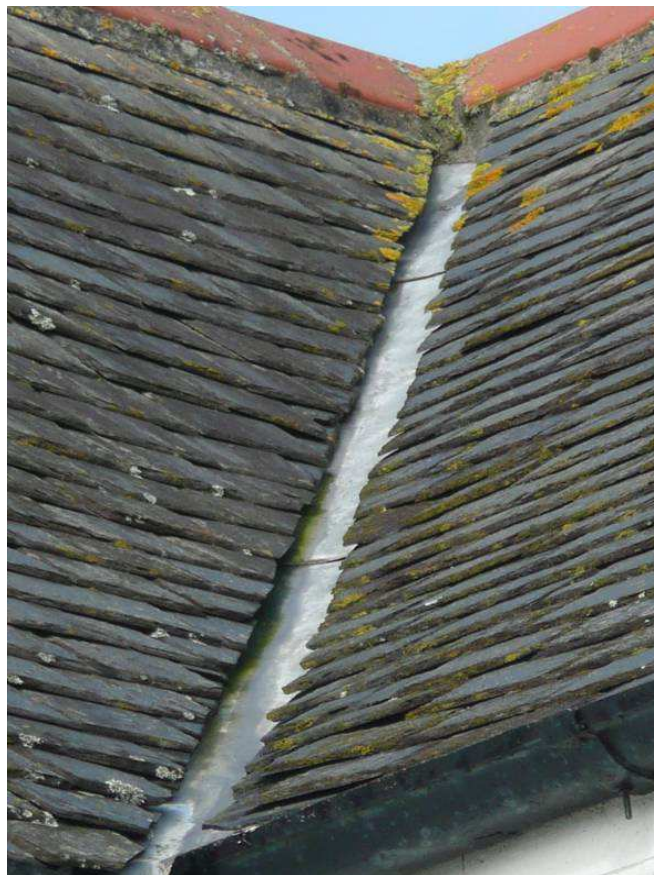
- 6) As with other slopes, this slope is covered with natural slate. The slope is true, straight and uniform and the ridge tiles are true and straight and adequately bedded. The verges are pointed with sand and cement and are in satisfactory condition. There was no sign of slippage or deflection to the slates or roof surface. The valley was clear of debris and joints are provided to the leadwork to take up expansion and contraction.

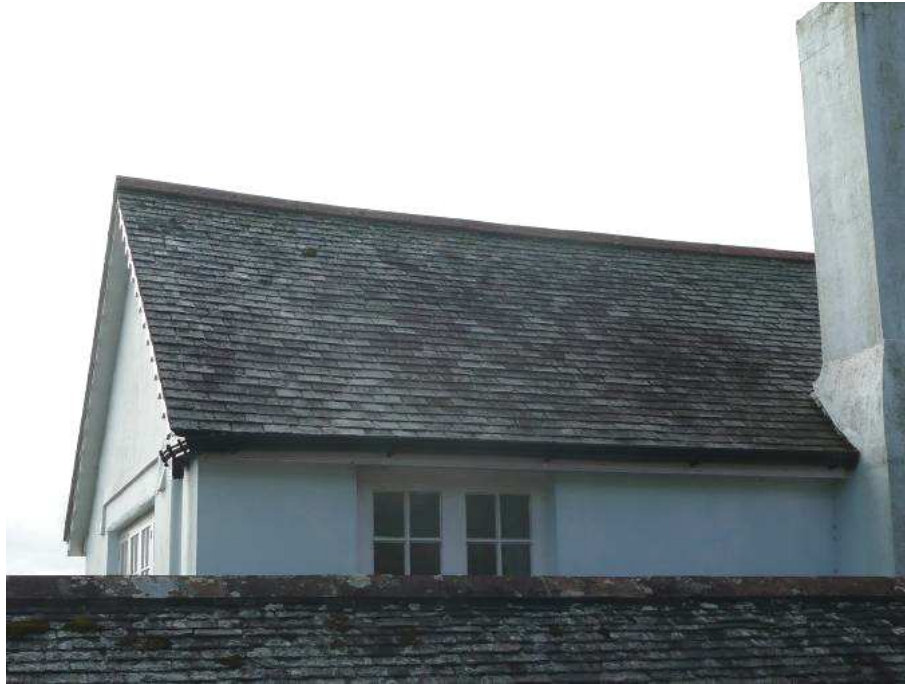
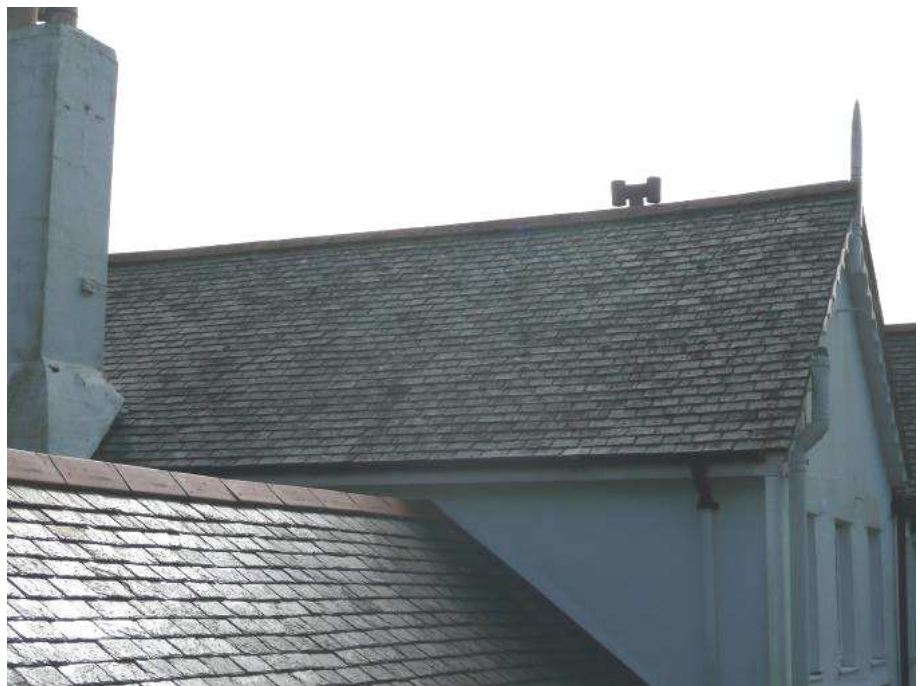
- 7) North facing roof slope. Again, I found this slope to be true, straight and uniform with no evidence of deflection or distortion or any significant damage to the slates. The pointed verges are in satisfactory repair.

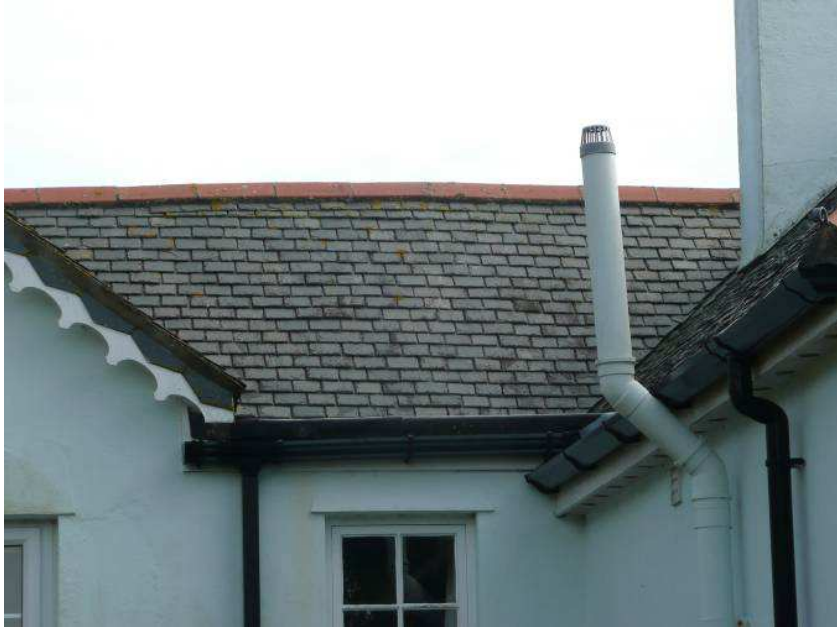
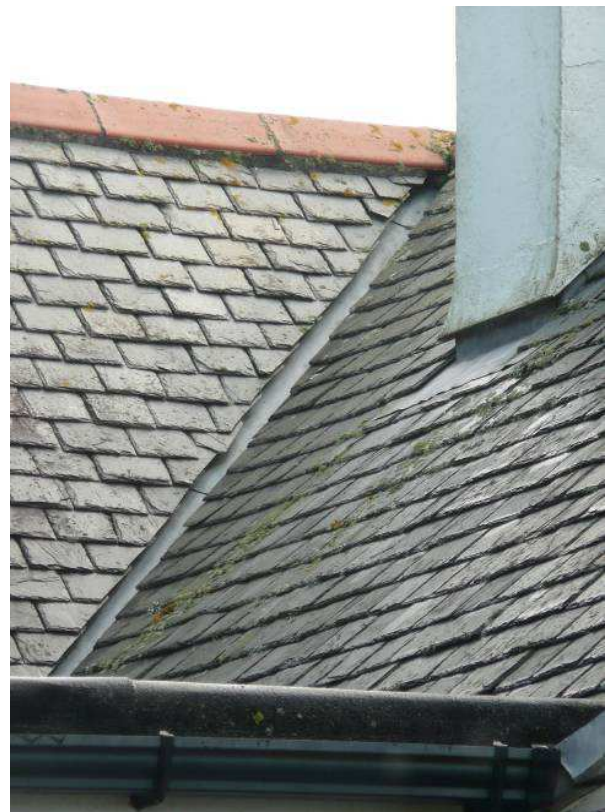
- 8) No vantage point could be gained from ground level where this roof slope could be viewed. The condition of the slates, therefore, could not be judged. The verges have been pointed in sand and cement and are in satisfactory repair. If you wish to confirm the condition of this roof slope, then you will need to arrange for access equipment to be made available. I would then be happy to return and inspect.
- 9) West-facing roof slope clad with natural slate; no sign of significant slippage. The valley abutment with roof slope 8 could not be viewed. The valley abutment with roof slope 10 appears satisfactory with joints provided to the lead and visible sections of the valley were clear of debris.

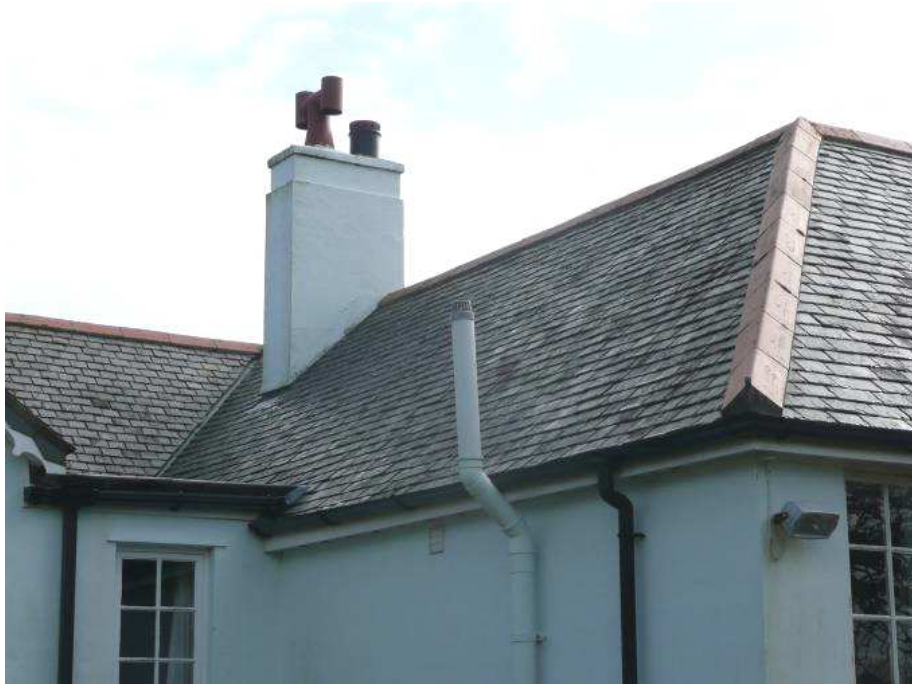
- 10) North-facing roof slope over the re-built section. Again, this roof slope I found to be true, straight and uniform and the hip and ridge tiles were adequately bedded; there was no evidence of any significant slippage or damage to the slates.

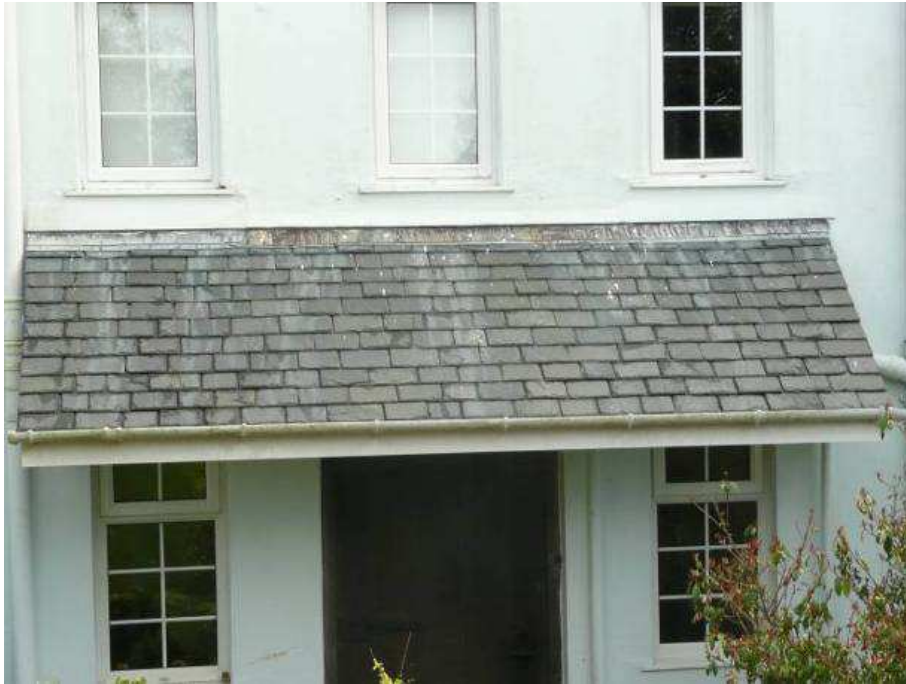
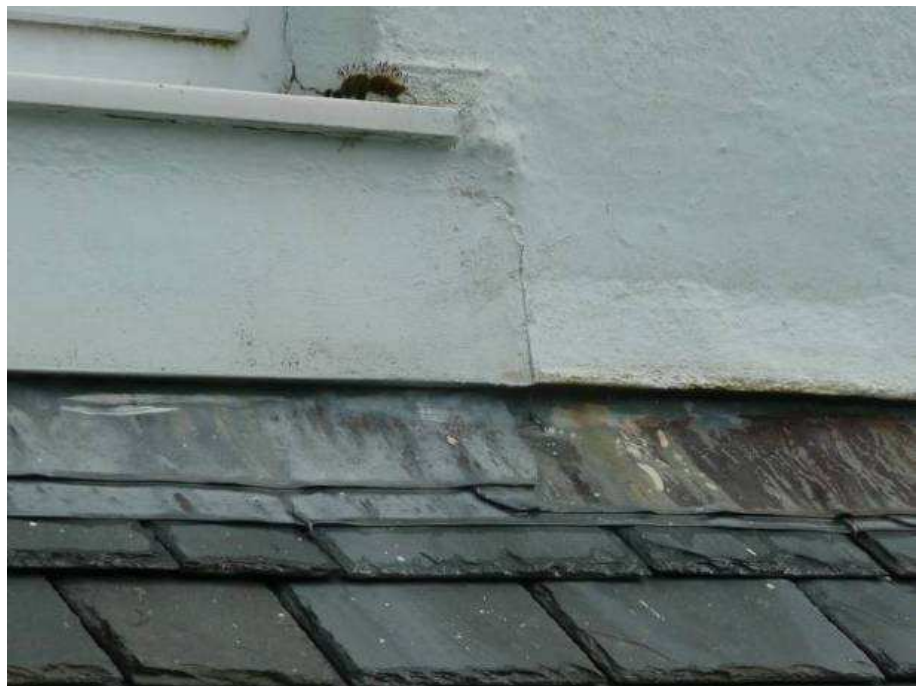
- 12) This is a small pitched slate roof over entrance the area. Proper lead flashings are formed at the abutment with the western wall of the building to create a weatherproof seal although there is some slight evidence of cracking to the bell cast and patch repairs will be needed.

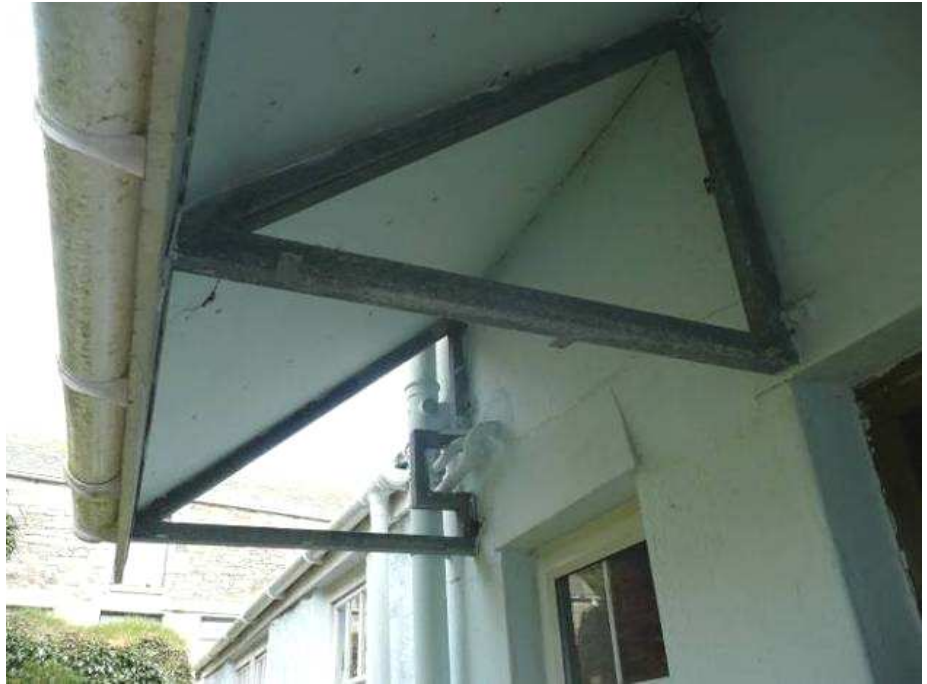
This roof is supported by a galvanised steel bracket fixed to the western wall of the building.

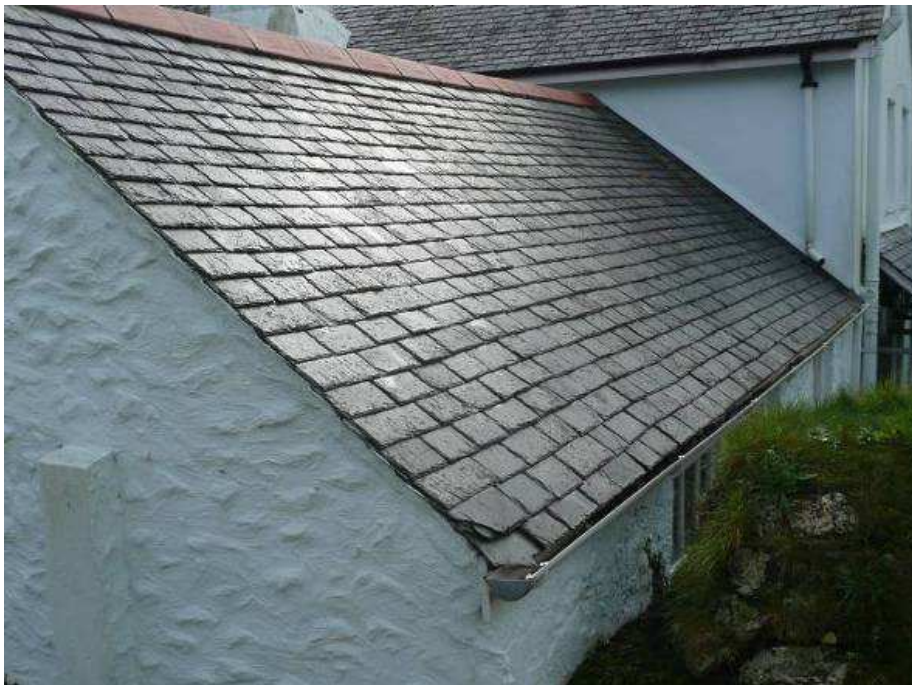
- 13) West facing roof slope over the breakfast area clad with natural slate with clay roof tiles and lead details formed to its northern end where it abuts the flank wall of the main building. Damage to slates on the north-western corner will need to be repaired and the felt, where lapped into the gutters, is starting to perish.

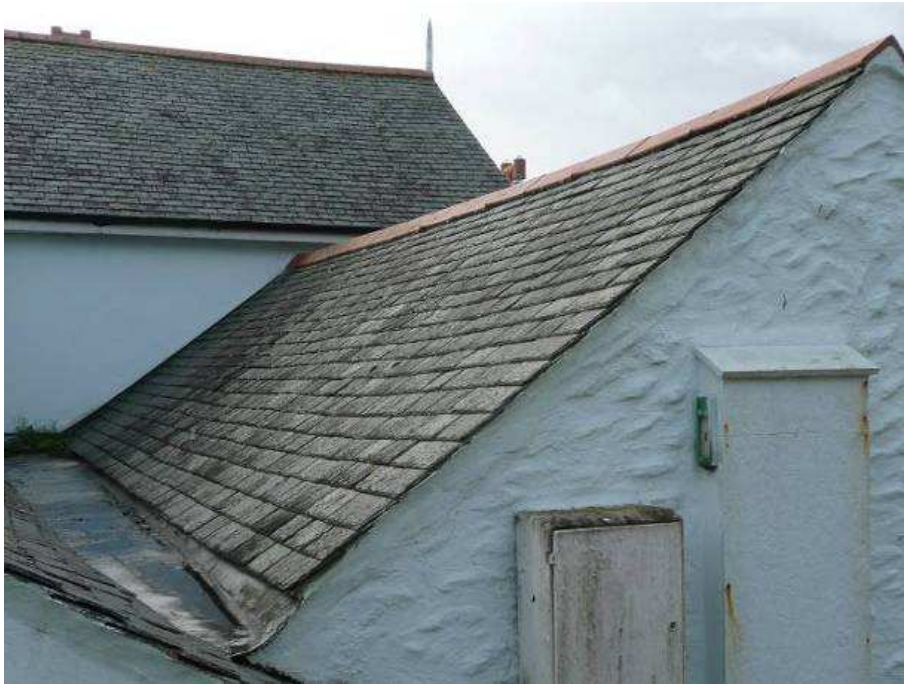
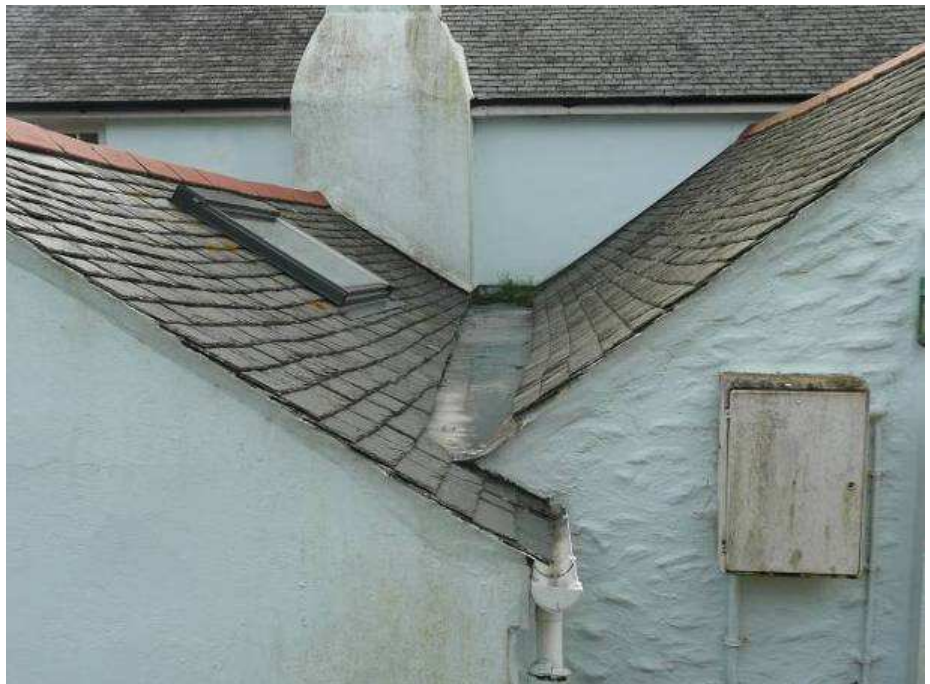
- 14) This roof surface is in satisfactory condition with no sign of any slippage or damage to the slates and lead flashings are formed at the abutment of the northern wall. Some general deflection, however, was noted to the roof surface where it follows the line of original timbers but this is within acceptable tolerances.

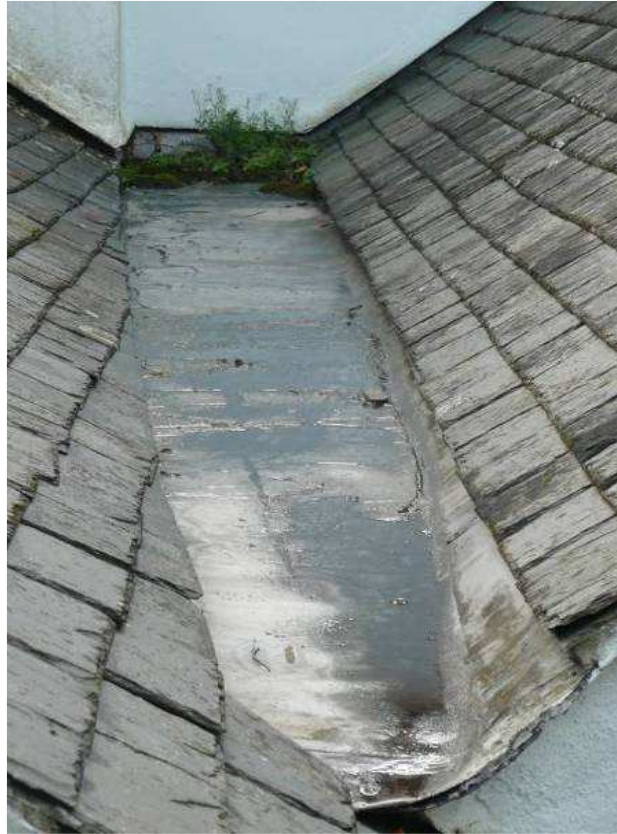
The valley gutter between slopes 14 and 15 is formed with bituminous felt run under the slates. There is some evidence of wear to the surface of the felt but internally there are no signs of any leaks. The valley is becoming quite congested towards the southern end and will need to be cleared. Being of bituminous felt, it is not going to have the same life expectancy as lead and replacement will be needed from time to time.

The older slate roofs, I consider, are serviceable and should continue to be subject to routine maintenance and repair. The felt-lined valley on the northern side will, however, perish and fail in time. In the short term, this valley needs to be cleared, but in the longer term replacement will probably be required.

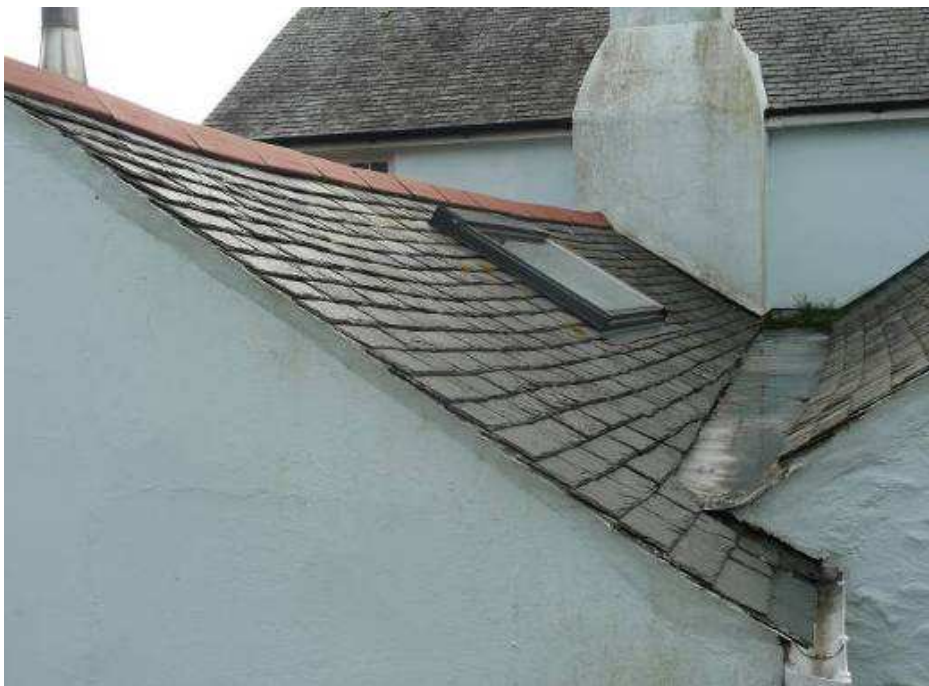
- 15) This is the west facing roof slope over kitchen incorporating a Velux window. The slates are in satisfactory condition with no sign of any significant slippage. Leadwork found at abutment with the chimney breast is in satisfactory repair. Again, some slight deflection was noted to the surface of the roof where it follows the original roofline.

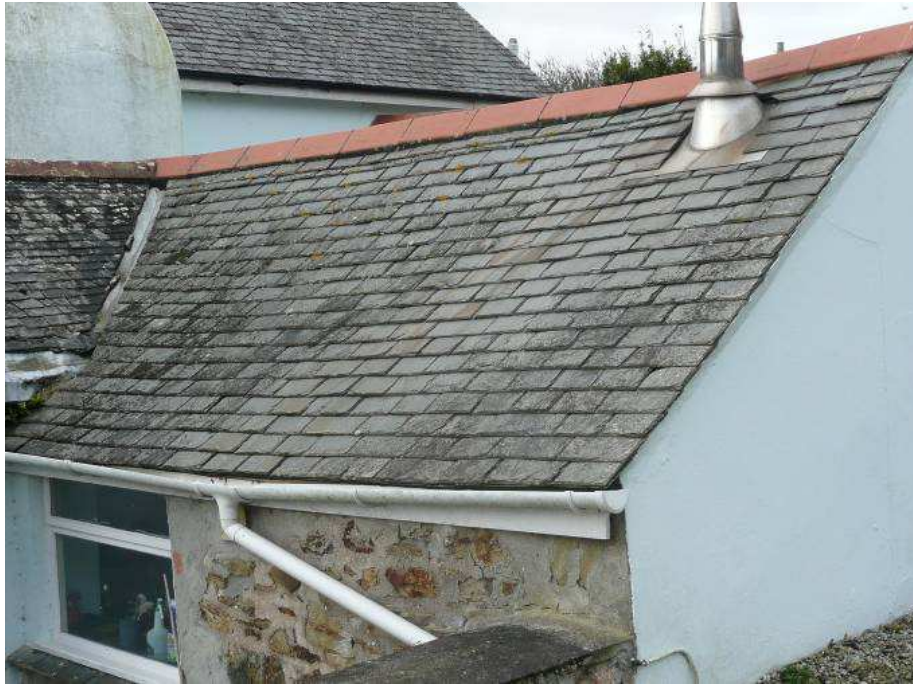
- 16) East facing roof slope over kitchen. This slope is clad with natural slate and is reasonably uniform with no sign of slippage or damage to the slates.

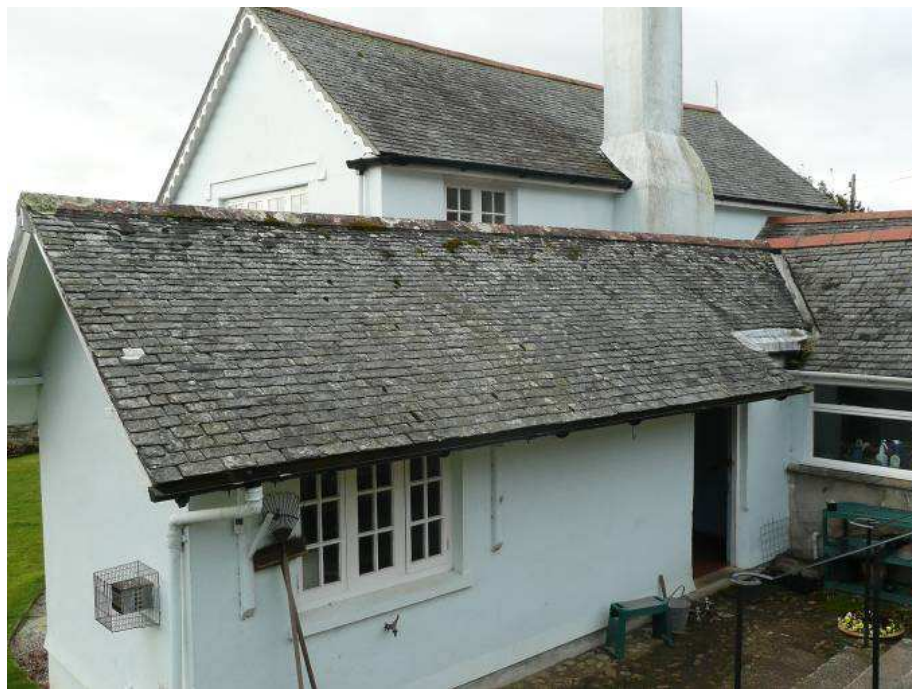
- 17) North facing natural slate roof over utility area. This is an older slate roof which was not re-covered at the same time as the other slopes. There are one or two cracked, broken and slipped slates and some weathering was noted to the ridge tiles.

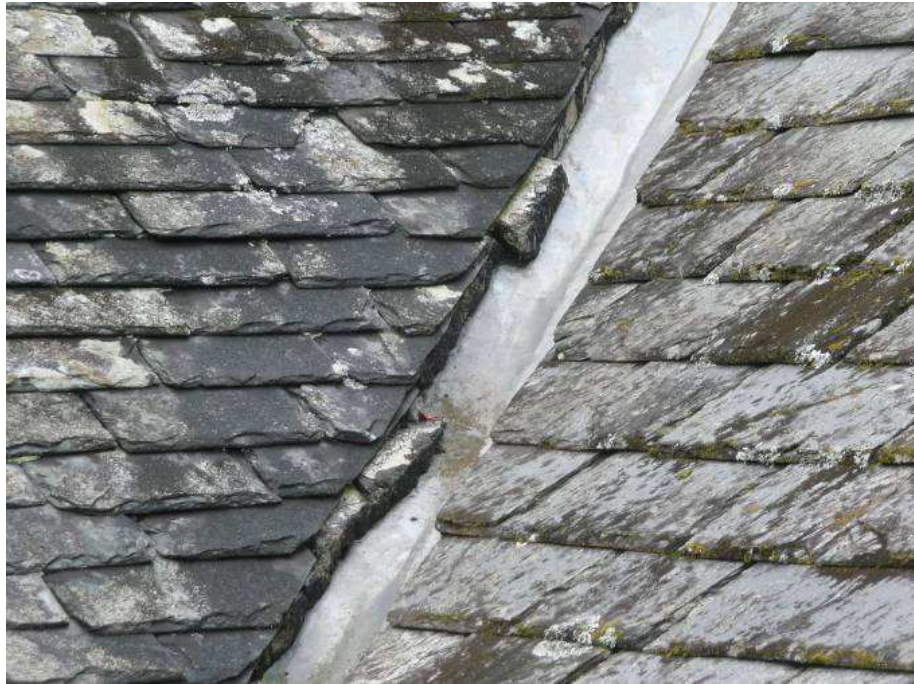
The valley abutment with roof slope 16 is formed with lead. Joints are provided to take up expansion although pointing to the sides of the valley is starting to wear and come loose; re-pointing required.

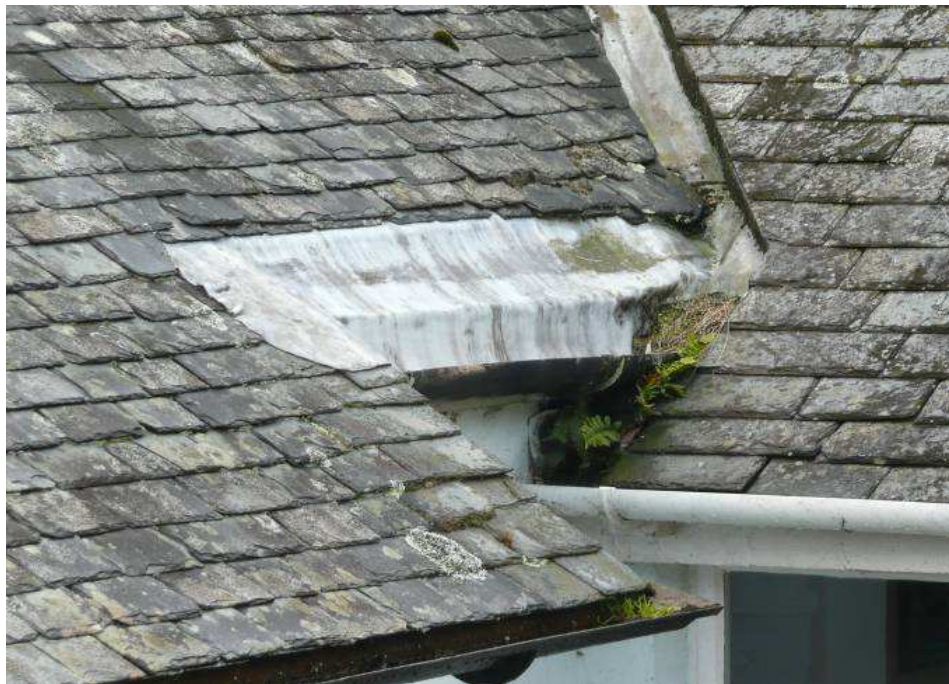
The valley is becoming quite choked and congested, particularly at the bottom edge. This area will need to be cleared of debris otherwise damp penetration will occur.

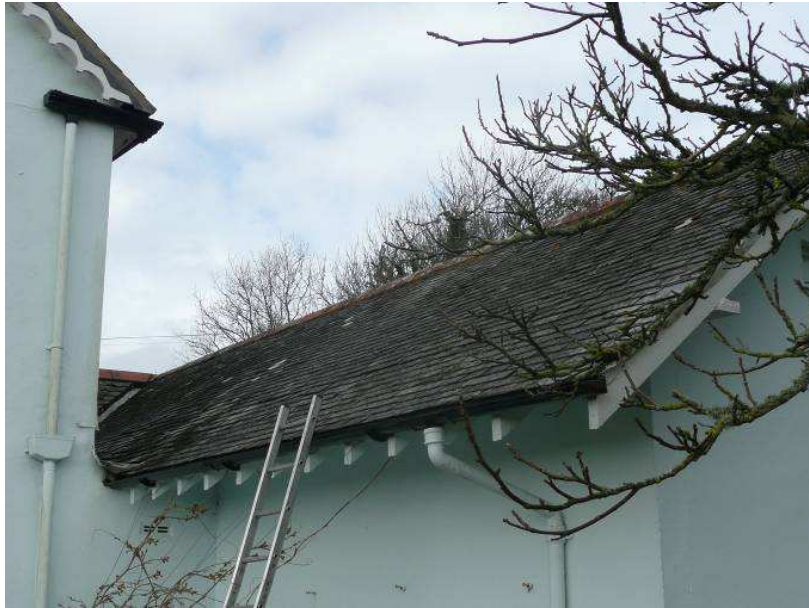
- 18) An older slate roof over the utility area; south facing. There are one or two cracked, broken and slipped slates, however, the roof slope is generally uniform.

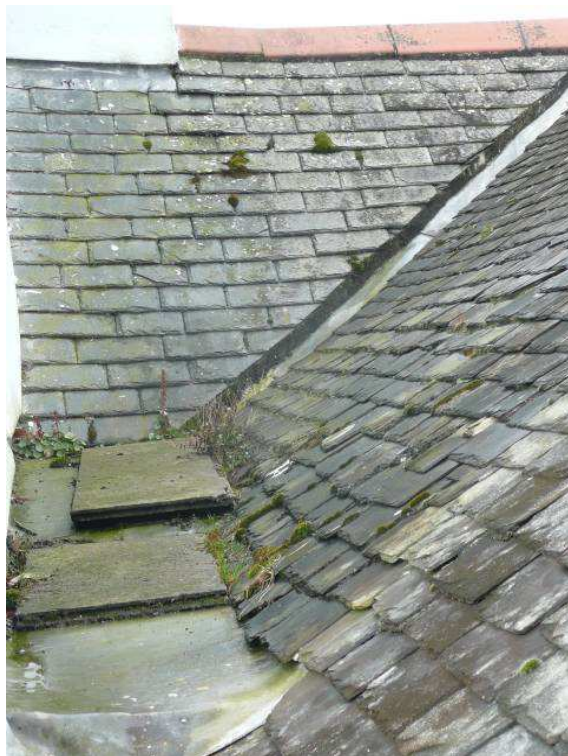
- 19) This is an older natural slate roof in satisfactory repair with a valley at the abutment with roof slope 18. The valley is formed with lead and is generally in satisfactory condition; however, it is becoming congested and choked towards its bottom edge. There is then a further valley gutter between roof slope 18 and the wall of the building and this is lined with lead. Again, this valley needs to be cleared and the boards removed so that water can discharge freely. Internally, at the moment, there are no signs of any leaks.

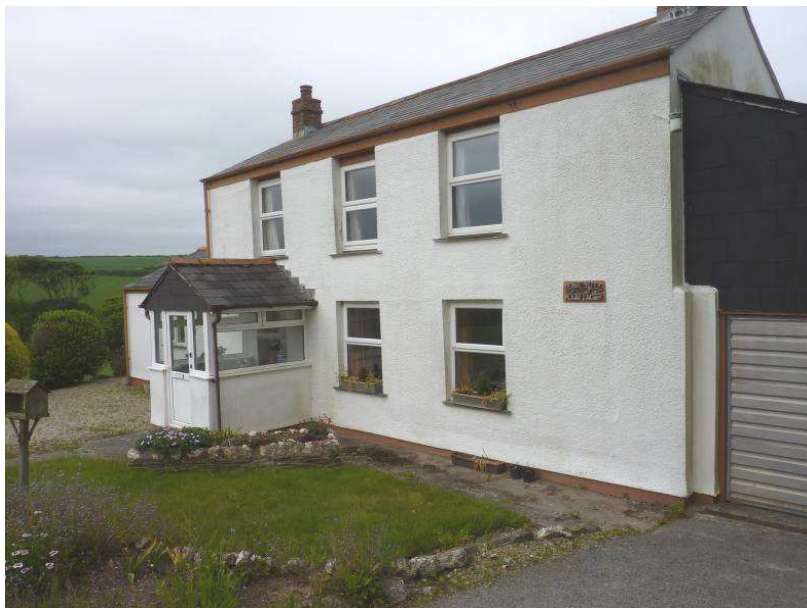
Dealing firstly with the eastern elevation, the walls here measure some 800mm in thickness. There are three openings at ground floor level and three at first floor level and the walls have a rough cast sand and cement render finish with slate sills.

This elevation was true, straight and uniform; there is no sign of any significant bulging or movement which would give cause for concern.
