## BUILDING SURVEY

**Example Composite Cottage  
Made Up Road  
Truro  
Cornwall  
TR1 2SQ**

3 January 2017

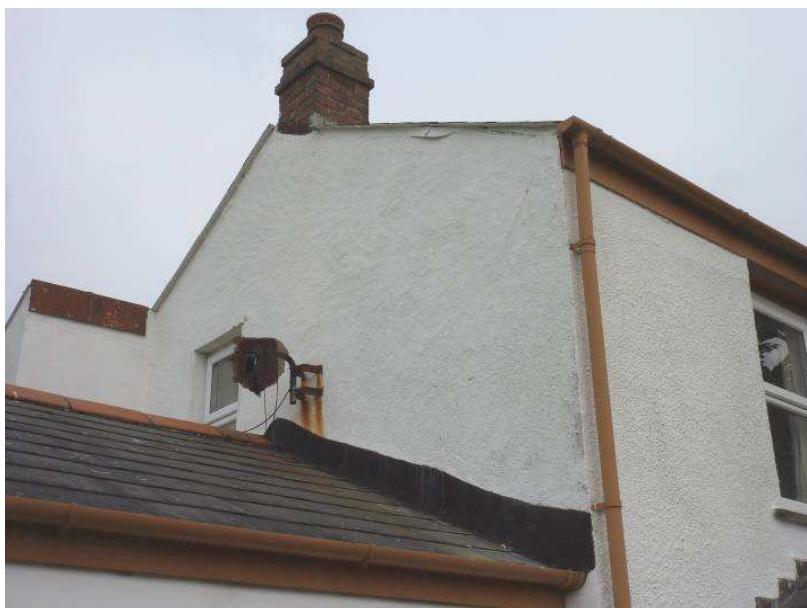
This wall, therefore, is clearly of two different forms of construction at least. The area between the lounge and the hallway is of stone or cob; however, the first floor section and the southern wall of the ground floor bedroom are, I consider, of blockwork.

The render finishes are reasonably uniform and there is no sign of any serious movement. There is some slight cracking, however, that has occurred above the bedroom window and the photographs which were shown me indicate that there was, in fact, a door in the position of the window originally and you can see where cracking has occurred where the doorway has been blocked up.

There is further slight cracking to the underside of the verge. This I do not consider is of any great significance but I suggest that the render crack be raked out and filled when you redecorate.

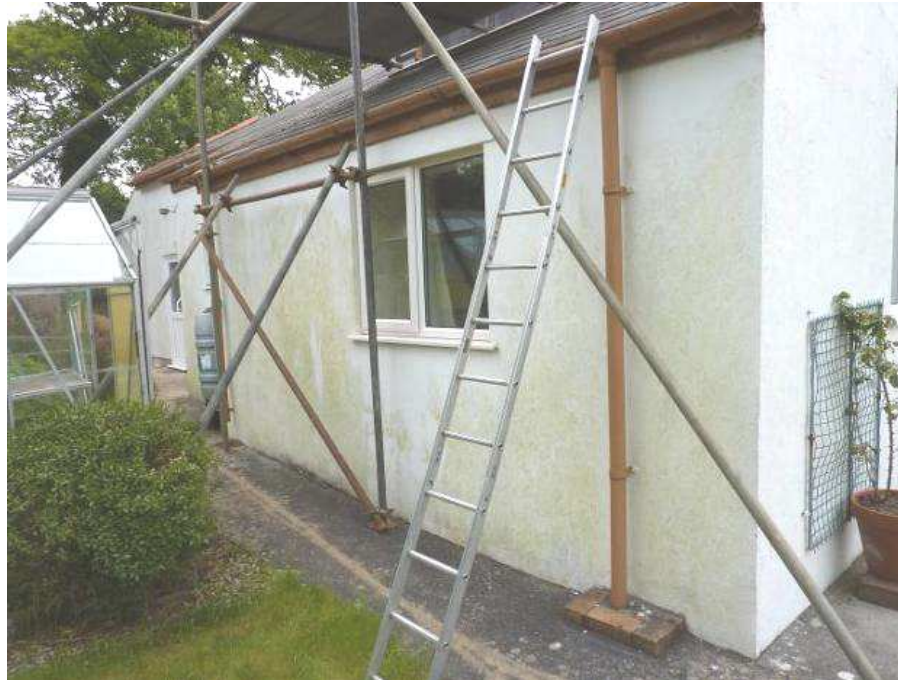
The western wall of the ground floor bedroom is of some 500mm in thickness and is of stonework. Photographs shown to me by the Vendor clearly indicate this although it has now been rendered with sand and cement. Again, the walls here were true, straight and uniform and there is only minor hairline render cracking that can be raked out and filled when you redecorate. However, I would have preferred to have seen this wall rendered with a lime-based mortar.

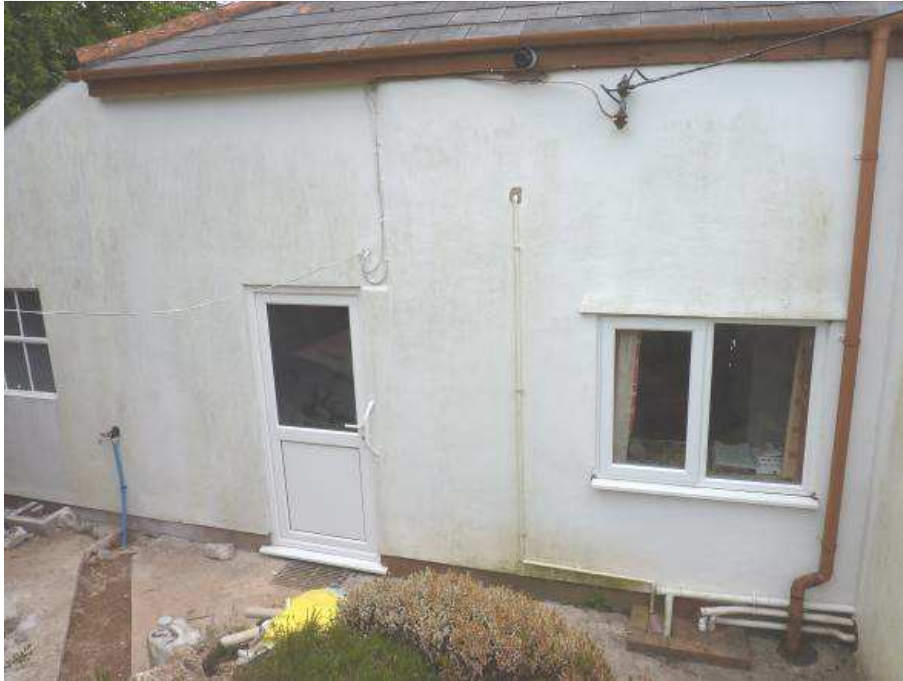
The western elevation of the original section towards the northern end is, again, of stone or cob. This has a sand and cement render and once more I would have preferred to have seen lime-based mortars used although the wall is true, straight and uniform with no indication of any significant cracking, movement or distortion.

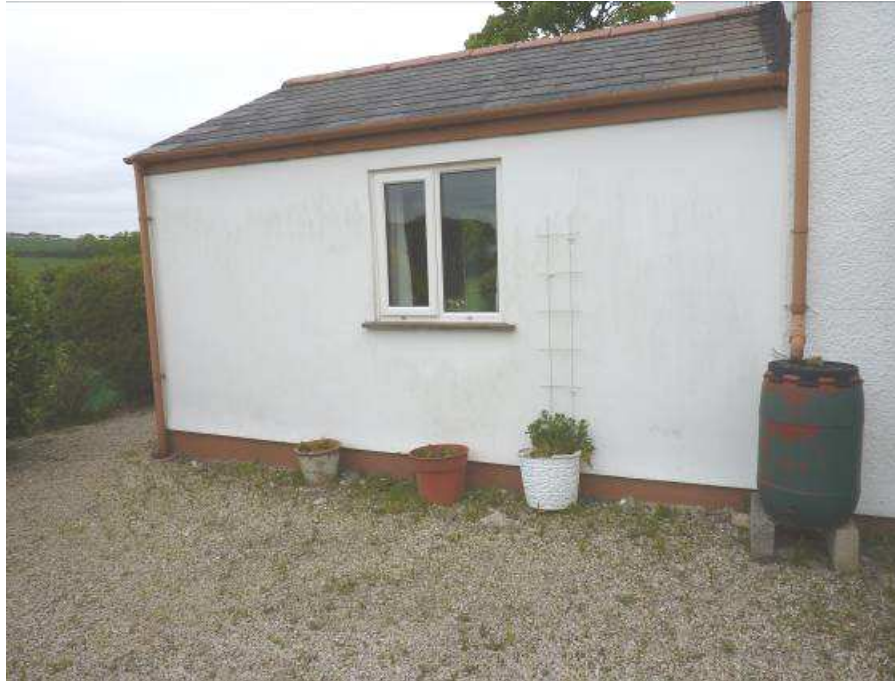
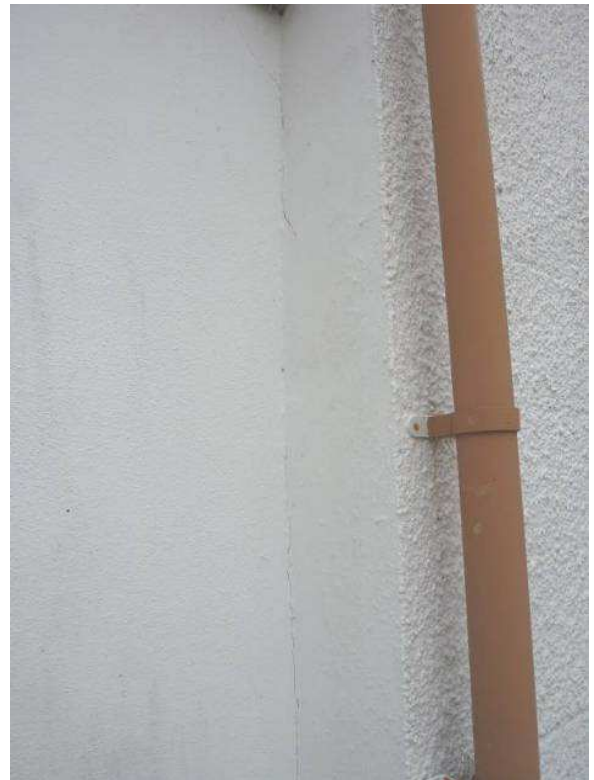
Again the southern elevation was found to be true, straight and uniform with only very limited minor hairline cracking to the render.

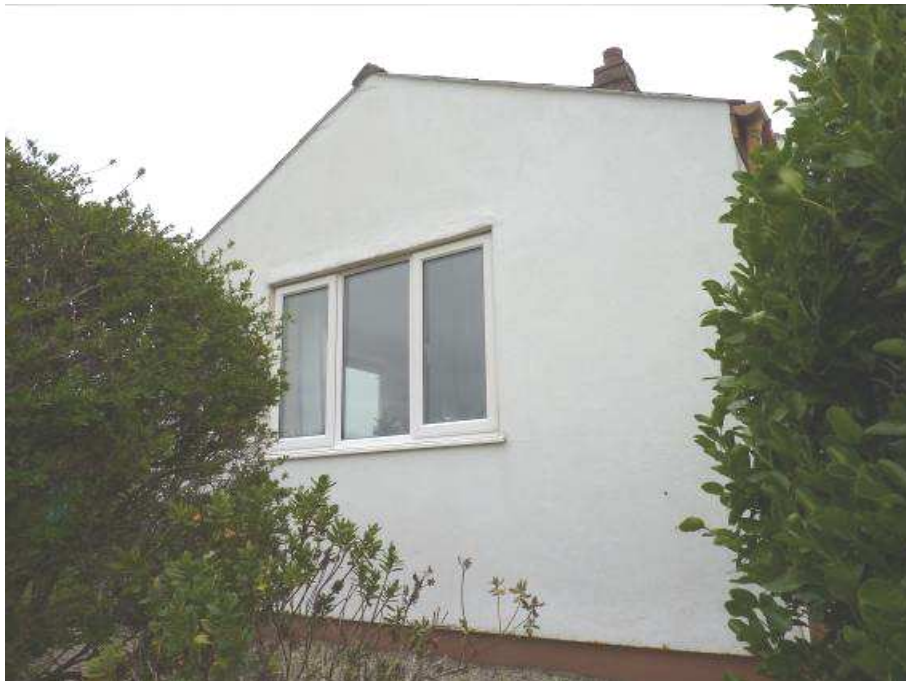
The western elevation, again, is true, straight and uniform with only very limited hairline render cracking of a minor nature.

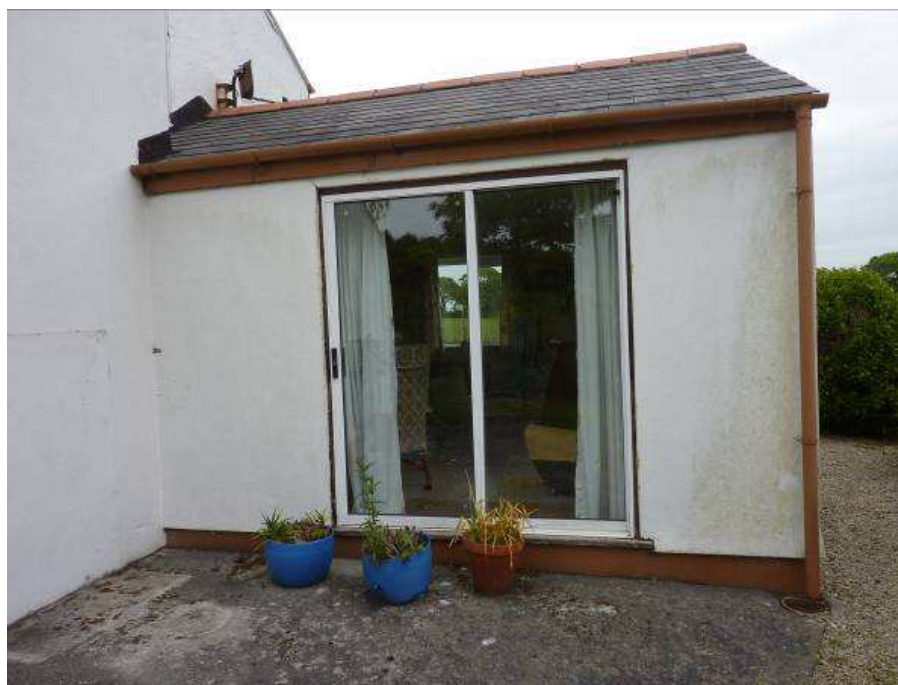
The walls to the porch are also of some 300mm rendered cavity concrete blockwork and these were in satisfactory condition.

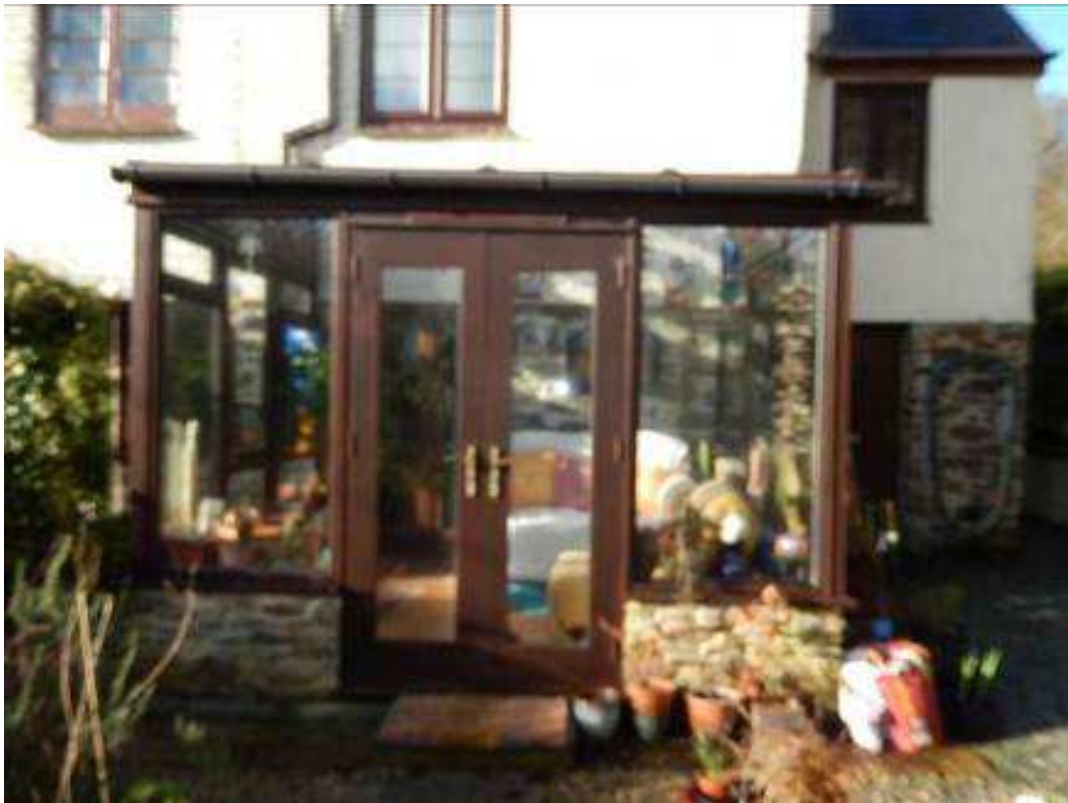
This has a double glazed timber roof supported by timber rafters. There is no indication of any leaks at the present moment nor could I find any evidence of rot or decay to the timber support which is functioning correctly.

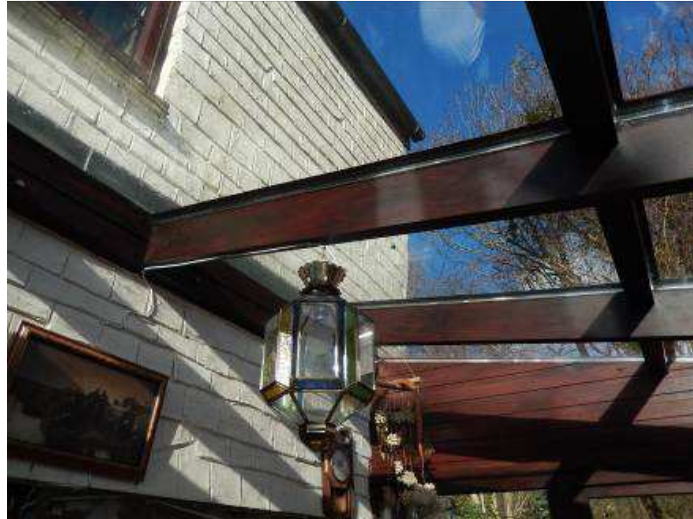
Bear in mind however that shallow pitched glazed roofs on conservatories of this type are particularly prone to leaks and one area which you will need to ensure is specially well maintained is the junction of the conservatory roof and the eastern wall of the cottage.

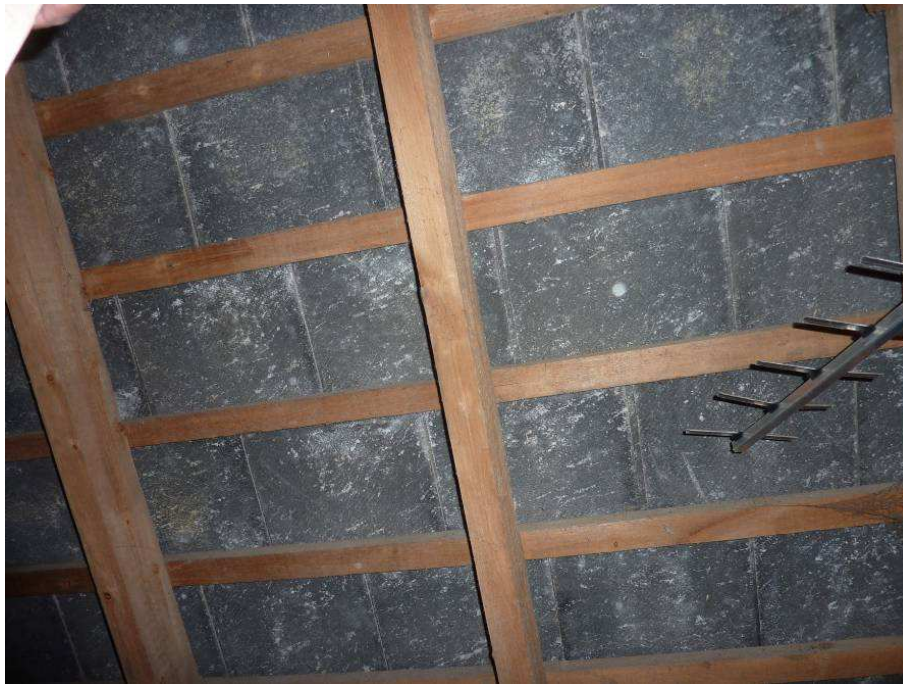
I found evidence of an old infestation of wood boring beetle to some timbers in the roof space. This, however, does not seem to be active and I understand from the vendors that treatments have been carried out under a guarantee.

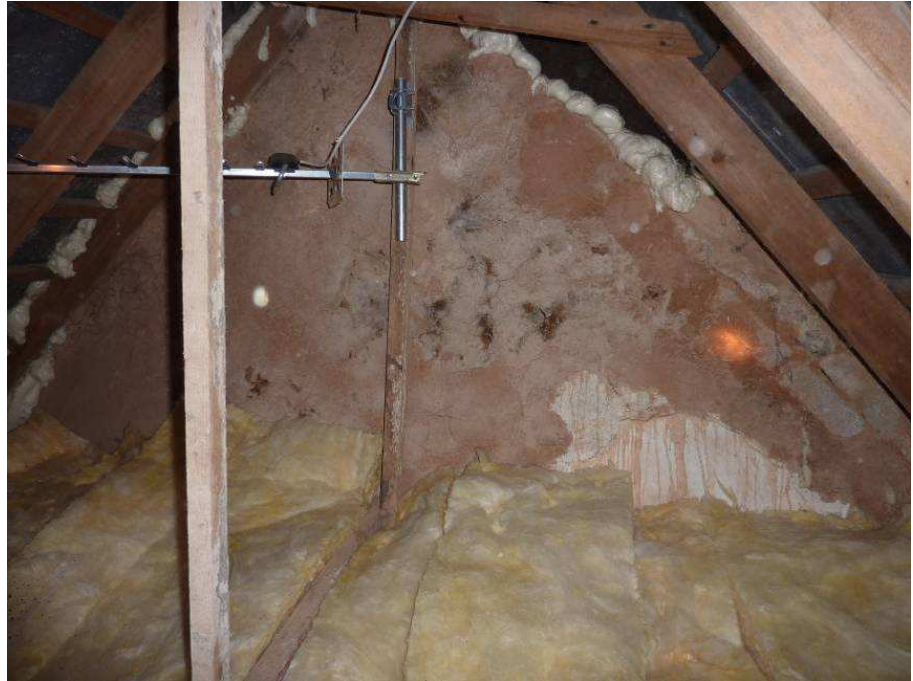
The south-eastern party wall was also accessible. Again, this seems to be of cob incorporating the chimney breast. There is some slight fretting to the surface of the chimney breast and limited dampness but this is within acceptable tolerances and no more than I would have expected to find in a building of this age and type.

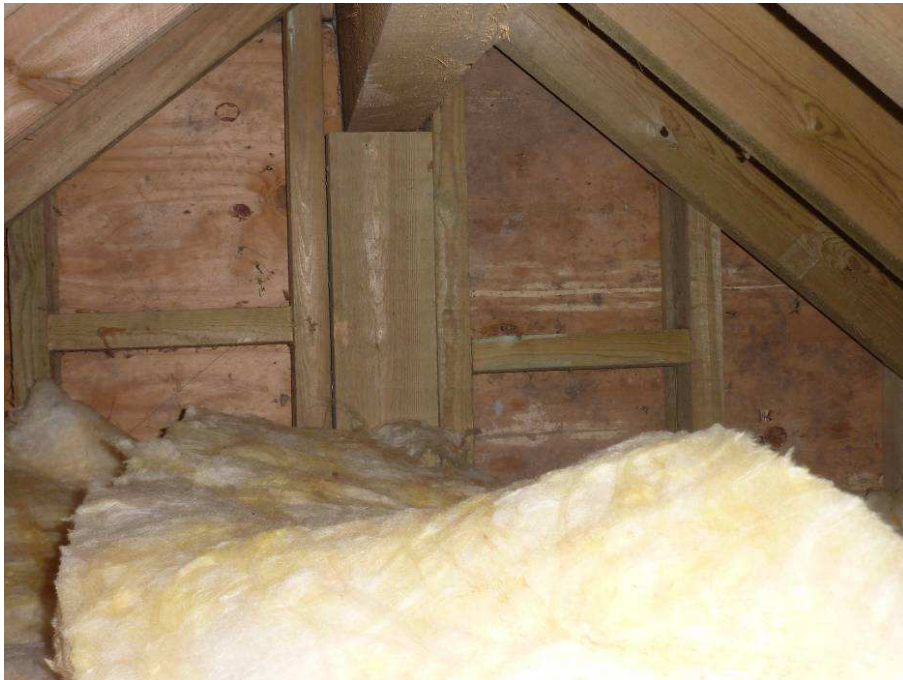
Again, this roof void over the north-eastern extension, I consider, is functioning correctly and there is no sign of stress, distortion or bowing to the timbers or any evidence of beetle infestation.
