## BUILDING SURVEY

Example Composite Cottage  
Made Up Road  
Truro  
TR1 2SQ

Julian P Crosby FRICS  
DowlingDodd  
Chartered Surveyors  
2A River Street  
Truro Cornwall TR1 2SQ

11<sup>th</sup> June 2010

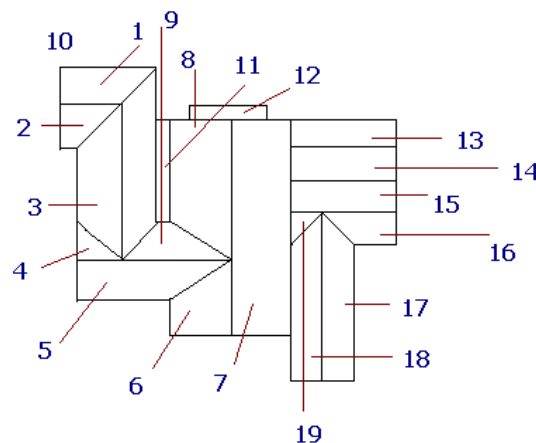
I shall describe the individual roof slopes below and for ease of reference and in addition to photographs, the annotated sketch plan identifies individual slopes.

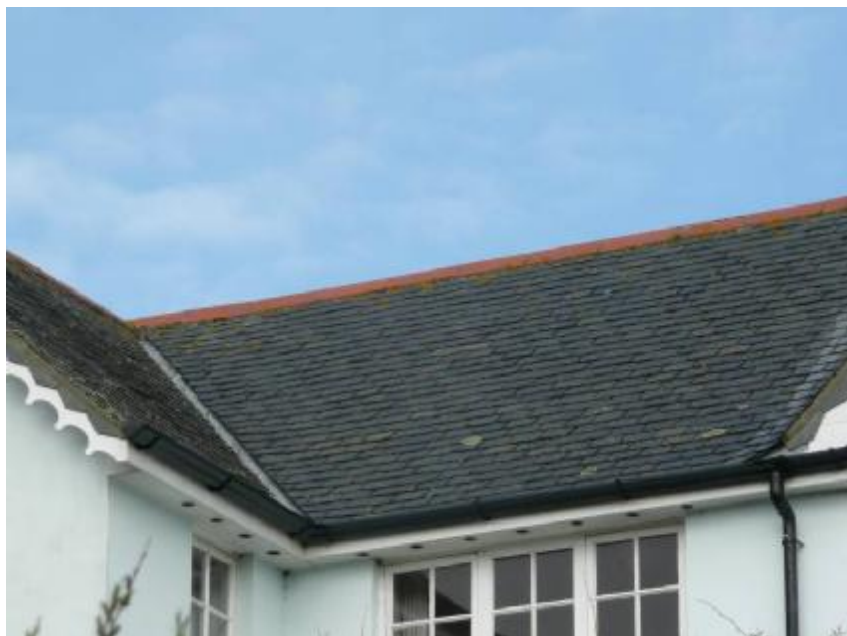
- 4) The west facing roof slope was true, straight and uniform, no significant slippage of slates was noted. Verges are pointed with sand and cement and in satisfactory repair. The lead valley between slopes 3 and 4 is in satisfactory condition and clear of debris, and joints are provided to take up expansion and contraction of the leadwork.

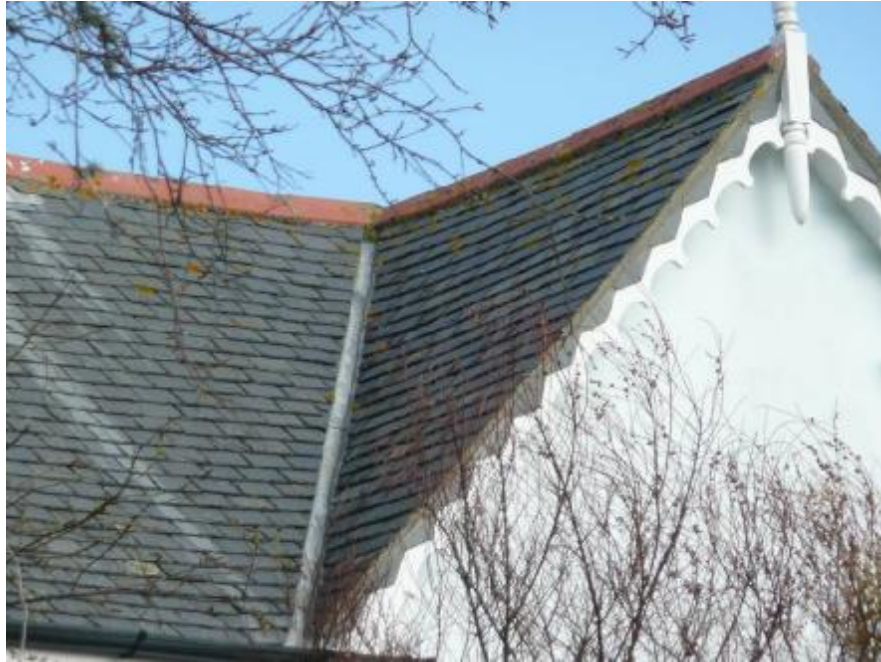
- 5) Again this slope is true, straight and uniform with no evidence of any significant damage or slippage to the slates. Verges pointed in sand and cement and in satisfactory condition. Slight rise in ridge tile corresponding to original roof line.

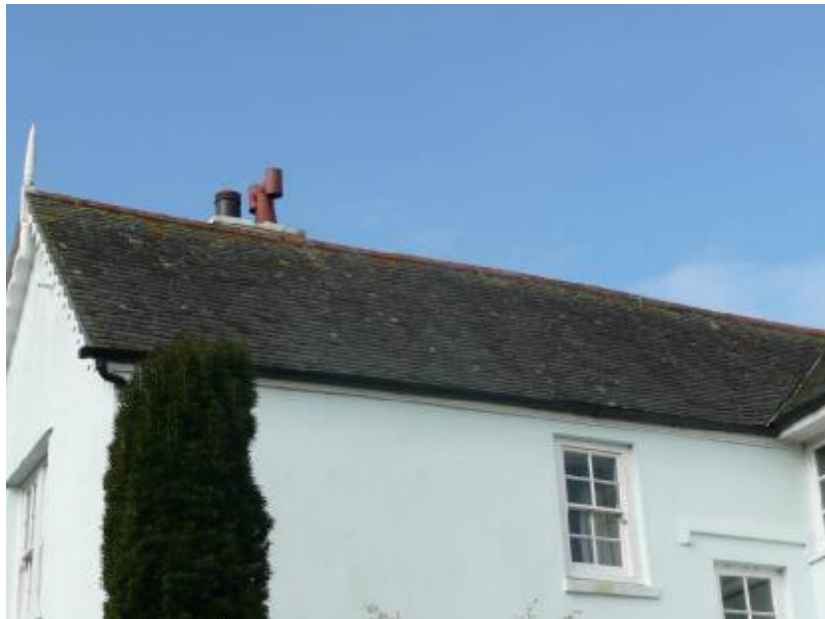
- 6) As with other slopes natural slate covered. The slope is uniform, true and straight, ridge tiles true and straight and adequately bedded. Verges pointed with sand and cement in satisfactory condition. No sign of slippage or deflection to the slates or roof surface. Valley clear of debris and joints are provided to the leadwork to take up expansion and contraction.

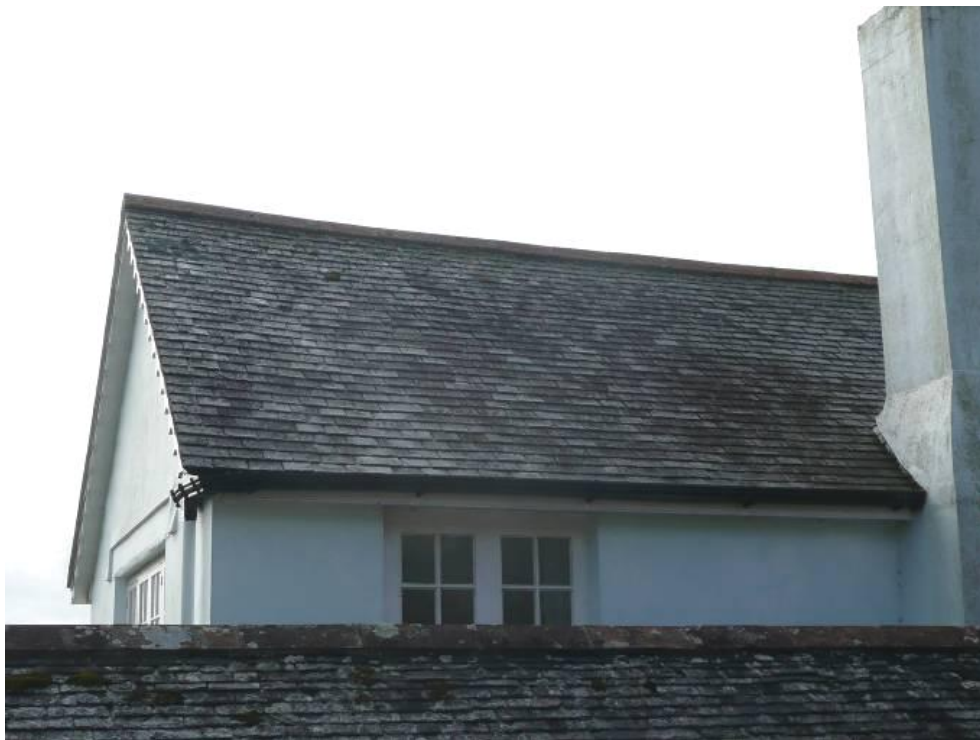
- 7) North-facing roof slope, again true, straight and uniform with no evidence of deflection or distortion, nor any significant damage to slates. Pointed verges in satisfactory repair.

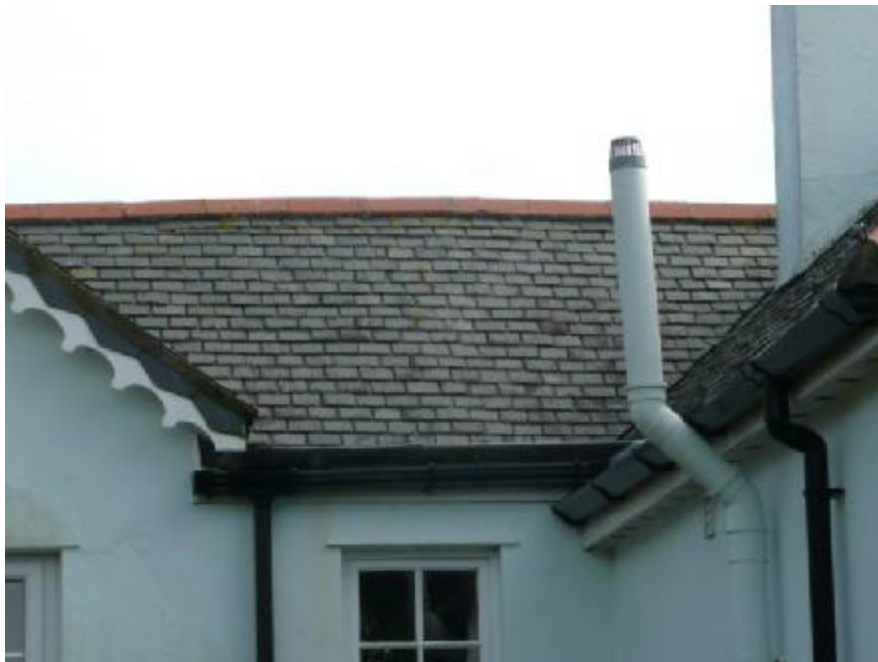
- 8) No vantage point could be gained from ground level where this roof slope could be viewed. Condition of slates therefore cannot be judged, verges pointed in sand and cement in satisfactory repair. If you wish to confirm the condition of this roof slope then you will need to arrange for access equipment to be made available. I would then be happy to return and inspect.
- 9) West-facing roof slope clad with natural slate, no sign of significant slippage. Valley abutment with roof slope 8 could not be viewed, valley abutment with roof slope 10 appears satisfactory, with joints provided to the lead and visible sections of the valley were clear of debris.

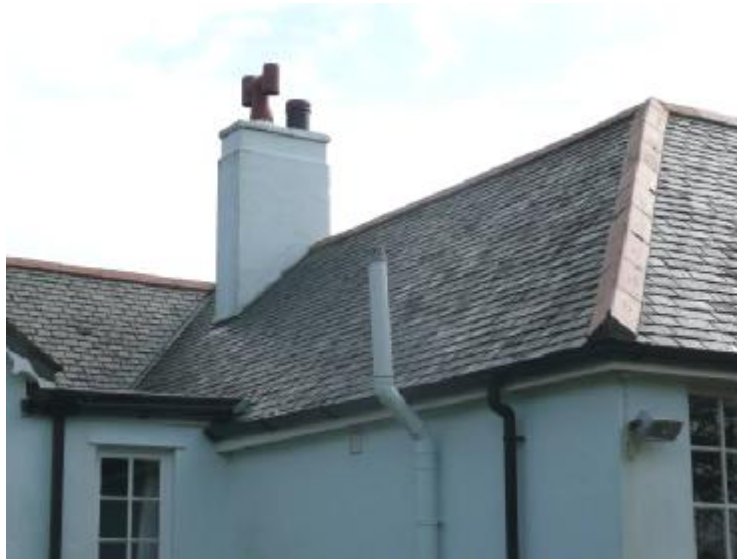
- 10) North-facing roof slope over re-built section, again roof slope true, straight and uniform, hip and ridge tiles adequately bedded, no evidence of any significant slippage or damage to the slates.

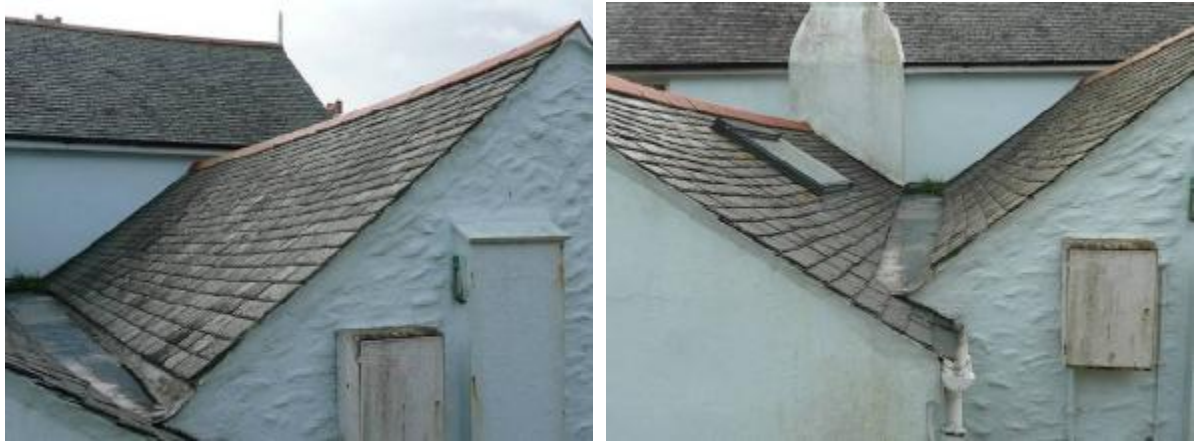
- 14) This roof surface and slates are in satisfactory condition, no sign of any slippage or damage and lead flashings formed at the abutment of the northern wall, some general deflection, however, noted to the roof surface where it follows the line of original timbers but are within acceptable tolerances.

Valley gutter between slopes 14 and 15 formed with bituminous felt run under slates. Some evidence of wear to the surface of the felt but internally there is no sign of any leaks. The valley is becoming quite congested towards the southern end and will need to be cleared. Being of bituminous felt, it is not going to have the same life expectancy as lead and replacement will be needed from time to time.

The older slate roofs I consider are serviceable and should continue to be so subject to routine maintenance and repair. The felt lined valley on the northern side will, however, perish and fail in time, in the short term it needs to be cleared, but in the longer term replacement will probably be required.

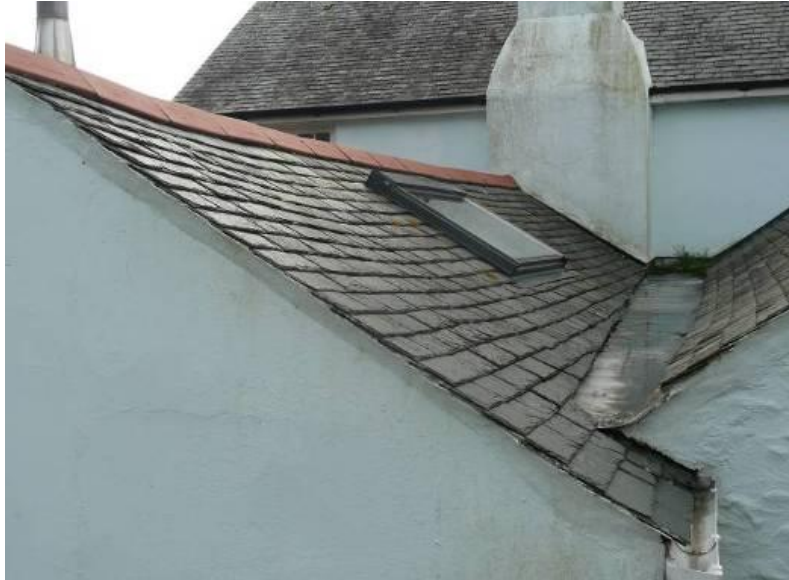
- 16) East-facing roof slope over kitchen clad with natural slate, reasonably uniform with no sign of slippage or damage to the slates.

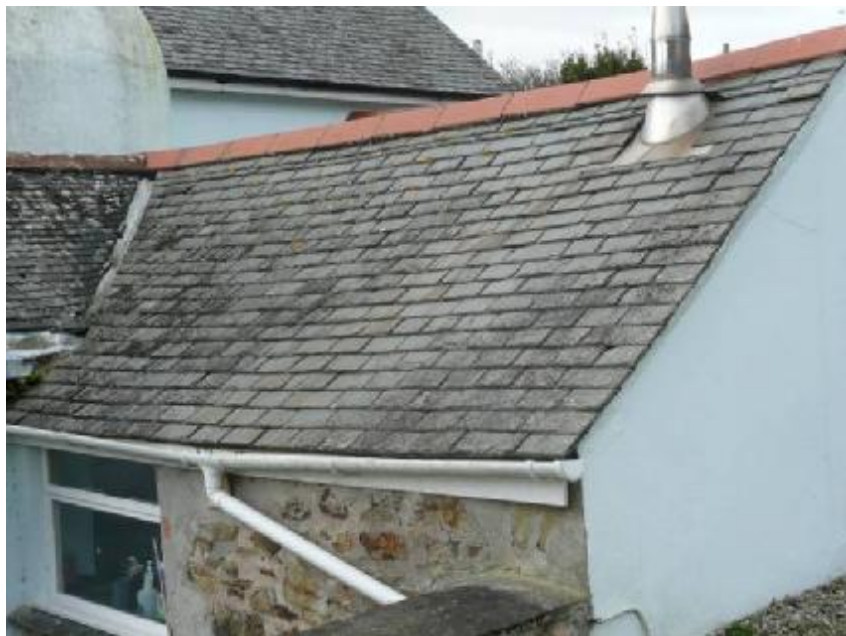
- 17) Natural slate roof over utility area, north-facing. This is an older slate roof which was not recovered at the same time as the other slopes. One or two cracked broken and slipped slates and some weathering noted to ridge tiles.

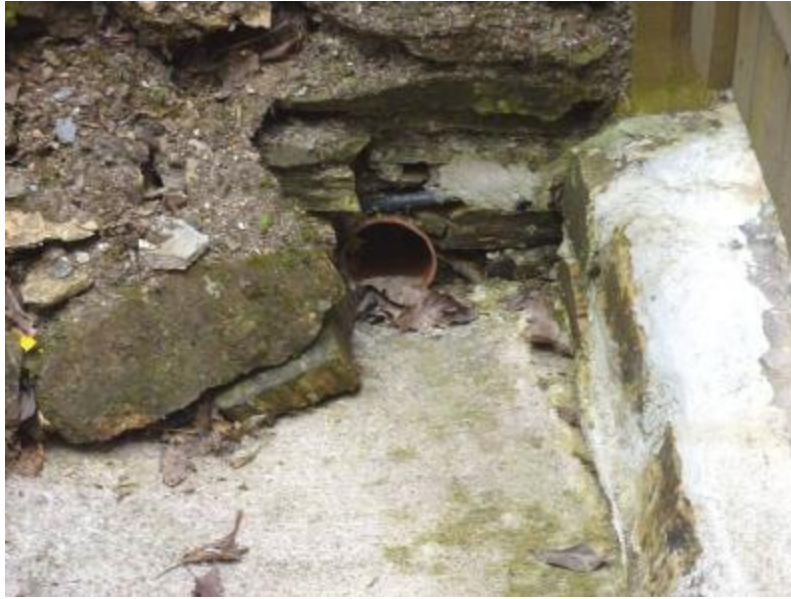
The gutters to the porch and shower room are also of plastic and these again discharge onto the path. Rainwater running along this path is routed via a plastic pipe under the hedge and out onto the pathway.

The gutters and downpipes are functioning correctly at the moment but you will need to keep them clear of leaves and debris at all times particularly during the autumn and winter months to prevent over spillage occurring.

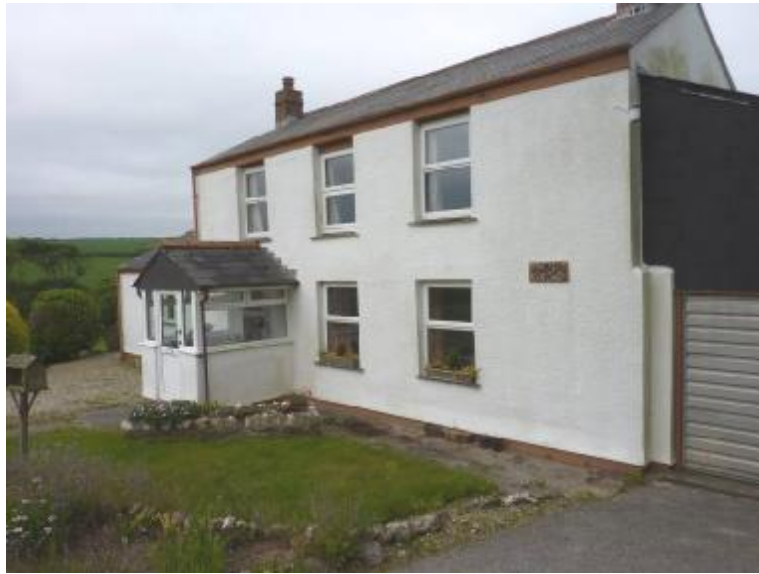
This elevation was true, straight and uniform; there is no sign of any significant bulging or movement which would give cause for concern.

There are however one or two areas where the render is hollow and has lost it's key.

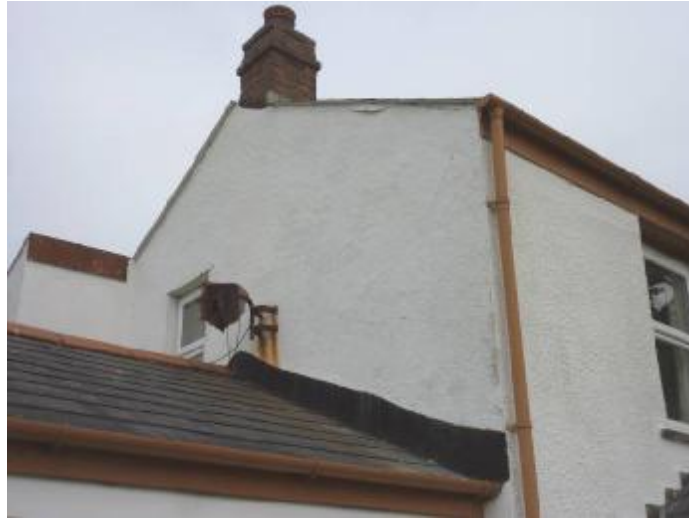
The render finishes are reasonably uniform and there is no sign of any serious movement. There is some slight cracking however that has occurred above the bedroom window and the photographs which were shown me indicate that there was in fact a door in the position of the window originally and you can see where cracking has occurred where the doorway has been blocked up.

There is further slight cracking to the underside of the verge. This I do not consider is of any great significance but I suggest that the render crack be raked out and filled when you redecorate.

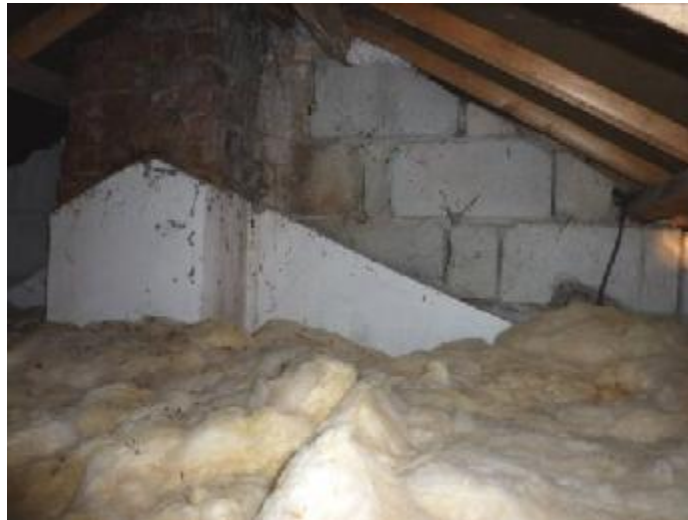
It is clear from the photographs that were shown to me that this wall pre-dates the extension which is why I concluded that it was an earlier alteration.

Whether it is of solid concrete block or cavity blockwork I simply cannot tell. The disadvantage of solid blockwork over cavity concrete blockwork is that it is more prone to laterally penetrating dampness due to the lack of any effective cavity. It also does not perform as well as cavity blockwork in terms of insulation and therefore at greater risk of condensation. Neither of these two shortcomings however was identified internally.

Before you purchase therefore unless it can be established that these walls are not of concrete blockwork or that they were built after 1950 then you must commission a Concrete Screening Test Report to comply with current RICS Guidance Notes.

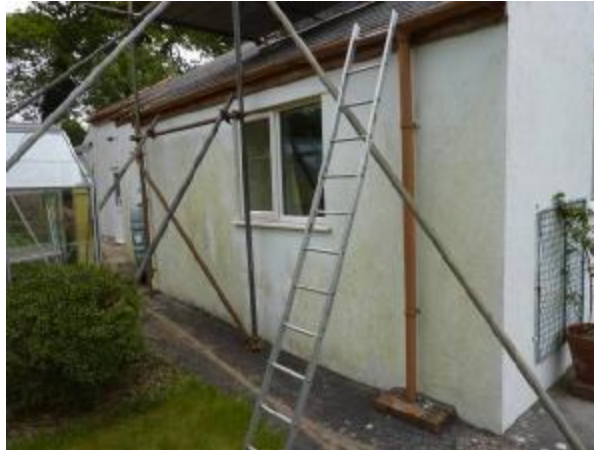
The western elevation of the original section towards the northern end is again of stone or cob. This has a sand and cement render and once more I would have preferred to have seen lime based mortars used although the wall is true, straight and uniform with no indication of any significant cracking, movement or distortion.

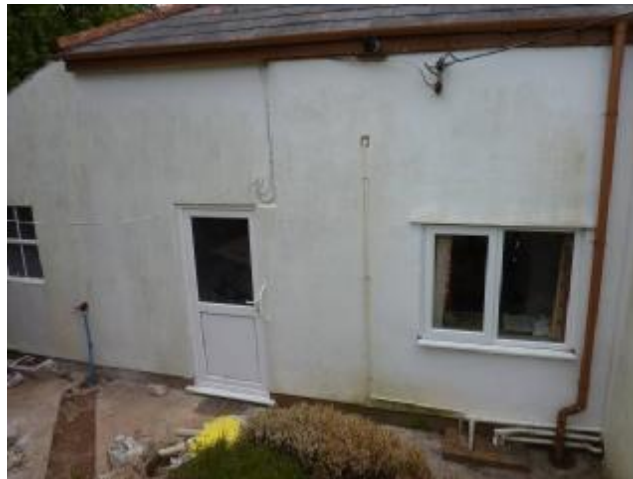
The northern elevation of the original building measures up to 800mm in thickness. This again is of stone and cob and indeed cob was clearly seen within the roof void and externally the apex has a sand and cement render finish and is true, straight and uniform.

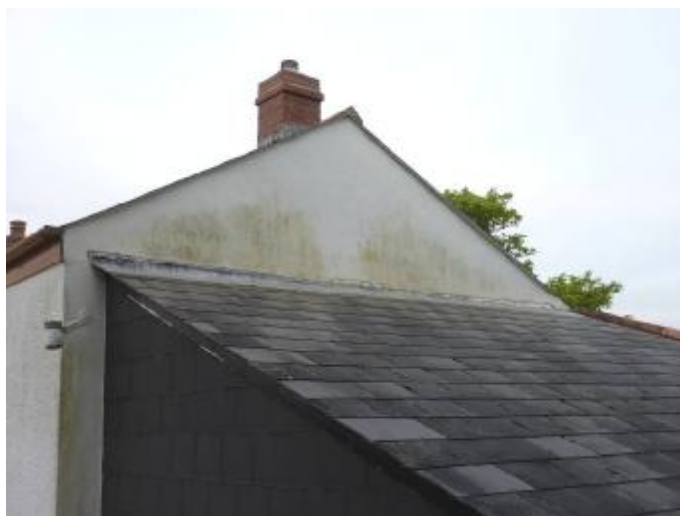
Within the garage this wall however has been lined with un-plastered concrete blockwork and from within the garage roof void I could look down the cavity between the blockwork and the original wall and cob can be clearly seen.

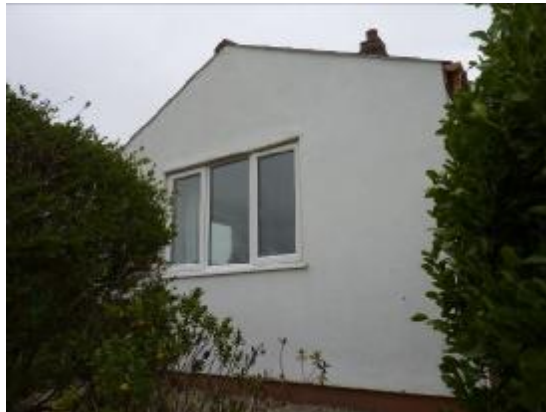
The western elevation again is true, straight and uniform with only very limited hairline render cracking of a minor nature.

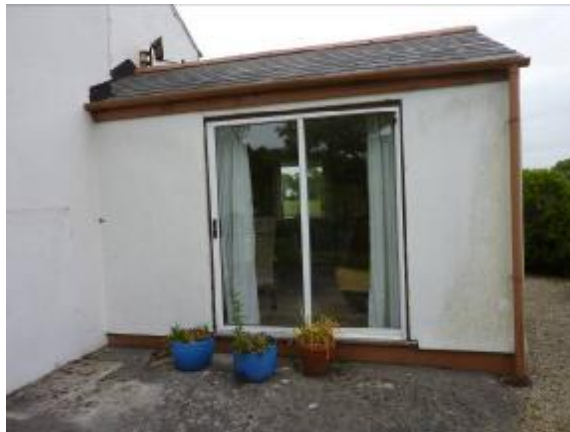
The walls to the porch are also of some 300mm rendered cavity concrete blockwork and these were in satisfactory condition.

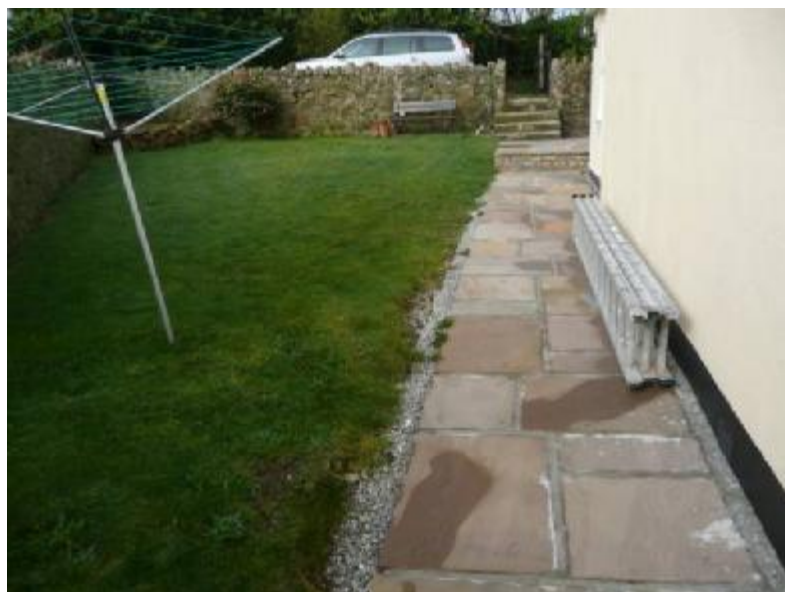
A pathway leads around the southern side of the building and the paving slabs and area of patio seem to have been recently laid with a small area of lawn.

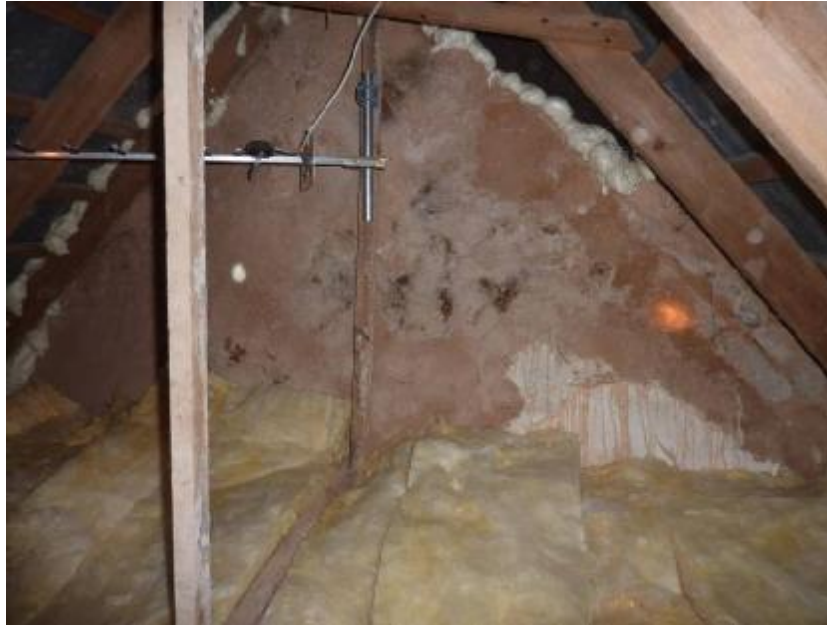
I was able to climb/crawl through to the north western party wall and this is I consider of plastered cob. The wall is in reasonable condition although the very top edges have been sealed with expanded foam at some stage in the past.

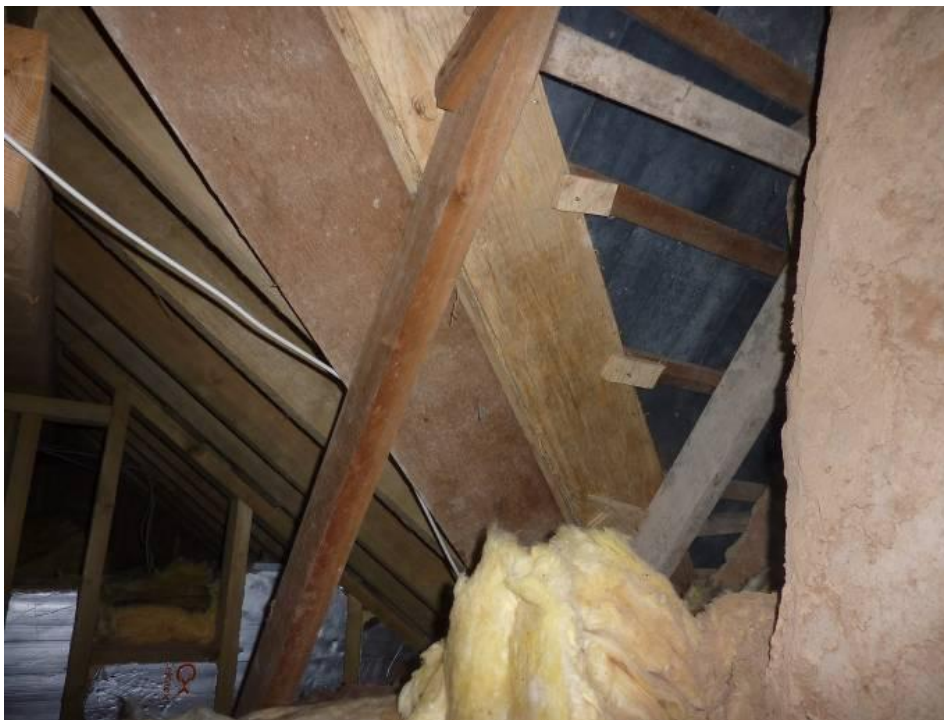
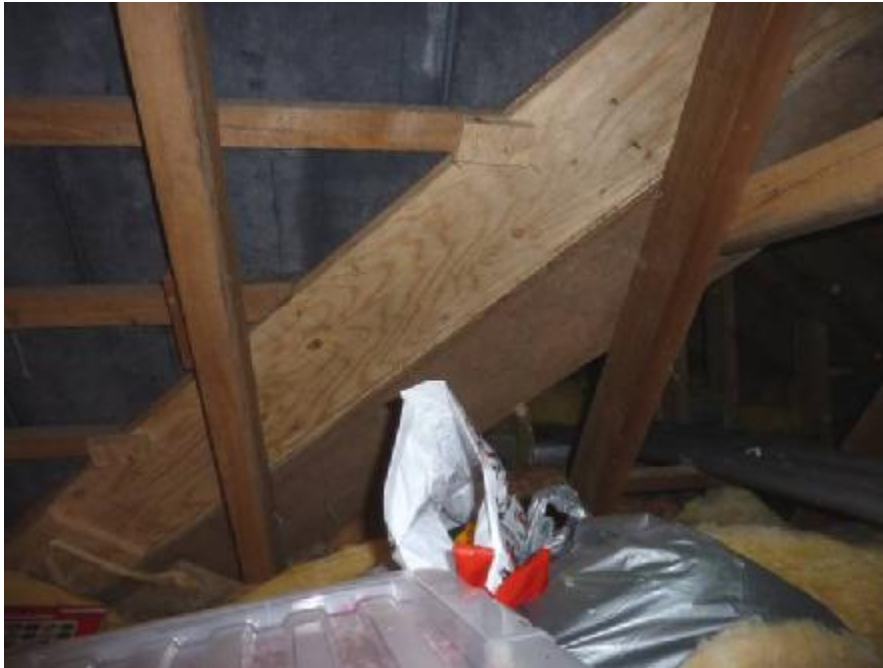
I was also able to gain a view of the underside of the valleys on the north eastern side and no sign of any staining or dampness was detected to the valley boards.

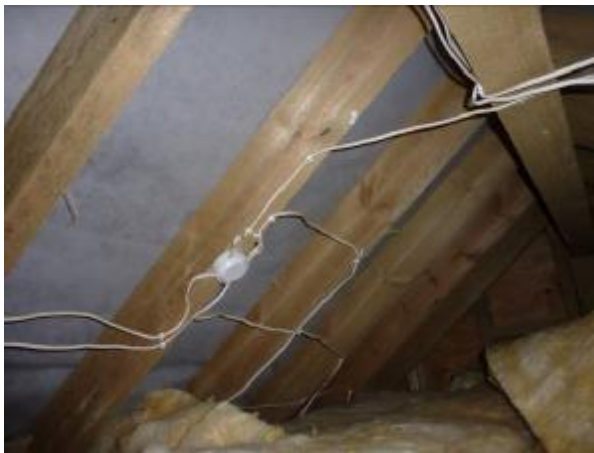
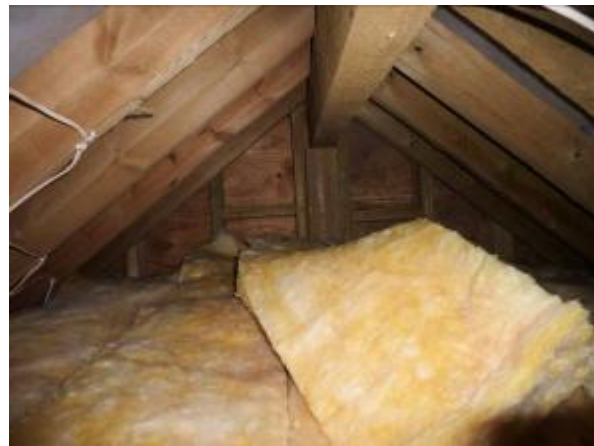
I then gained access to the roof void over the extension via a trap hatch in the rear bedroom. This again is of conventional construction comprising 50mm x 145mm rafters at approximately 400mm centres with a substantial 100mm x 220mm ridge beam supported to its south western end by timber frame work and to the north eastern end by timber posts.

The underside of this roof slope has been felted with a modern breathable type roofing felt and this provides through ventilation within the roof void.

Insulation is again laid on top of the ceilings although this I consider is an average of 200mm and really should be topped up to 270mm.

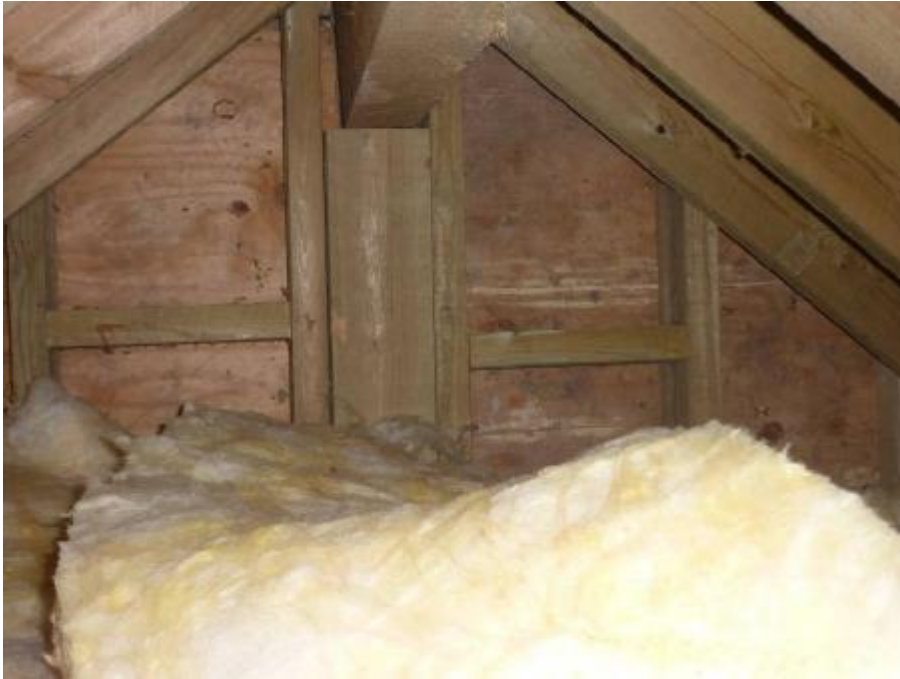
I was able to see the north eastern timber frame gable wall and the internal face of the sheeting board and the posts supporting the ridge beam and no sign of defects were found.

Again this roof void over the north eastern extension, I consider is functioning correctly and there is no sign of stress, distortion or bowing to the timbers nor any evidence of beetle infestation.

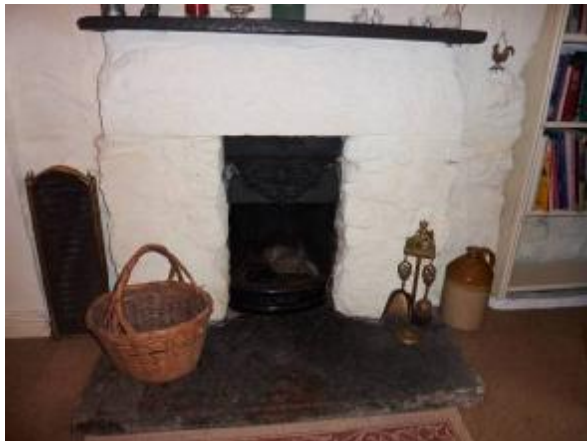
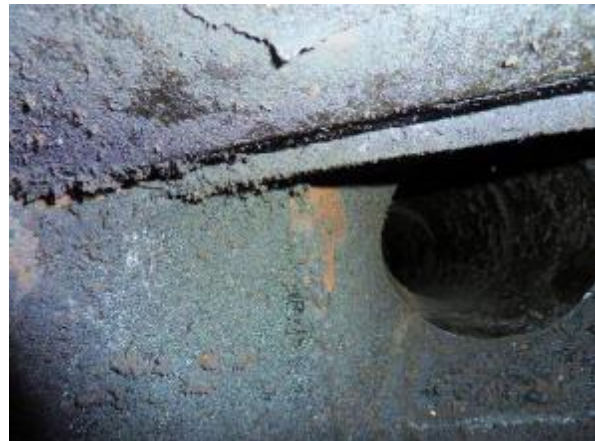
In the lounge there is an open stone fireplace with a slate hearth. The flue appears to have been lined at some stage in the past possibly when the chimney was rebuilt.

The fire was not lit during my visit therefore obviously I am unable to confirm how well it draws but there was no evidence of any significant staining to the surround which would suggest that the fireplace may smoke.

This flue however must now be professionally swept before the fireplace is used.

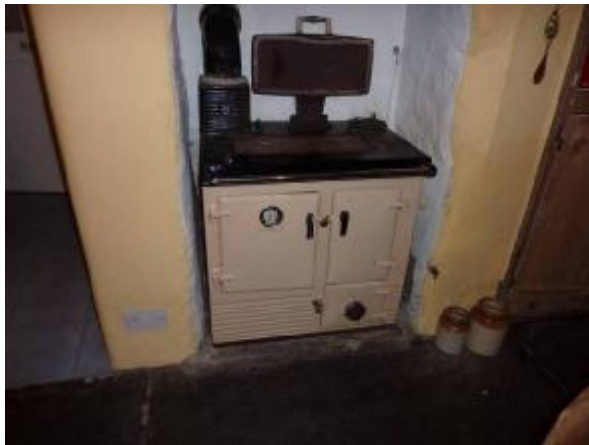
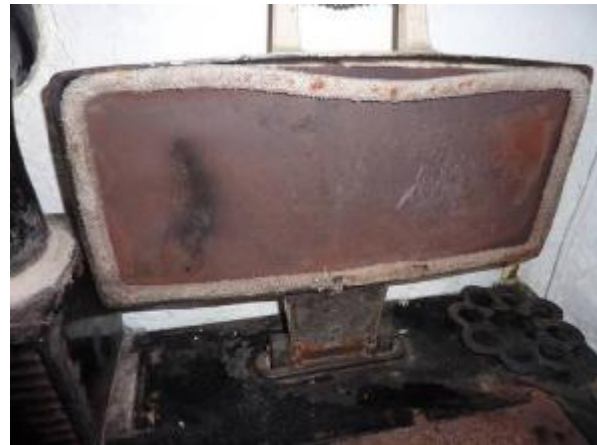
Around the lid to the hot plate there is a rope sealant which looks quite old and seems to be of an asbestos based material.

This is becoming loose and detached and it must now be replaced, specialist advice will need to be sought in relation to replacement and disposal of the old rope.

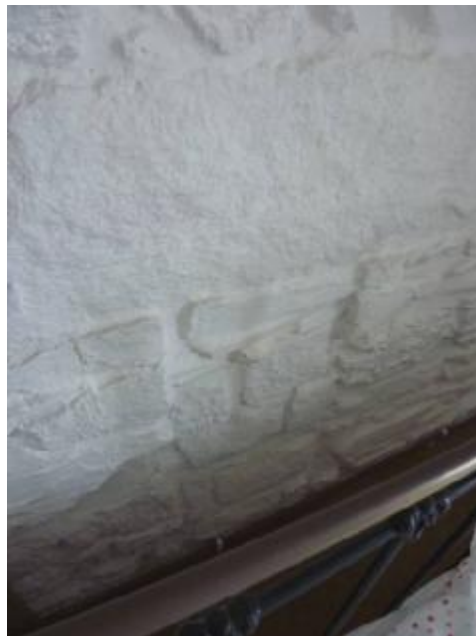
In the southern bedroom you can clearly see the position of the old fireplace which has been blocked up behind the bed.

All old disused fireplaces should be opened, swept, capped and vented to avoid conditions where moisture and dampness in the flues could build up giving rise to condensation and timber decay.

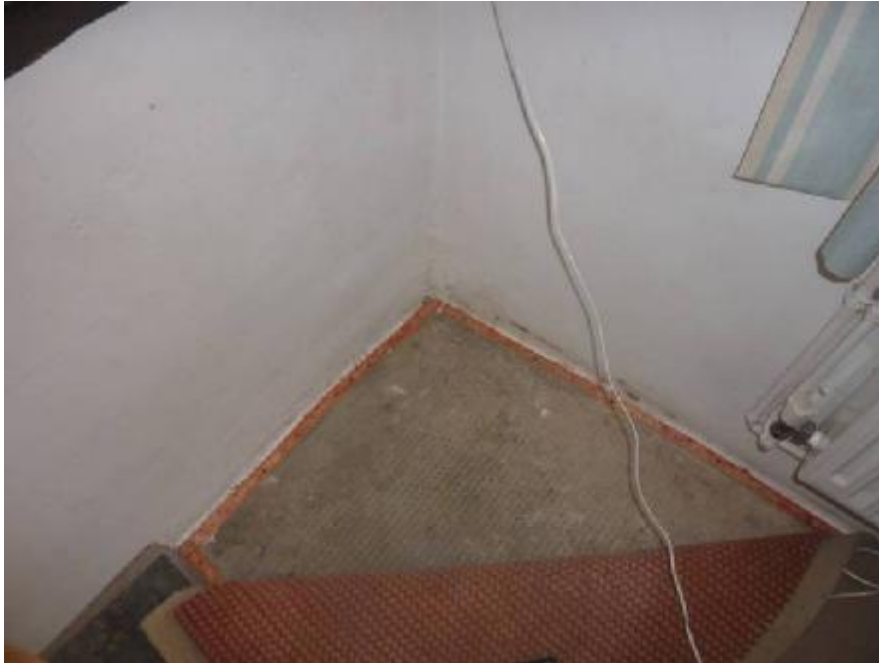
In the lounge, the floor has been carpeted. I was only able to lift a small corner to the south eastern side and this revealed a relatively modern concrete floor slab.

When I checked later through fitted carpets with my moisture meter, no indication of any dampness could be found.

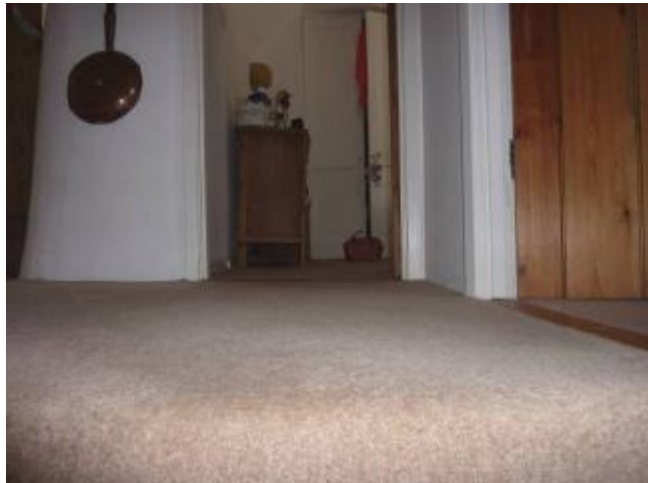
There is inevitably some deflection to the suspended timber floors in the original part of the building. This can perhaps best be seen looking through to the south eastern bedroom off the landing where it is quite obvious that the floor drops towards the middle.

This is quite common particularly in older properties due to the fact by modern day standards the floor joists will be undersized and spaced too far apart.

Consequently there is some give, spring and non uniformity to the suspended timber floors in the original part of the building but no more than I would have expected to have found and within acceptable tolerances.

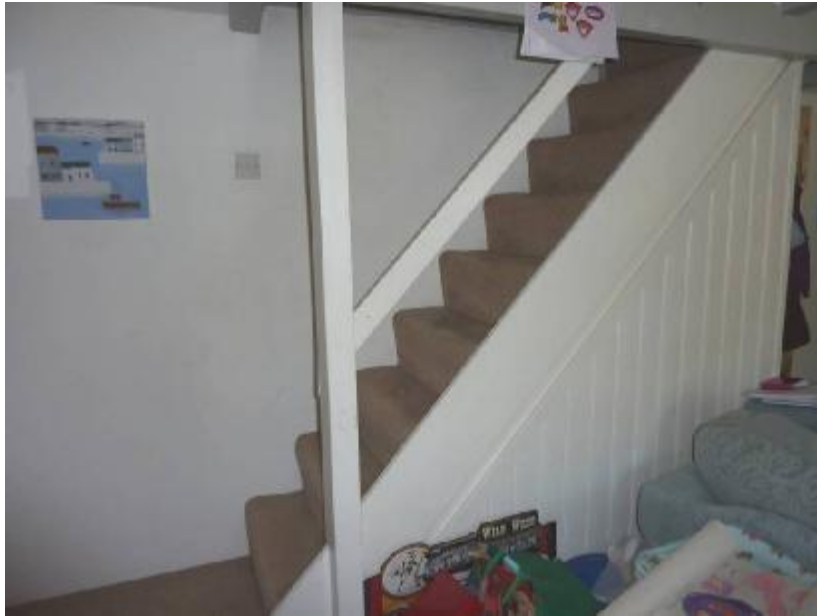
The stairs from ground to first floor are reasonably firm and level but as with most old cottages they are quite steep and will need to be negotiated with care.

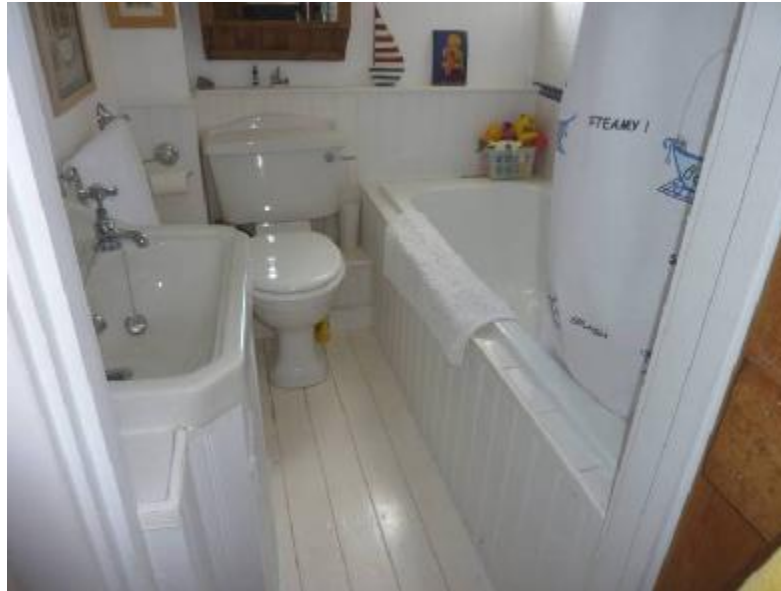
This comprises a white bathroom suite at first floor level with steel panel bath, wash hand basin and WC all of which were serviceable. There is an electric shower above the bath although this has not been tested. There was no proper shower screen, only a curtain.

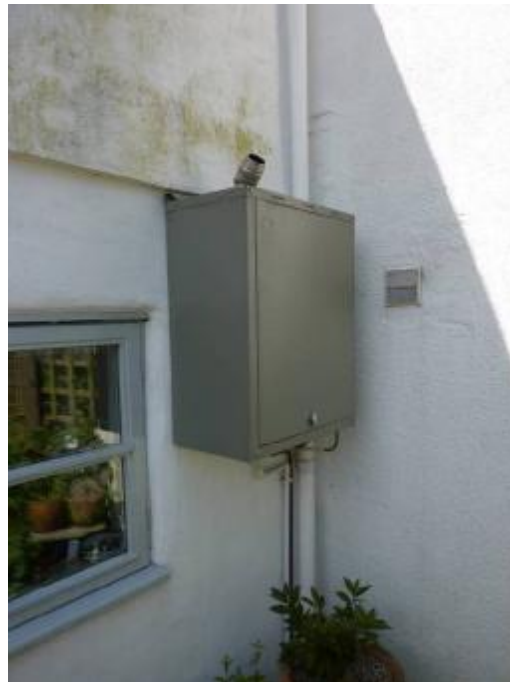
Space heating comes from an external wall mounted oil fired boiler which I believe the vendors have had installed quite recently.

The system is now probably due for a service and therefore before you purchase, I recommend that you ask a qualified heating engineer to check and service the boiler or arrange for the owners to do this and then you should set in hand an annual maintenance agreement.

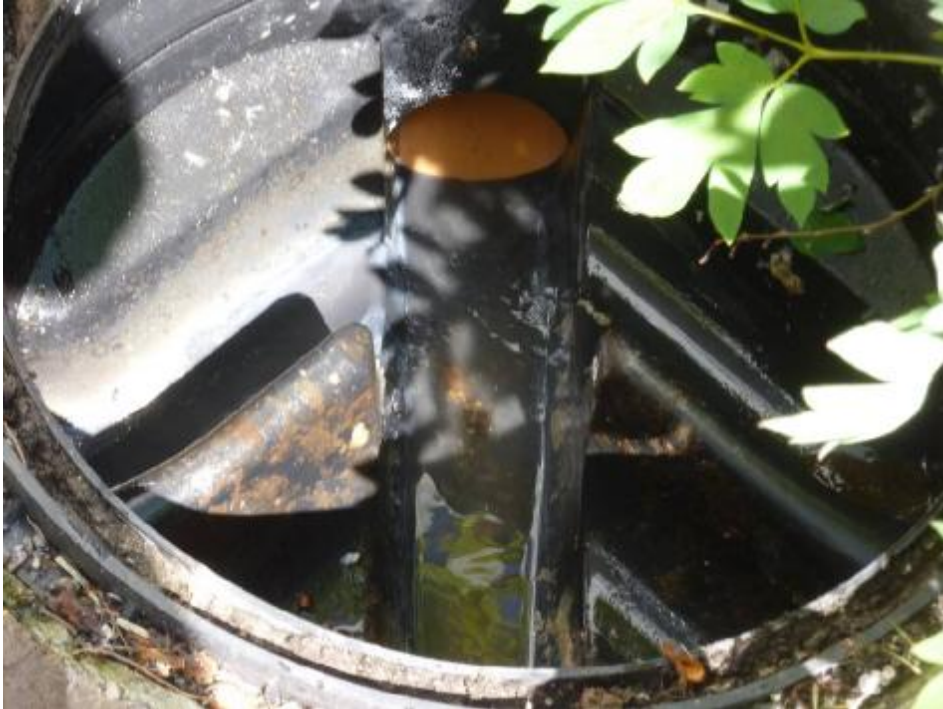
There is only one inspection chamber in the rear yard. This was lifted and waste was run through the system and is discharging satisfactorily with no sign of any blockages.
