## BUILDING SURVEY

**Example Composite Cottage  
Made Up Road  
Truro  
Cornwall  
TR1 2SQ**

3 January 2017

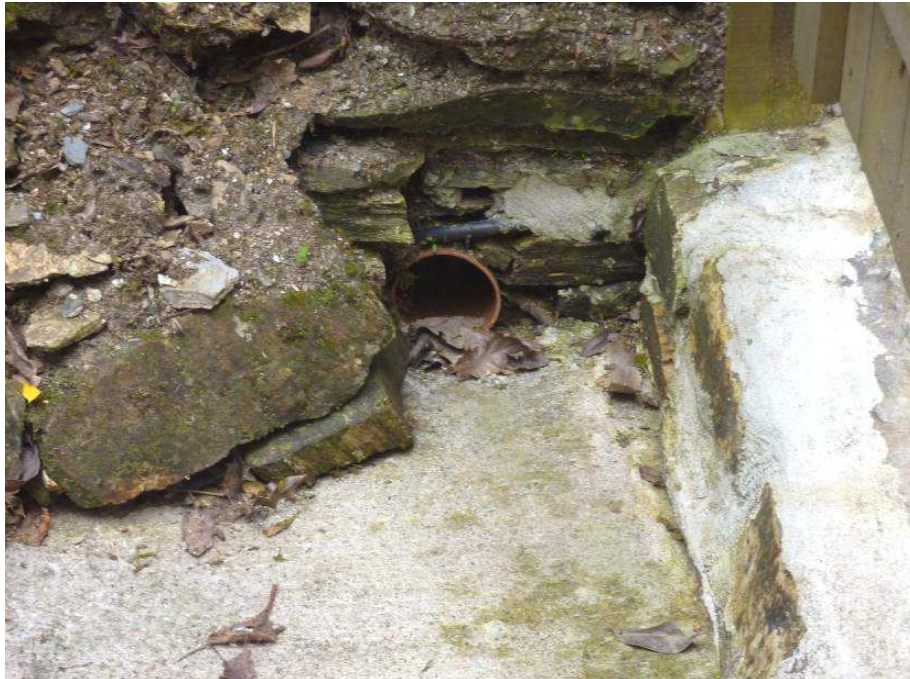
On the south-western side of the building, there are plastic gutters to the roof over the original building and to the extension. These both discharge via plastic downpipes onto the ground. Water from these downpipes then runs around the side of the building.

The gutters to the porch and shower room are also of plastic and these, again, discharge onto the path. Rainwater running along this path is routed via a plastic pipe under the hedge and out onto the pathway.

The gutters and downpipes are functioning correctly at the moment but you will need to keep them clear of leaves and debris at all times, particularly during the autumn and winter months to prevent over-spillage occurring.

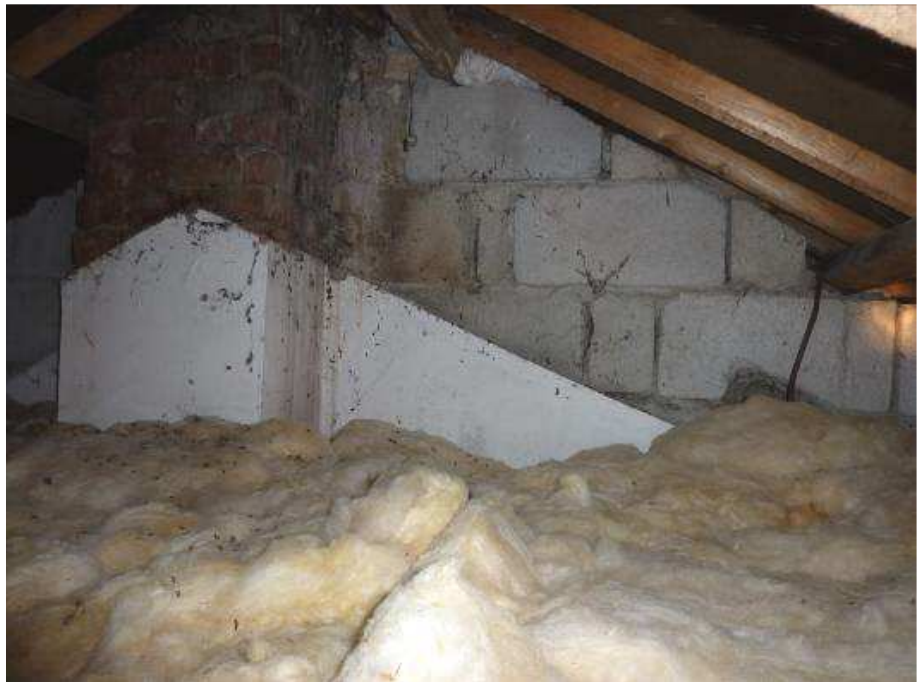
When I carried out my inspection of the roof void, evidence of concrete blockwork to this southern gable was clearly apparent and it looks also that the roof pitch may have been lifted here slightly as below the exposed blockwork in the roof space is an area of rendered blockwork.

It is clear from the photographs that were shown to me that this wall pre-dates the extension which is why I concluded that it was an earlier alteration.

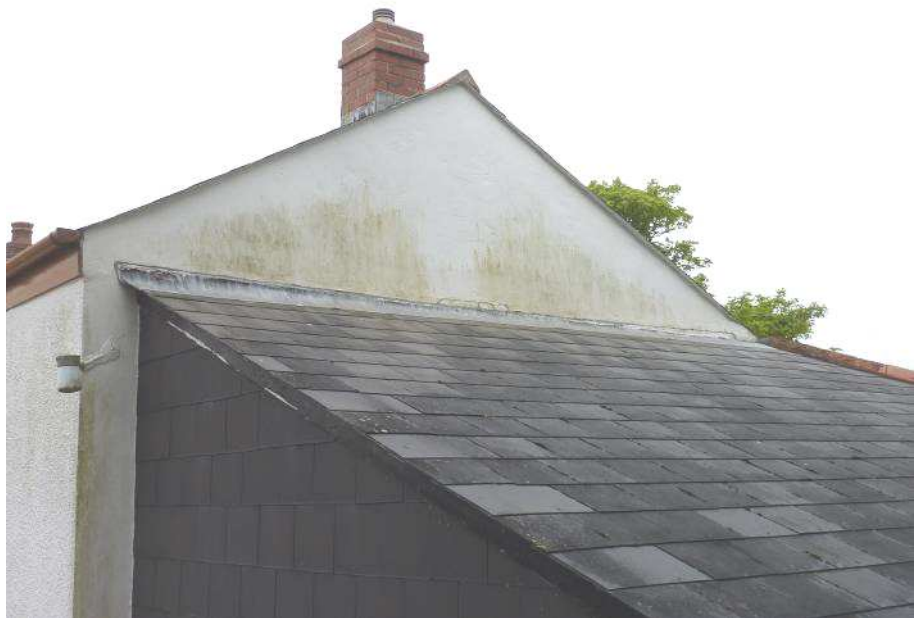
The northern elevation of the original building measures up to 800mm in thickness. This, again, is of stone and cob and indeed cob was clearly seen within the roof void and externally the apex has a sand and cement render finish and is true, straight and uniform.

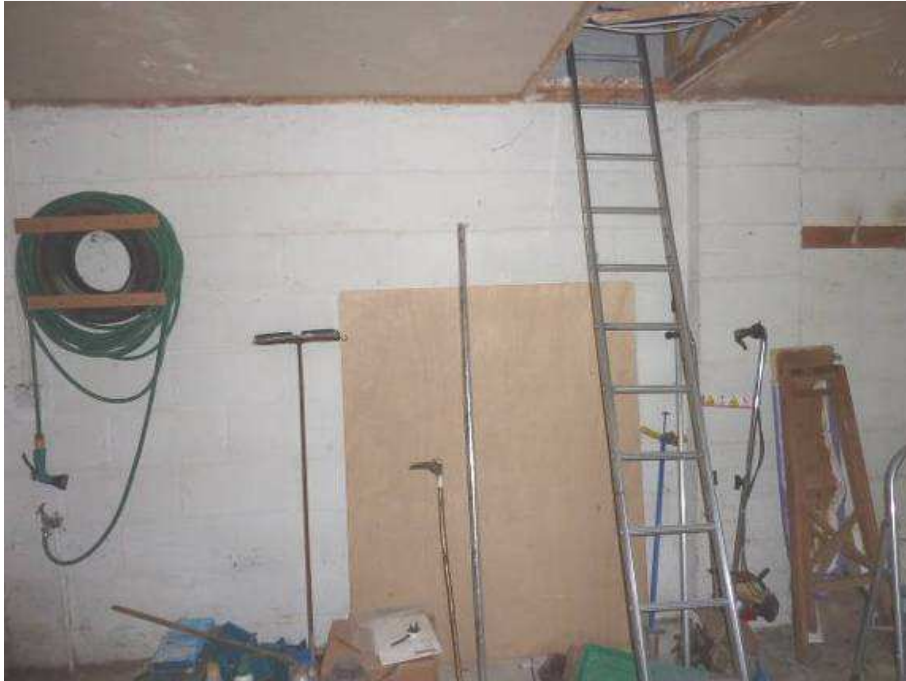
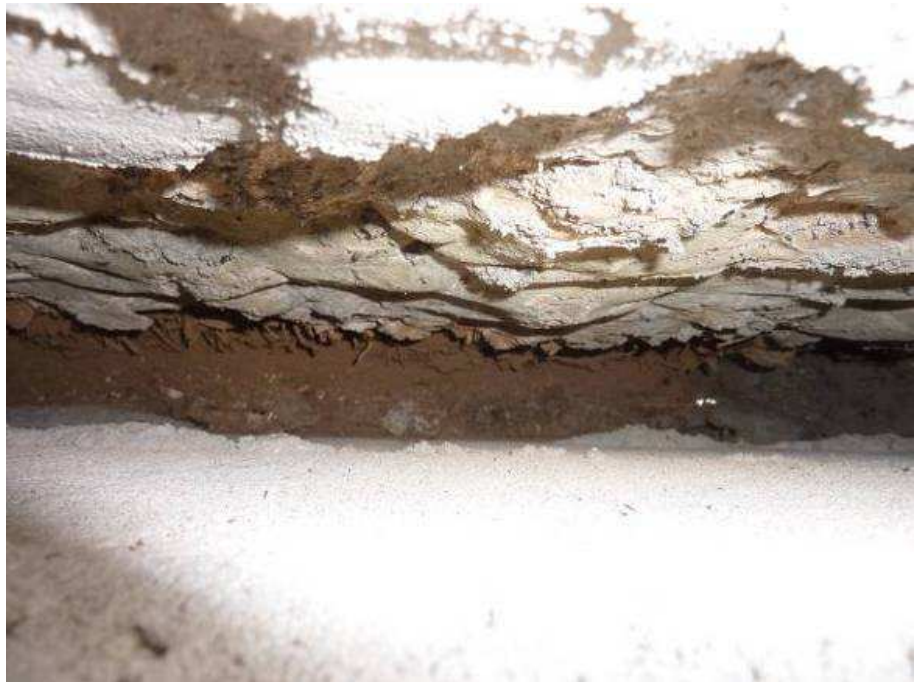
Within the garage, however, this wall has been lined with un-plastered concrete blockwork and from within the garage roof void I could look down the cavity between the blockwork and the original wall and cob can be clearly seen.

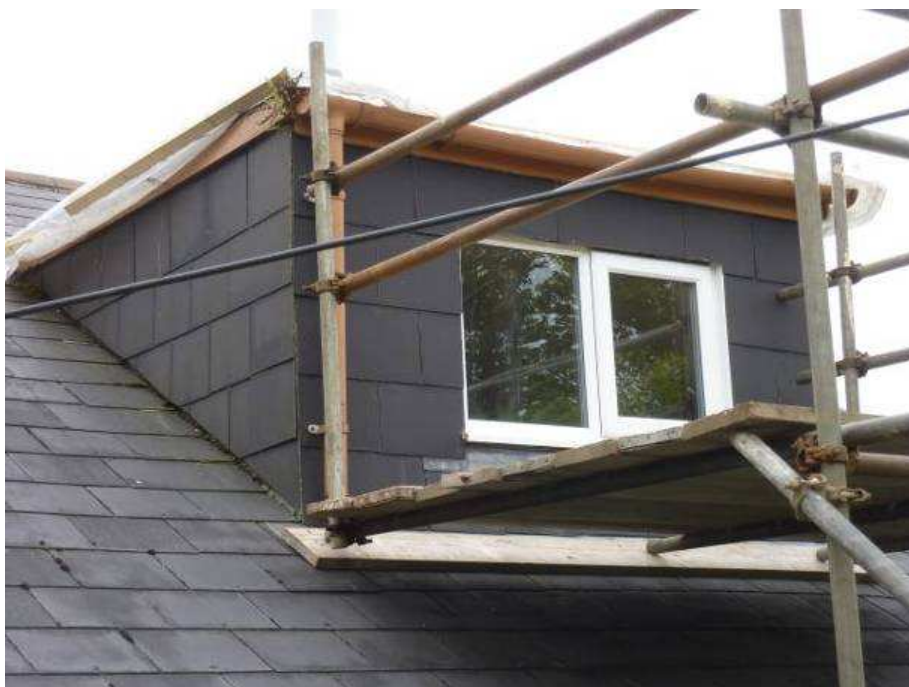
The dormer on the western side is a fairly basic timber framed structure which has been clad with manmade tiles and proper lead flashings are formed where this dormer breaks through the western roof slope forming a weatherproof seal.

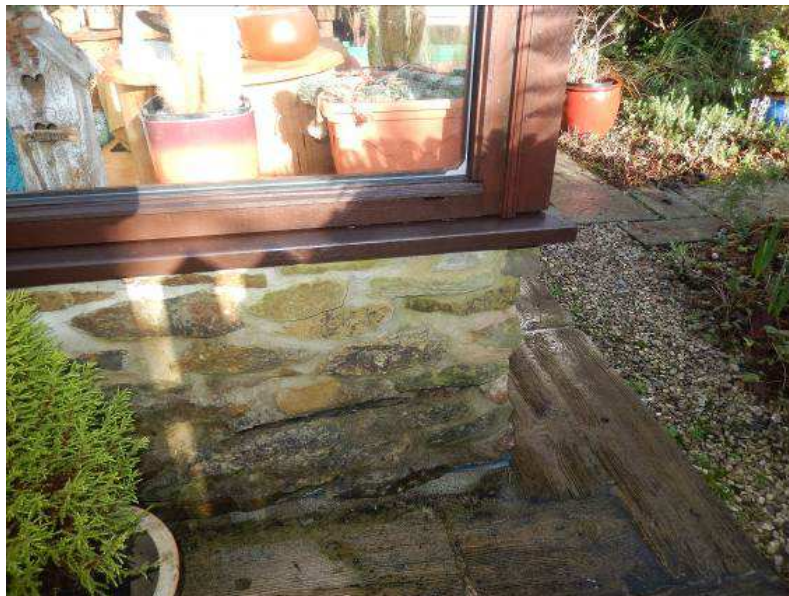
The conservatory is built off a low stone wall off a concrete base.

The floor is of solid concrete and I found it to be firm and level overlaid with timber

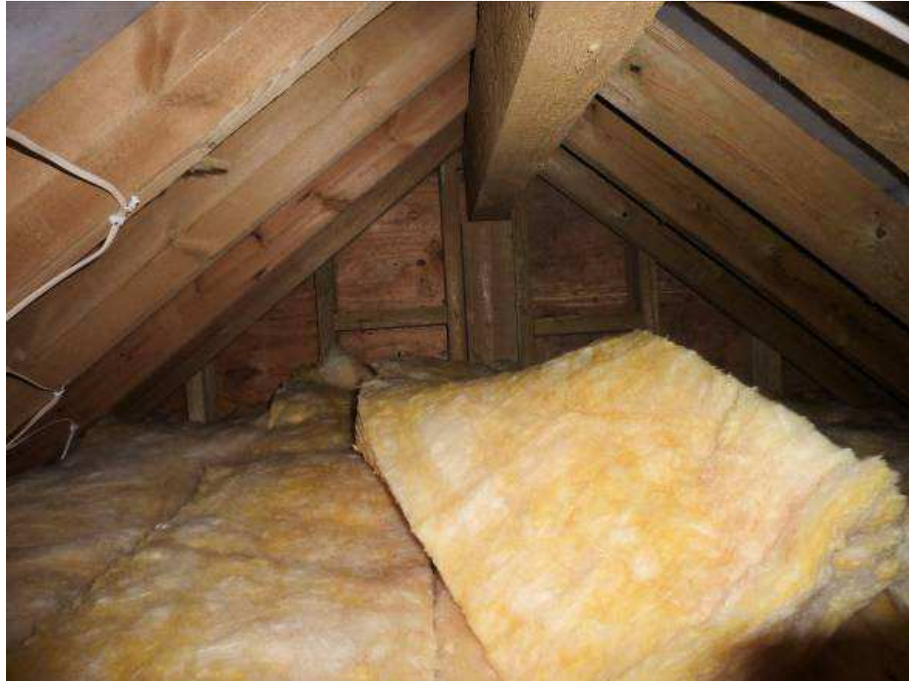
The underside of this roof slope has been felted with a modern breathable type roofing felt and this provides through ventilation within the roof void.

Insulation is again laid on top of the ceilings although this, I consider, is an average of 200mm thick and really should be topped up to 270mm.

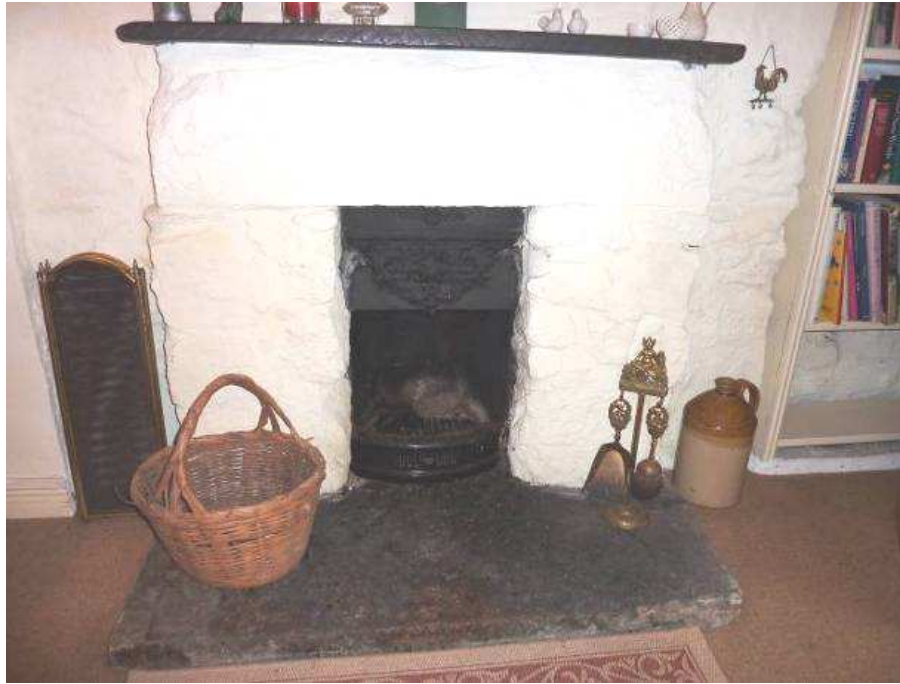
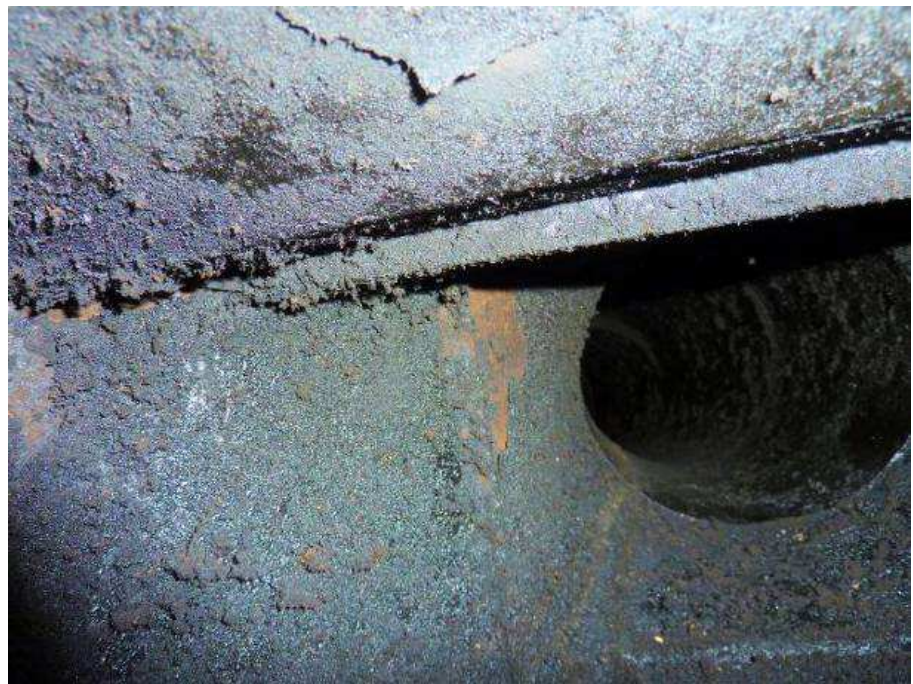
In the lounge there is an open stone fireplace with a slate hearth. The flue appears to have been lined at some stage in the past, possibly when the chimney was rebuilt.

The fire was not lit during my visit and therefore I am unable to confirm how well it draws but there was no evidence of any significant staining to the surround which would suggest that the fireplace may smoke.

This flue, however, must now be professionally swept before the fireplace is used.

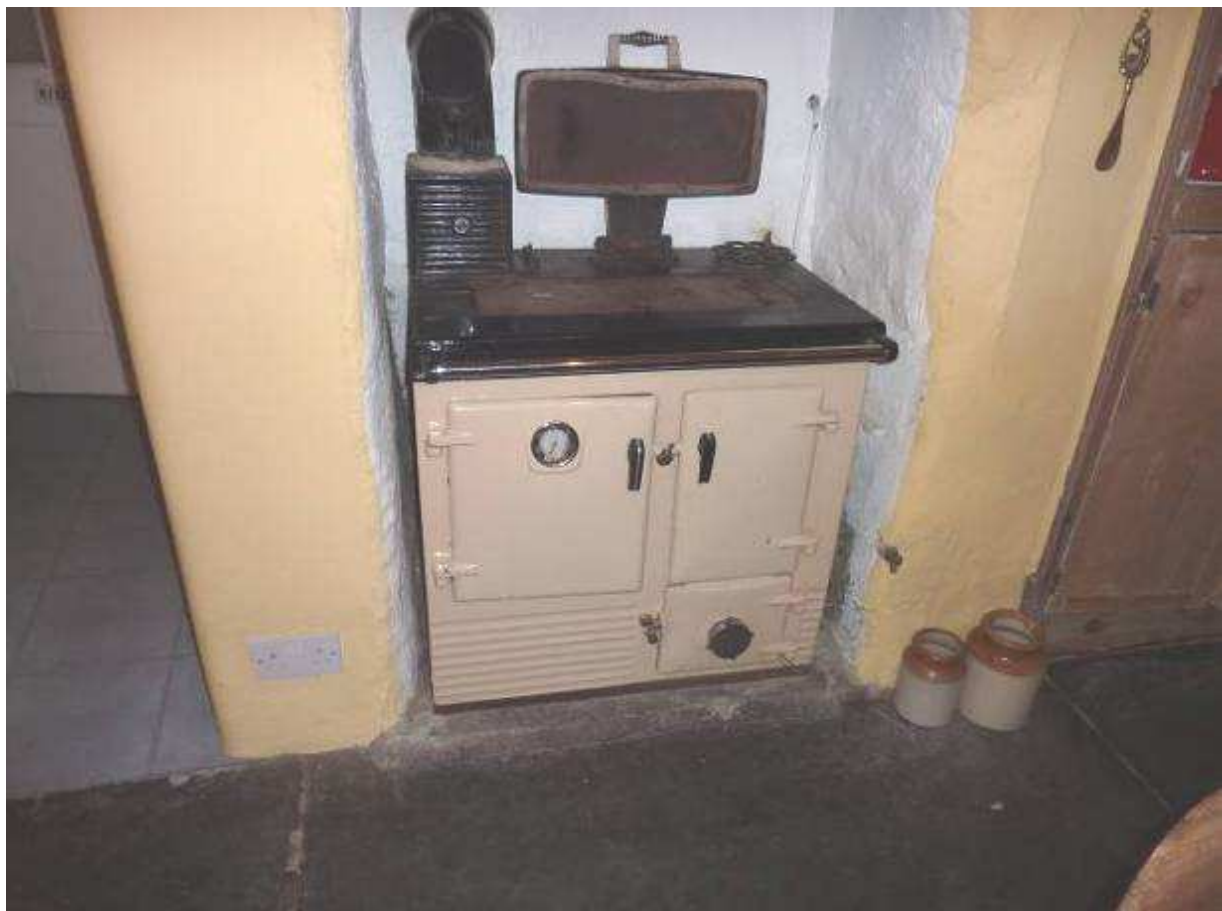
Around the lid to the hot plate there is a rope sealant which looks quite old and seems to be of an asbestos based material.

This is becoming loose and detached and it must now be replaced. Specialist advice will need to be sought in relation to the replacement and disposal of the old rope.

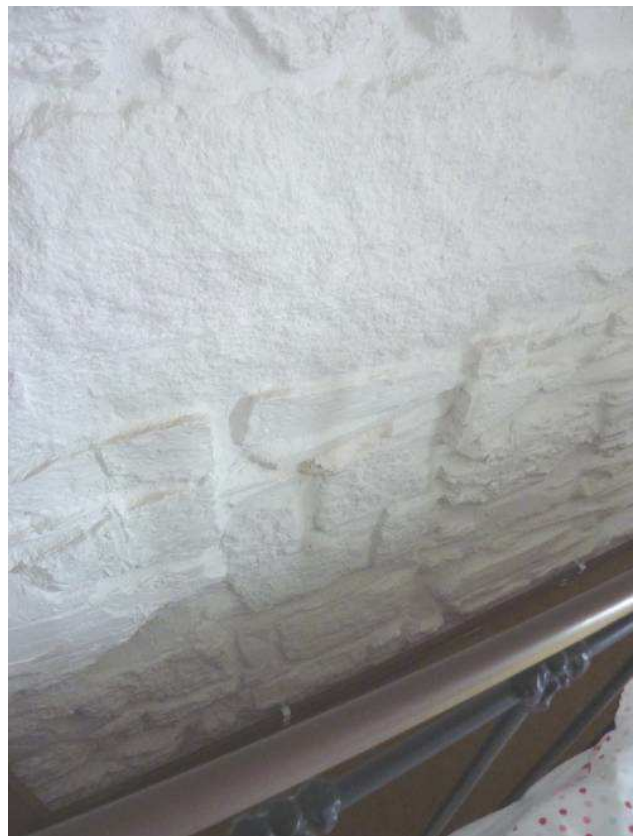
In the southern bedroom you can clearly see the position of the old fireplace which has been blocked up behind the bed.

All old disused fireplaces should be opened, swept, capped and vented to avoid conditions where moisture and dampness in the flues could build up giving rise to condensation and timber decay.

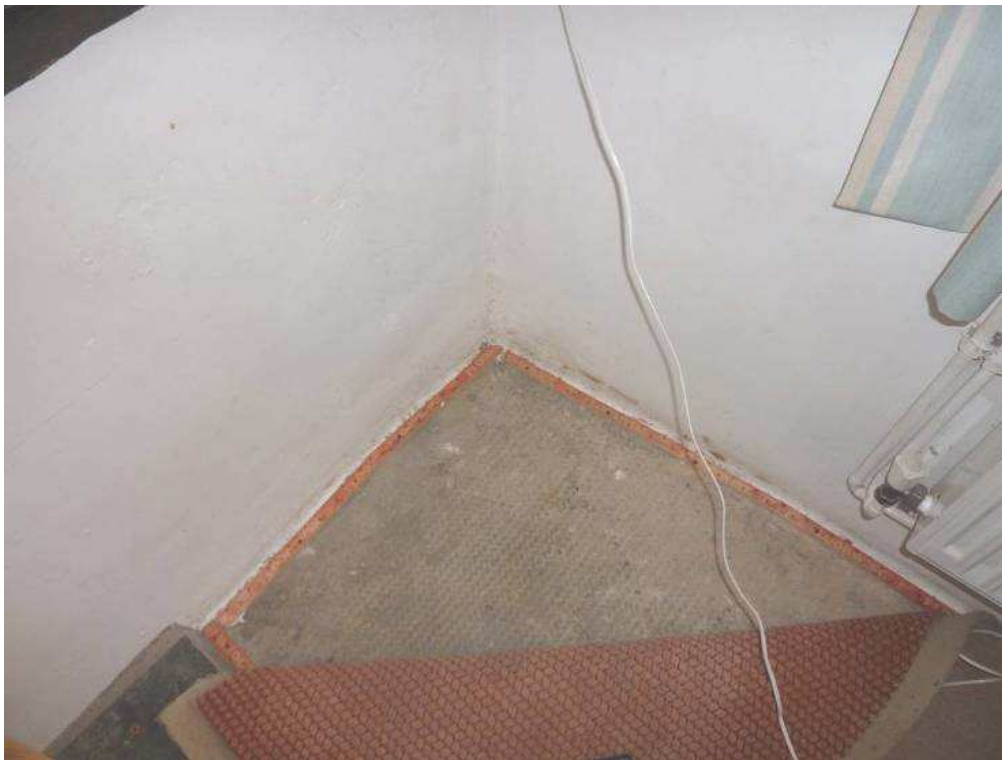
In the lounge, the floor has been carpeted. I was only able to lift a small corner to the south-eastern side and this revealed a relatively modern concrete floor slab.

When I checked later through fitted carpets with my moisture meter, no indication of any dampness could be found.

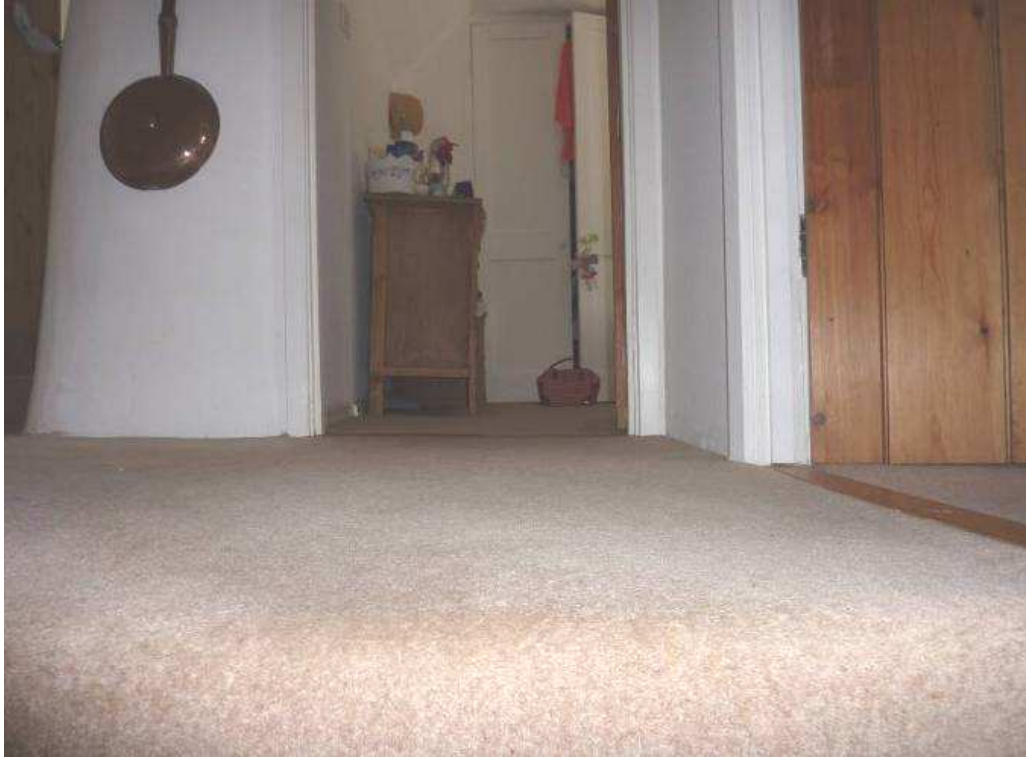
There is inevitably some deflection to the suspended timber floors in the original part of the building. This can perhaps best be seen looking through to the south-eastern bedroom off the landing where it is quite obvious that the floor drops towards the middle.

This is quite common, particularly in older properties, due to the fact by modern day standards the floor joists will be undersized and spaced too far apart.

Consequently, there is some give, spring and non uniformity to the suspended timber floors in the original part of the building but no more than I would have expected to have found and within acceptable tolerances.

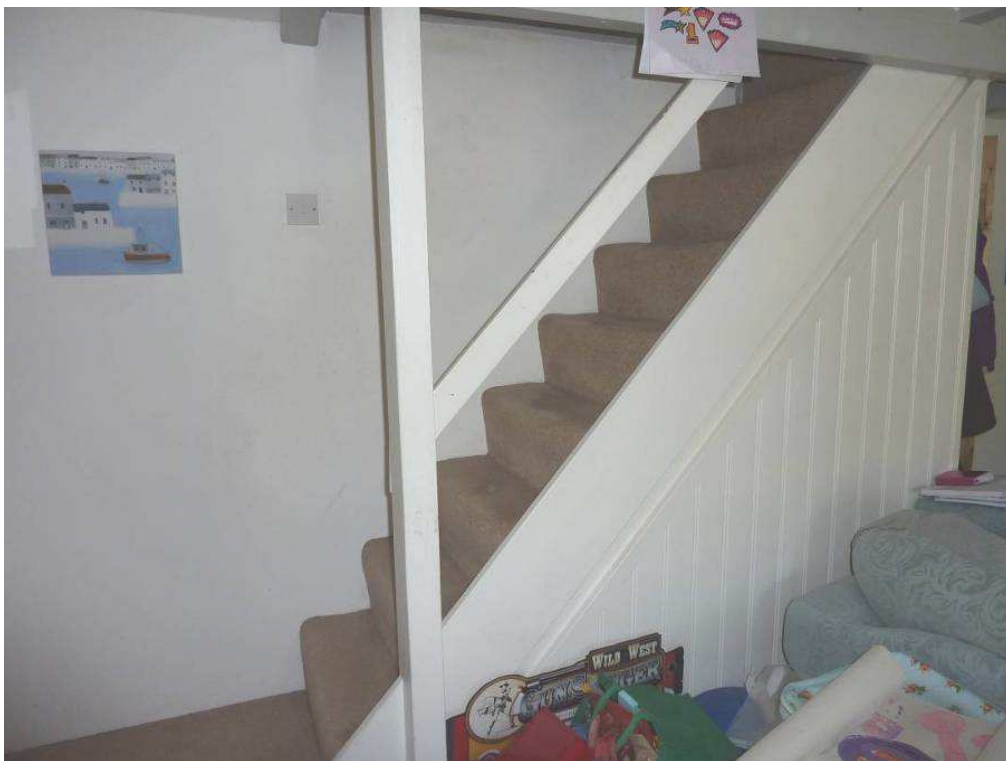
The stairs from ground to first floor are reasonably firm and level but as with most old cottages they are quite steep and will need to be negotiated with care.

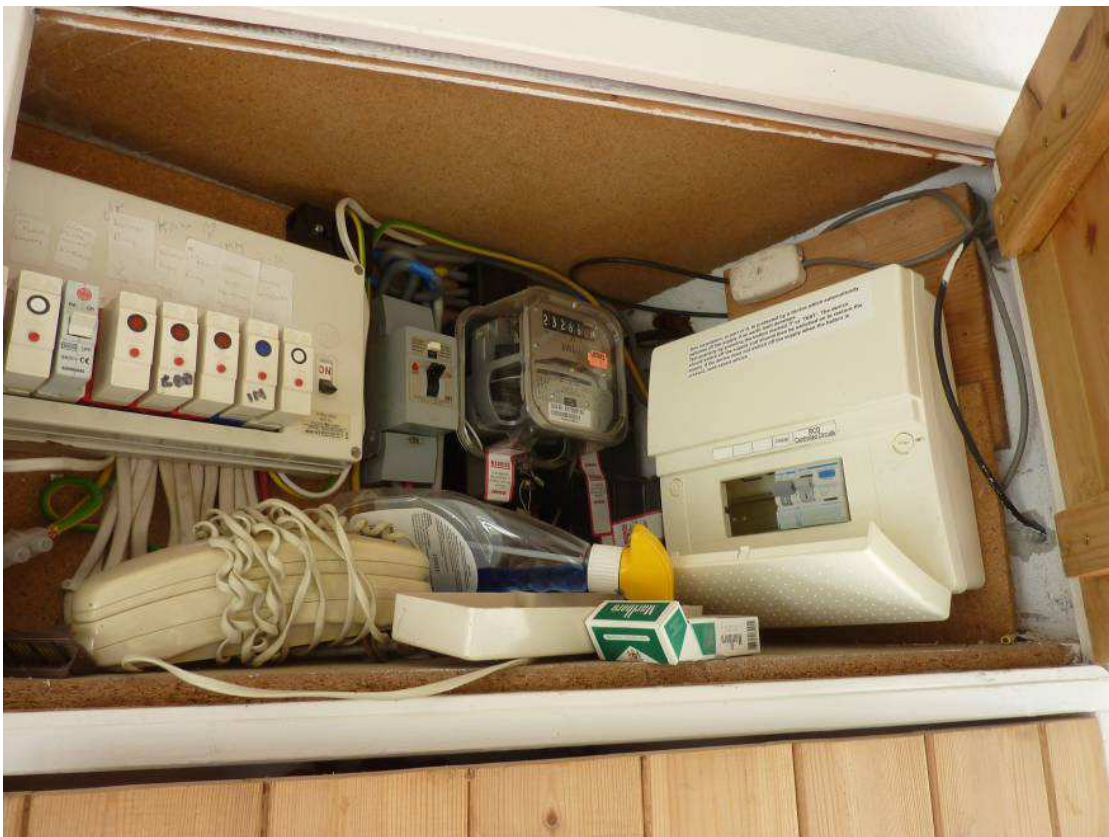
I am unaware when the system was last checked or tested and although I could see no sign of any obvious problems, it is always recommended that electrical installations be checked upon change of ownership.

I recommend therefore that prior to purchase, you ask an electrical contractor to carry out a brief inspection and to check the system and confirm whether or not it is safe and advise you if any updating is required.

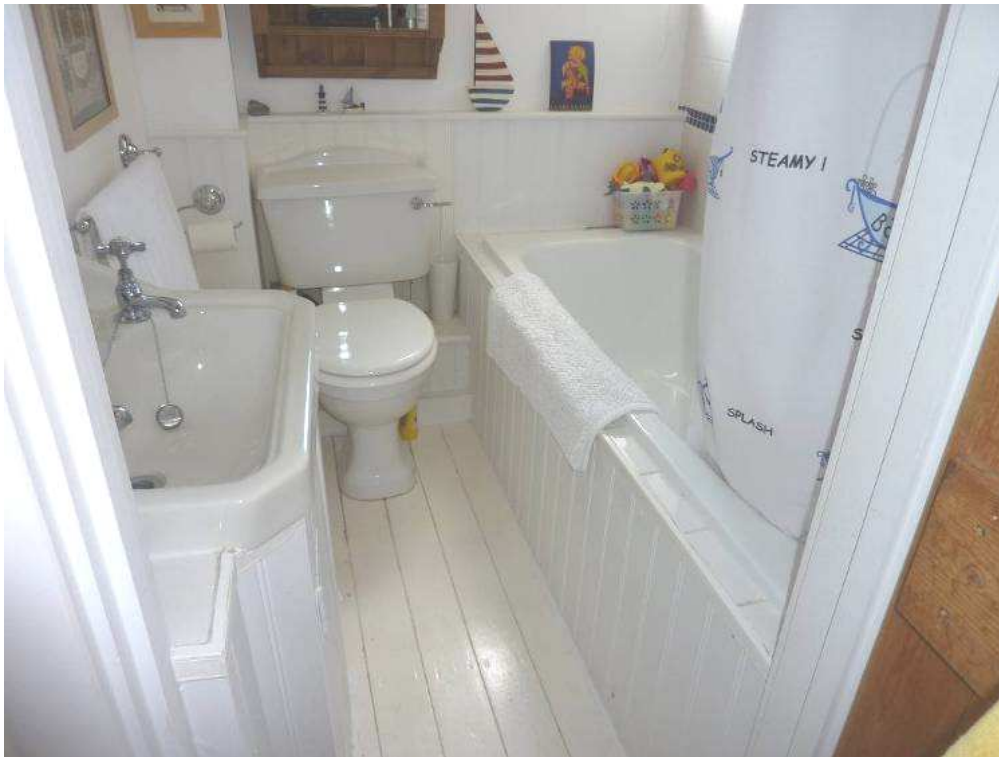
This comprises a white bathroom suite at first floor level with steel panel bath, wash hand basin and WC, all of which were serviceable. There is an electric shower above the bath although this has not been tested. There was no proper shower screen, only a curtain.

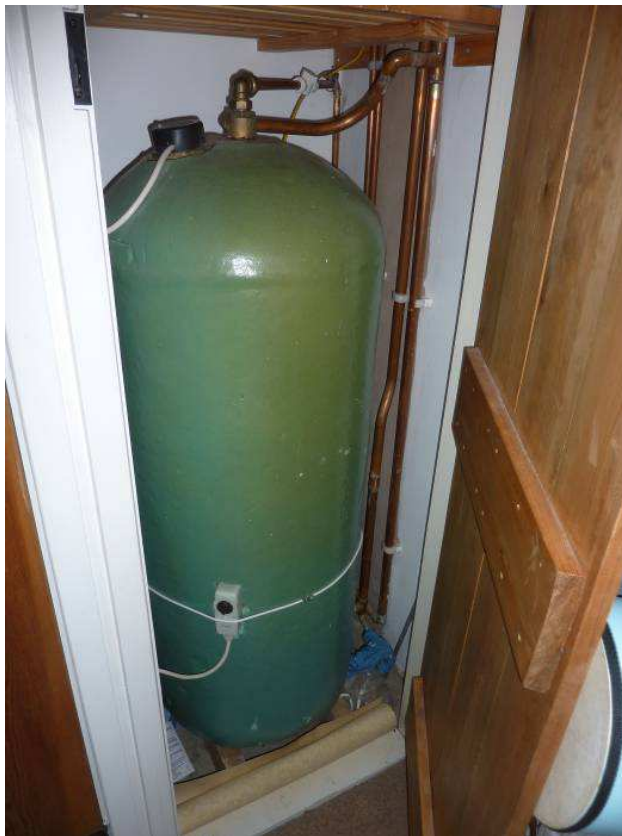
The boiler serves radiators as well as providing hot water and hot water is supplemented by means of a factory lagged copper cylinder with an immersion heater fitted in the airing cupboard in the back bedroom.

The system is now probably due for a service and therefore before you purchase, I recommend that you ask a qualified heating engineer to check and service the boiler or arrange for the owners to do this and then you should set in hand an annual maintenance agreement.

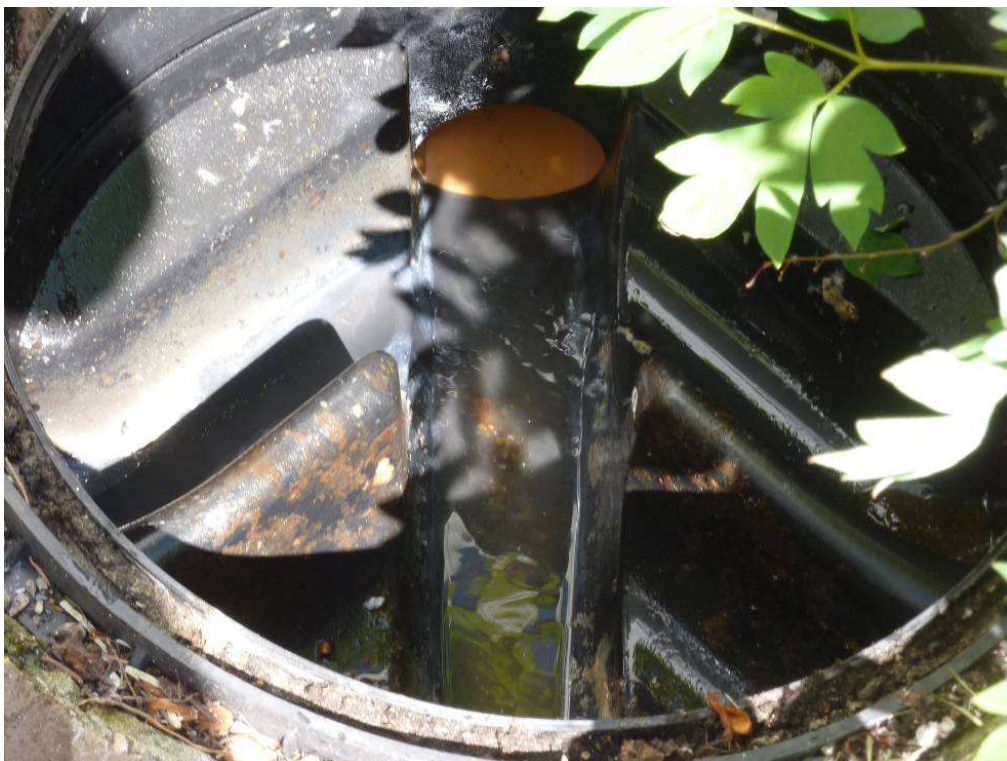
There is only one inspection chamber in the rear yard. This was lifted and waste was run through the system and is discharging satisfactorily with no sign of any blockages.
