LEVEL 2

Your survey report

24 Trevenson Road Truro Cornwall TR1 2SQ

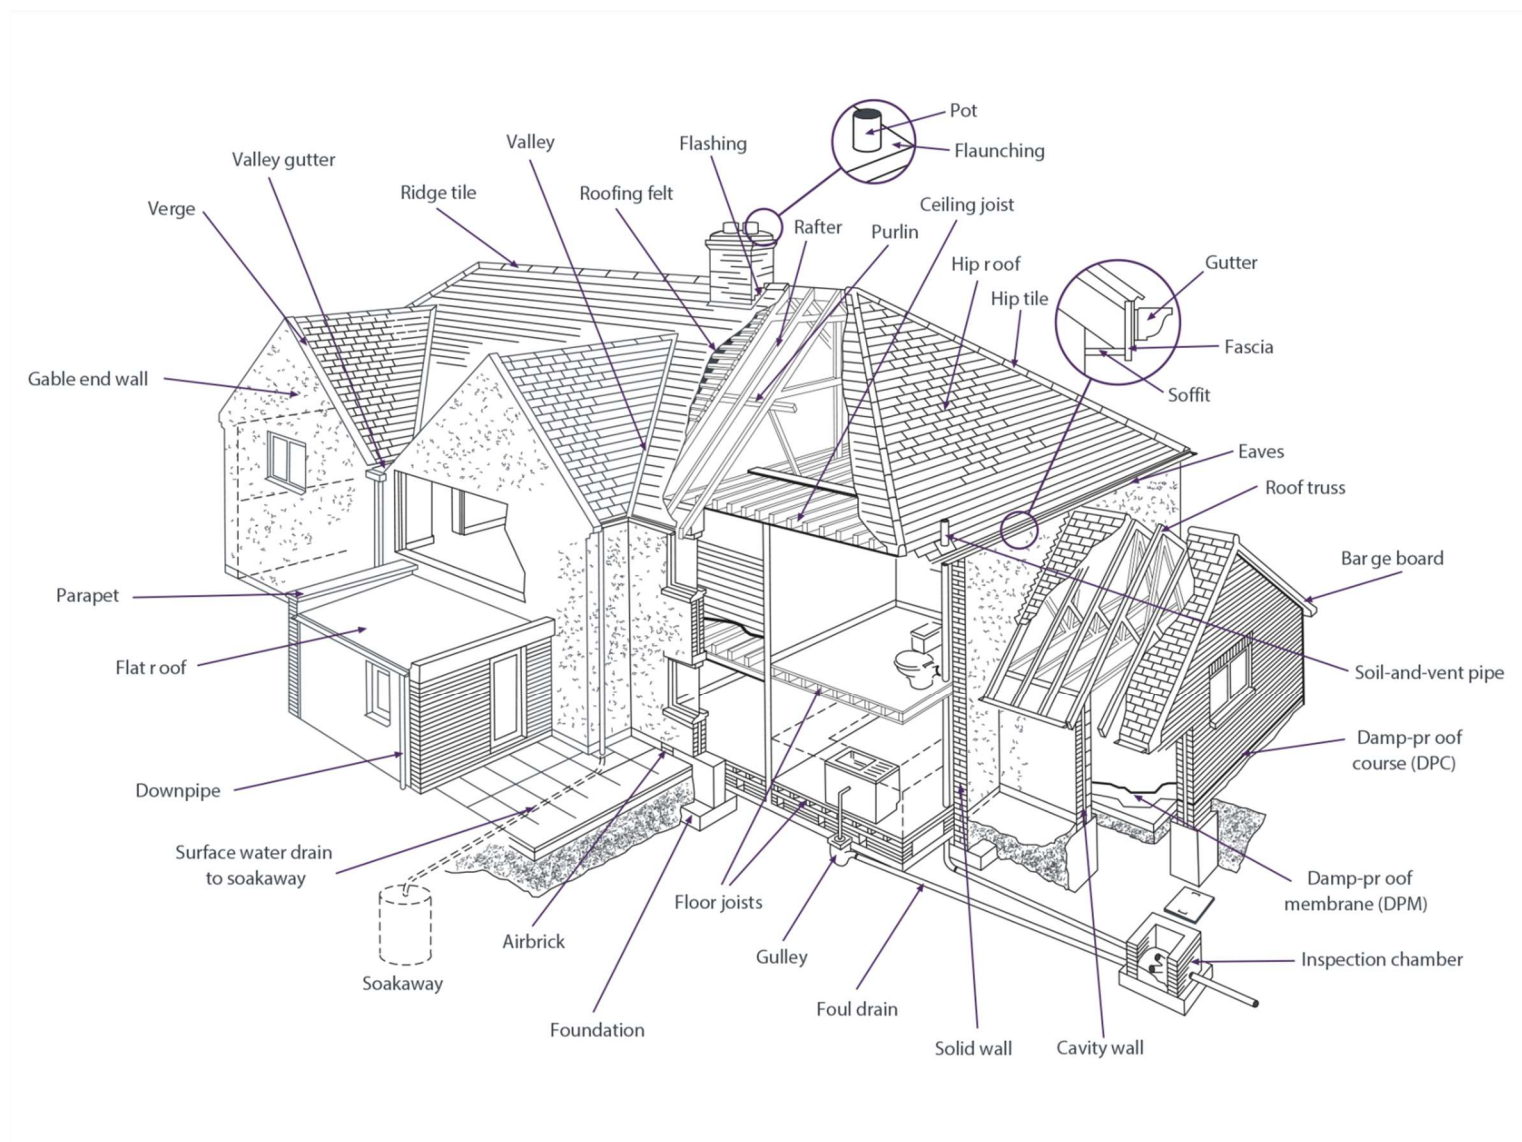
Typical house diagram

This diagram illustrates where you may find some of the building elements referred to in the report.
